**Restoring Chemical Warfare M1 Collective Protector System**  
**Battery Gunnison/New Battery Peck**  
***Ft. Hancock, New Jersey***

In the spring of 2014, the Army Ground Forces Association began locating and fabricating the required materials to restore the M1A1 Collective Protector Chemical Warfare system in Battery Gunnison/New Battery Peck. During this time AGFA was able to obtain a very significant quantity of original chemical warfare equipment, to include a 3,500 rpm AC motor and blower, switches, valves, pulleys and ancillary materials. Most of this equipment was in good to excellent condition and well within the capabilities of the membership to restore to a functional condition.

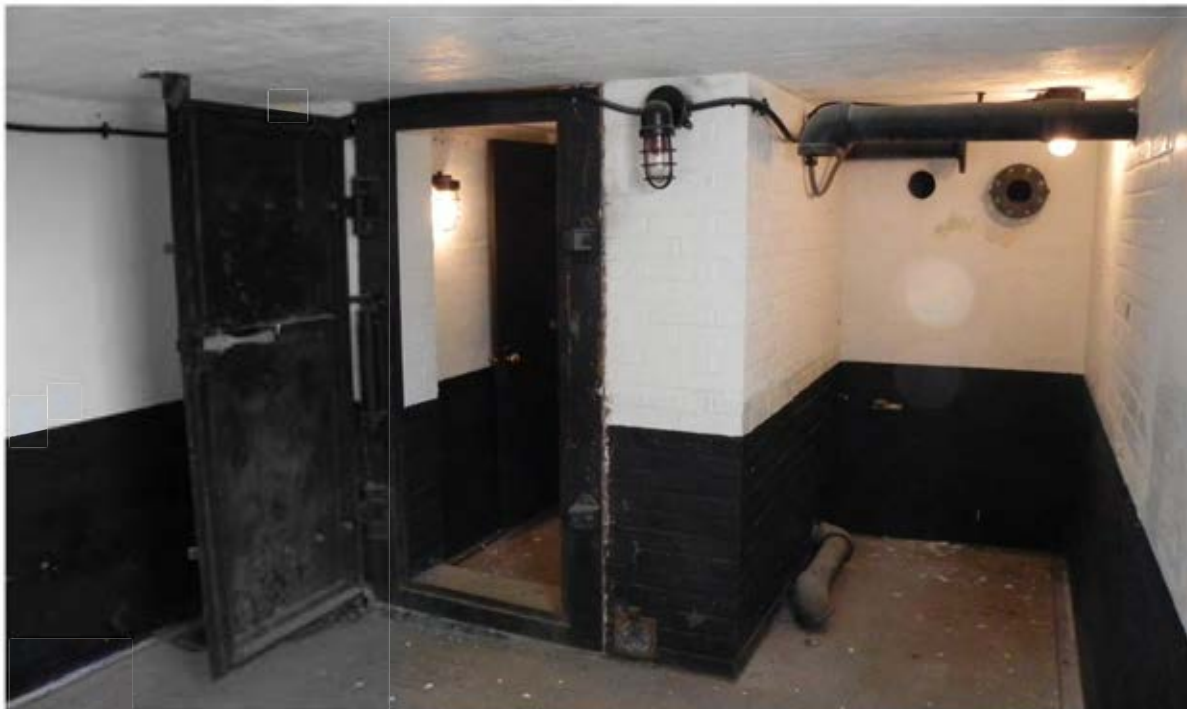
The location for the M1 Collective Protector is shown below as it existed in Oct 2012. The four existing pipes (three top of room, one on floor) were all that remained of the original installation. In 2011 the vintage lighting pictured was re-installed. The lighting was revised to the correct configuration for 1943 in 2018.

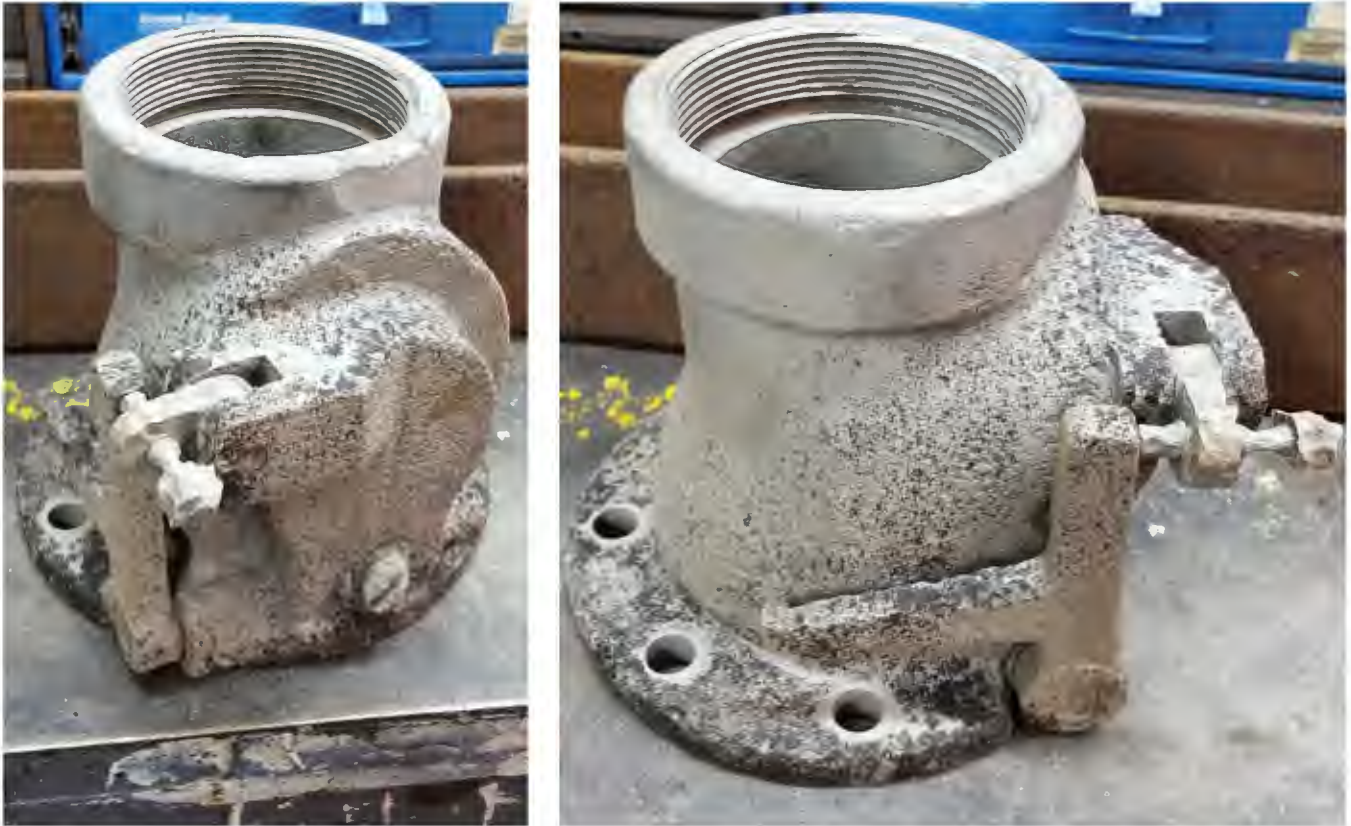
The photo below shows the top bypass filter valve under restoration. This valve is affixed to the top of the M1 Canister Filter and 4-inch cast iron pipe leading to the plotting room (protected space) air delivery pipe and the bypass pipe.

The work to obtain the lower valve and a more intact upper valve is addressed later in this paper.

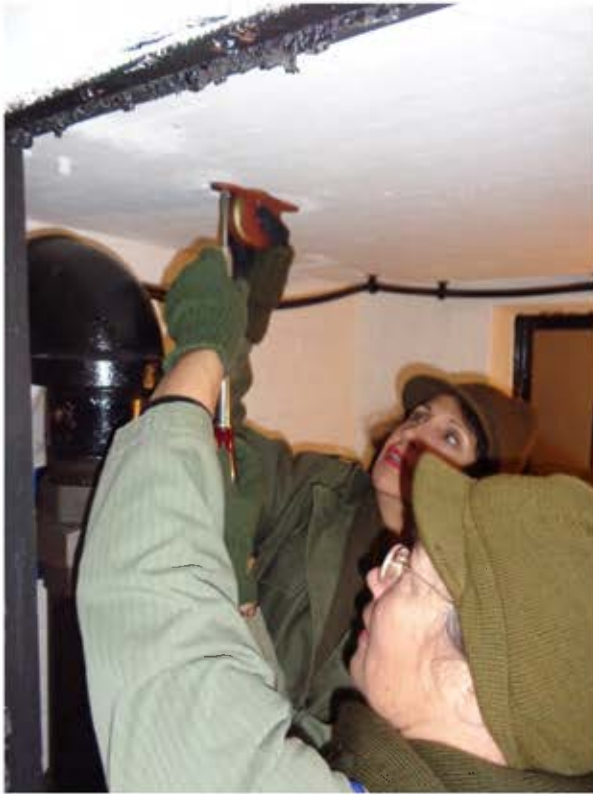
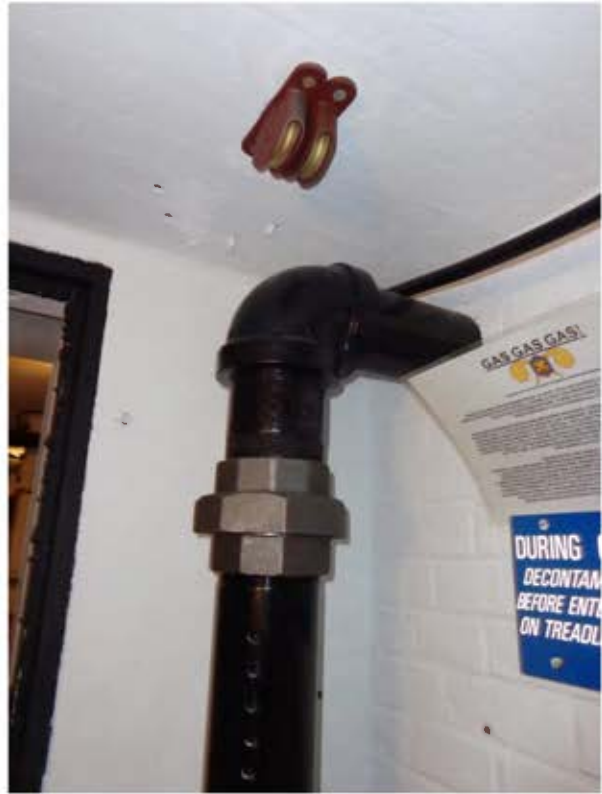
In January 2017 the installation of the switching began with the installation of the two restored pulleys. The picture on the left shows the two pulleys being installed and the picture on the right shows them in position. The heavy joiner assembly on the pipe was an initial installation that proved unworkable and was removed.

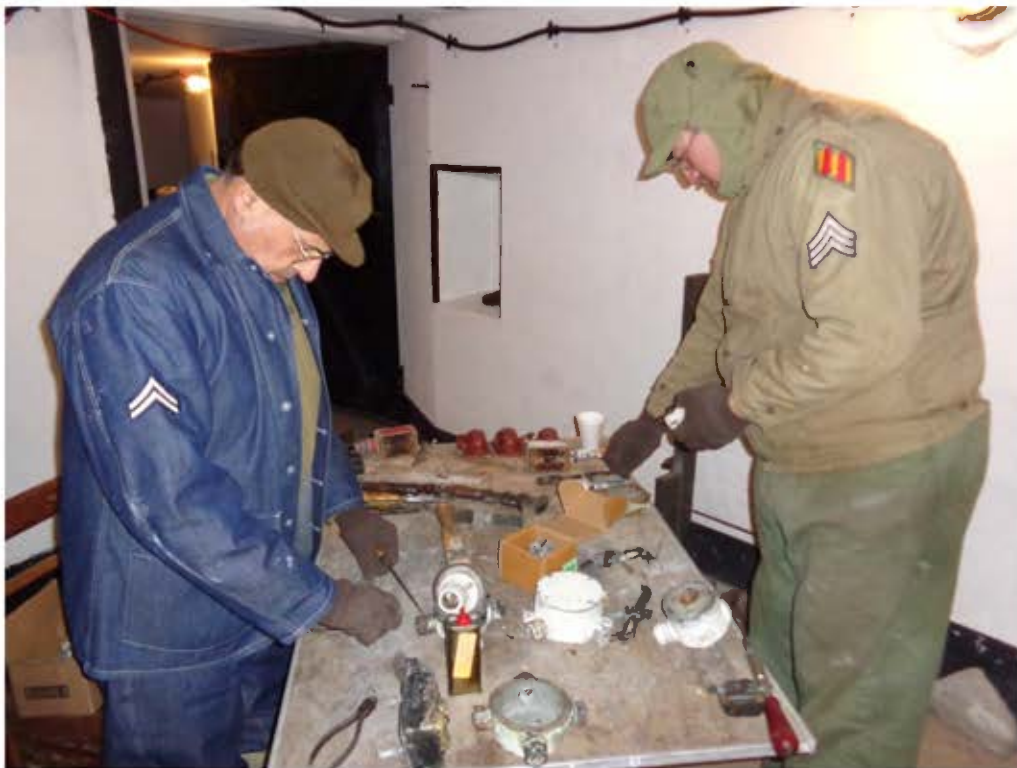
In January 2017 AGFA began restoring a significant amount of original chemical warfare equipment obtained from outside of Gateway from a very similar installation. This windfall provided functional switches and controls otherwise unavailable.

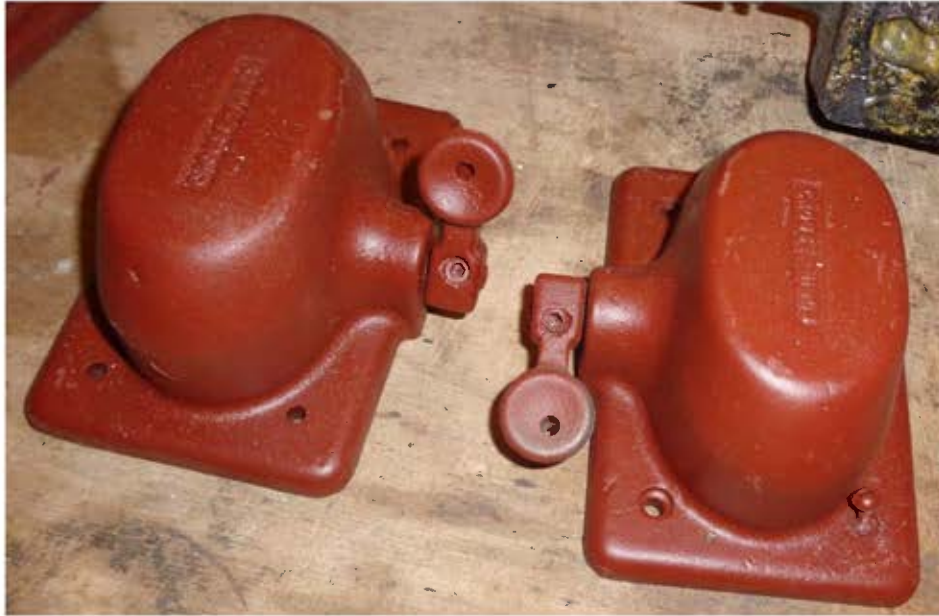
The two items below are switch covers and actuators as primed after cleaning.

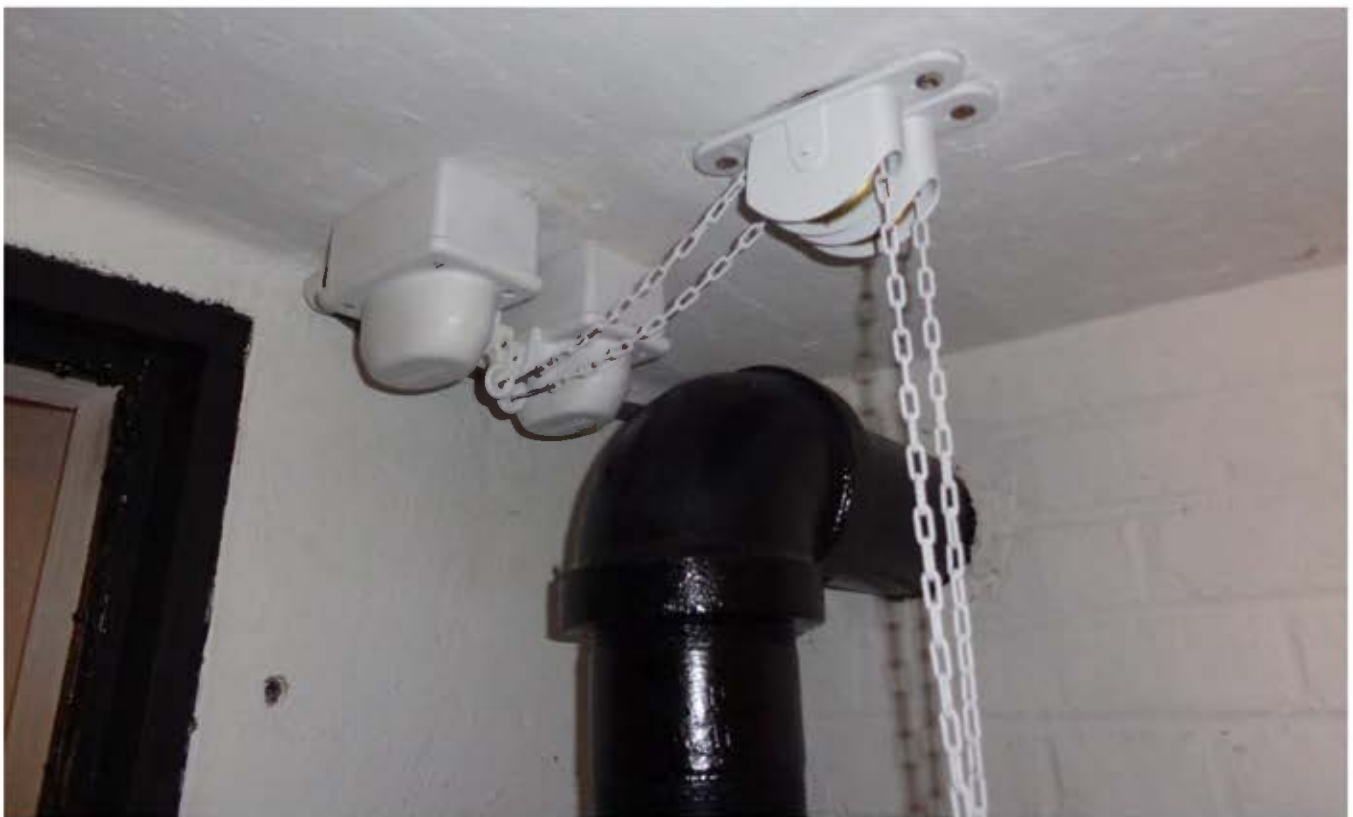
The two switches, actuating chains and pulleys are shown below in place as of May 2017. The chains shown in the photograph are attached to the treadle on the floor of the decontamination chamber. They are spring loaded on the chain and when the treadle is released, the switches turn off automatically. One switch controls the blower motor, the other controls a red light on the exterior entrance door inside the chemical warfare equipment room. This is the entry point into the plotting room during a chemical agent attack.

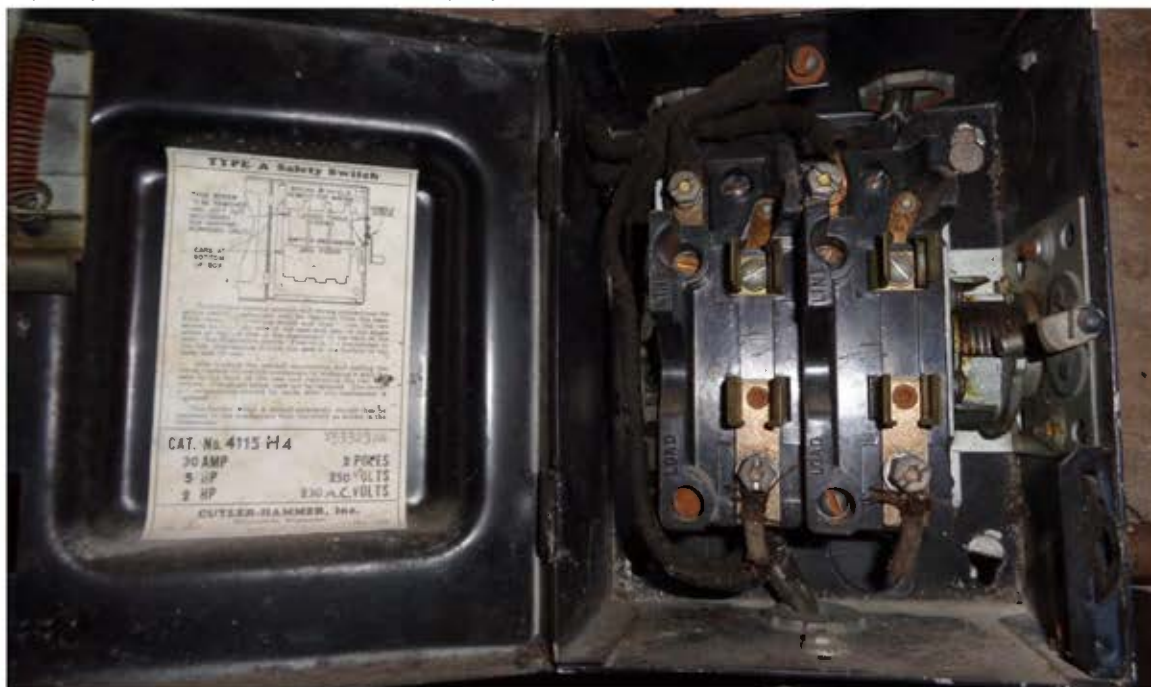
Two Type A safety boxes historically were installed with blower motors. None of the boxes on the systems at Fort Hancock have survived. The boxes AGFA obtained are both from 1939 and in near mint condition. The motors are 3,500 revolutions per minute (RPM) Alternating Current (AC) from the 1930s.

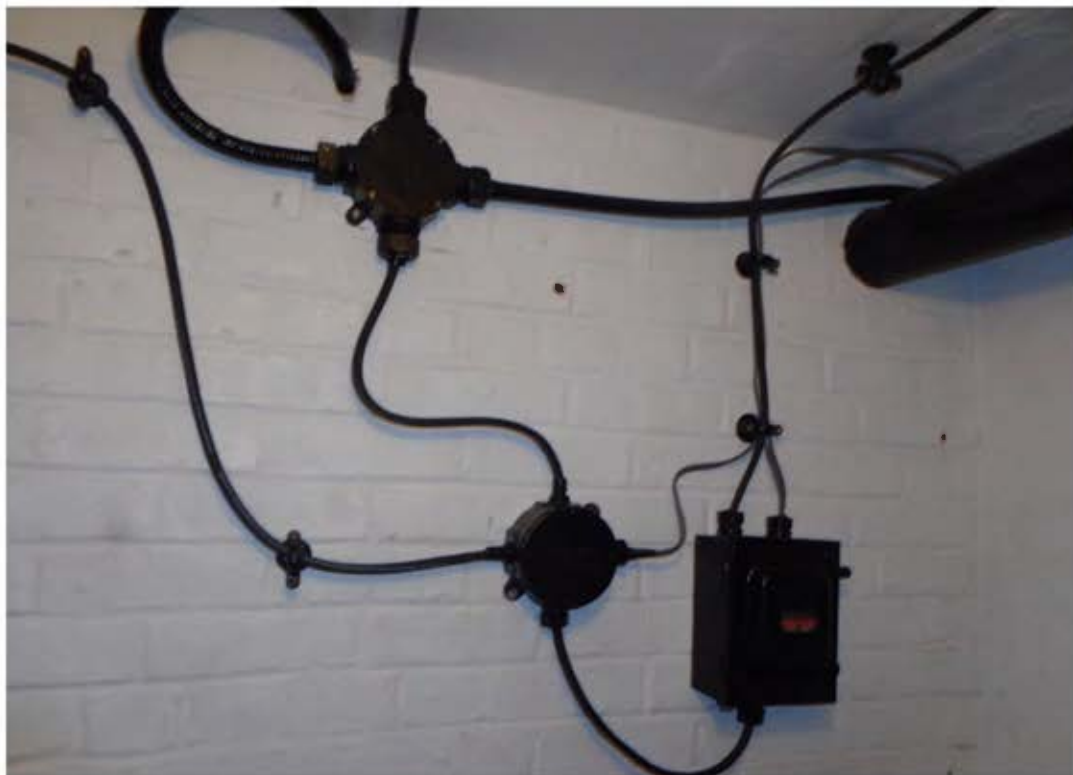
In the photo below from May 2017 the Type A box is installed in the lower right. This box controls the decontamination room blower motor. The cables going into the decontamination station in the upper right of the photo go to the switches on the ceiling of the decontamination station. They are actuated by stepping on the treadle on the floor of the decontamination chamber. The conduit penetrating the wall to the left is to the historic 1920s wall light inside the decontamination chamber. The four way box at the top of the picture is from 1920, The one in the center 1940.

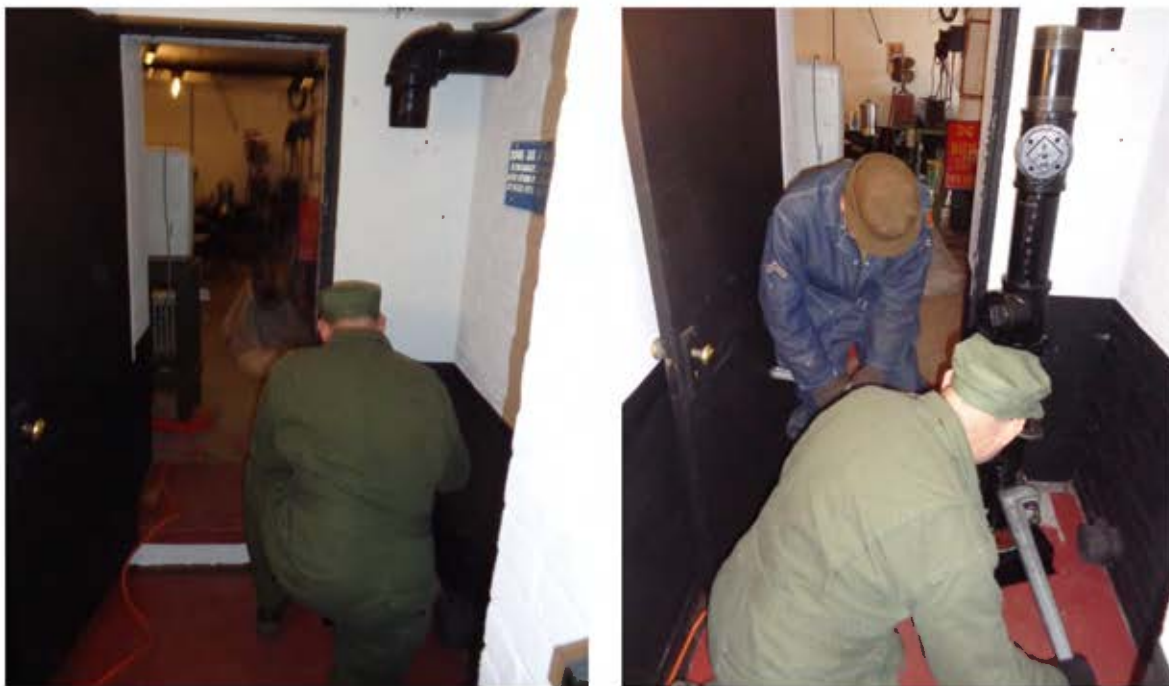
The photo below on the left shows the Decontamination room prior to the installation of the stand pipe. The photo on the right shows the assembled stand pipe being installed by AGFA members.

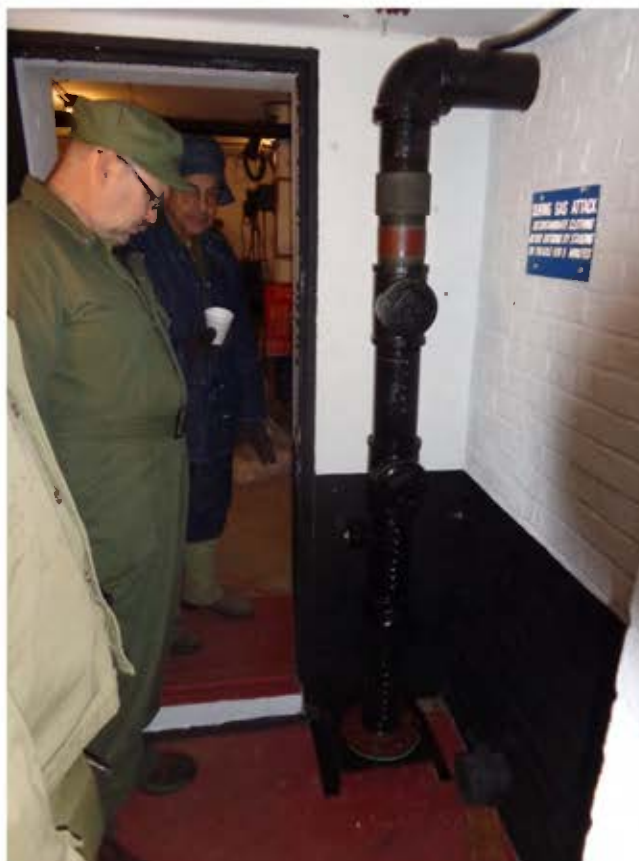
Below the installed standpipe is shown in place on its base. The base had to be fabricated and holes for bolts drilled and taped. This photo shows the standpipe before the treadle and switching assemblies were installed. This work was done in March 2017.

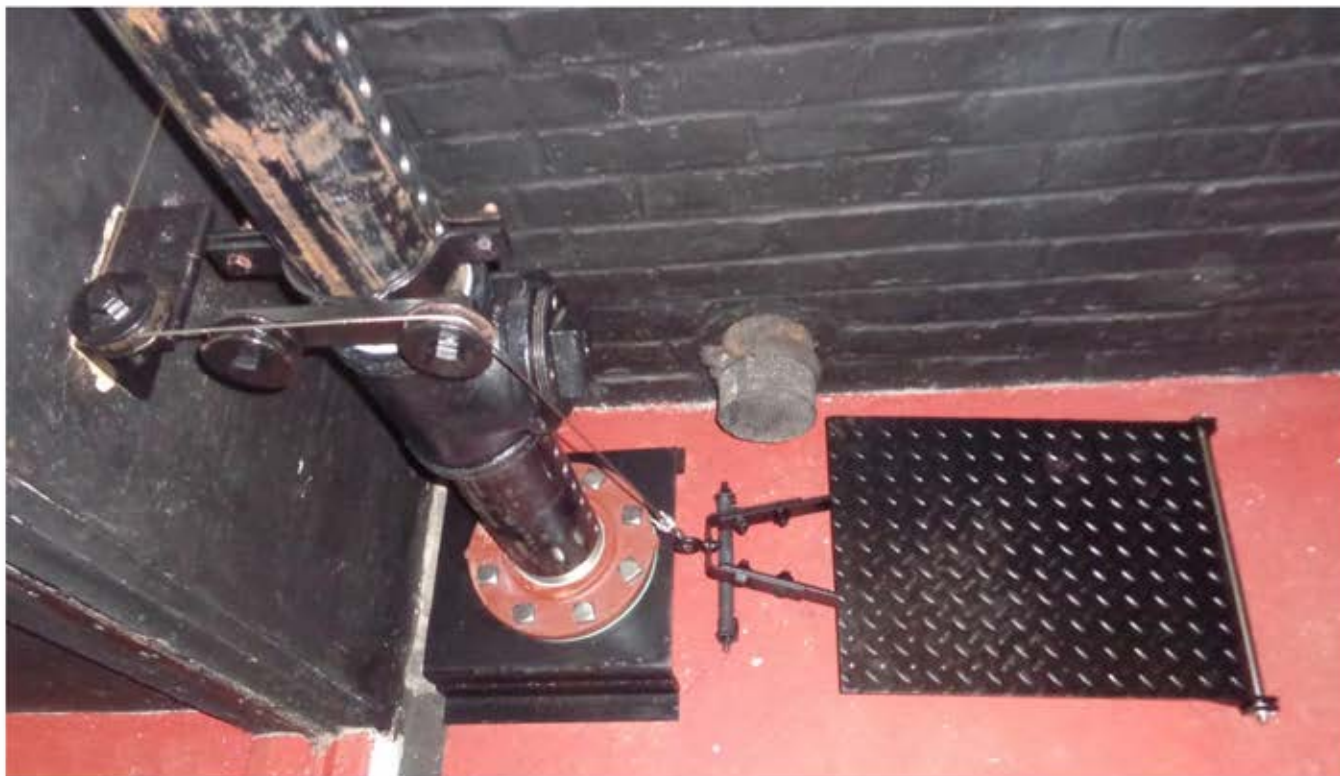
The photo below shows the newly installed treadle plate on the floor of the decontamination chamber. Notice the cable riding on the pulleys to the left and connected to the treadle. In addition to operating the blower motor and the warning light, the treadle also operates a valve on the other side of the wall that changes the direction of the air filter intake from the exterior of the battery to the air scavenging vent protruding from the wall below between the stand pipe and the treadle. The contaminated air from the chamber is then purified in a filter and blown into the plotting room to keep it at proper overpressure and safe during a chemical warfare attack. The pipe has since been primed and painted.

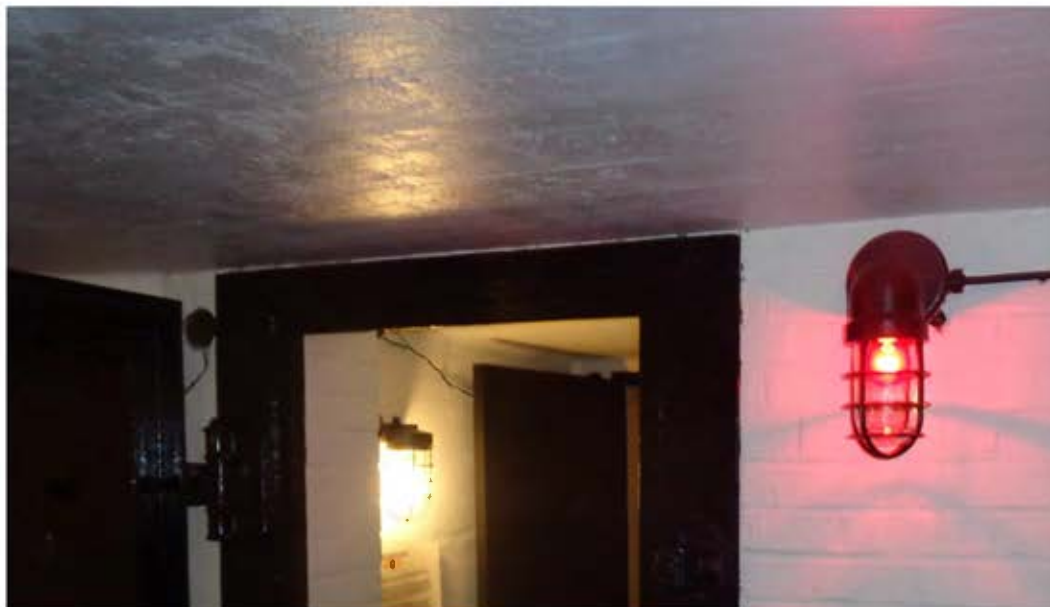
The photo below shows the red warning light (right) signifying that the decontamination chamber is in use. This light was restored and is a 1940 vintage Crouse and Hinds light. The light to the right inside the decontamination chamber is vintage to the 1920s.

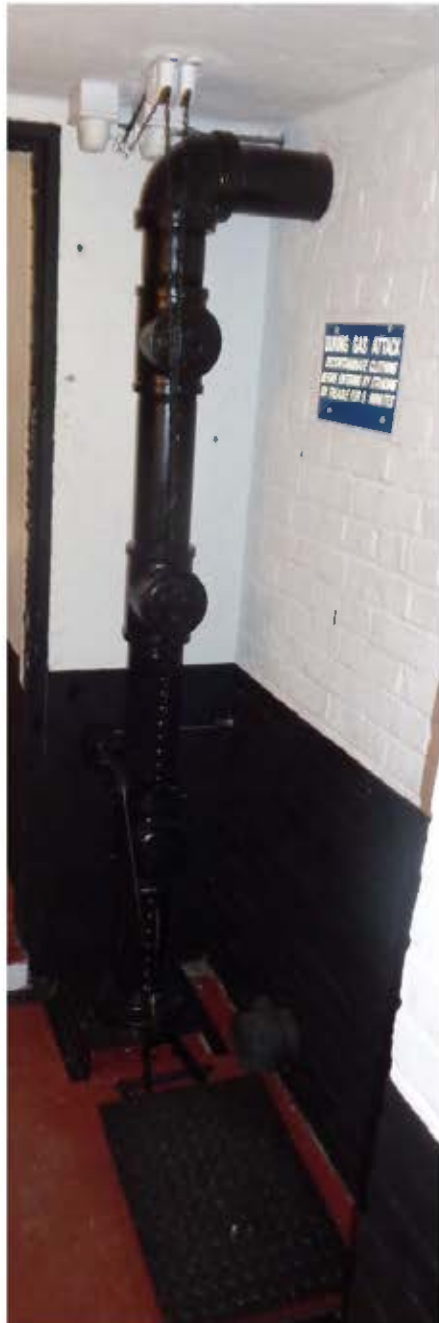
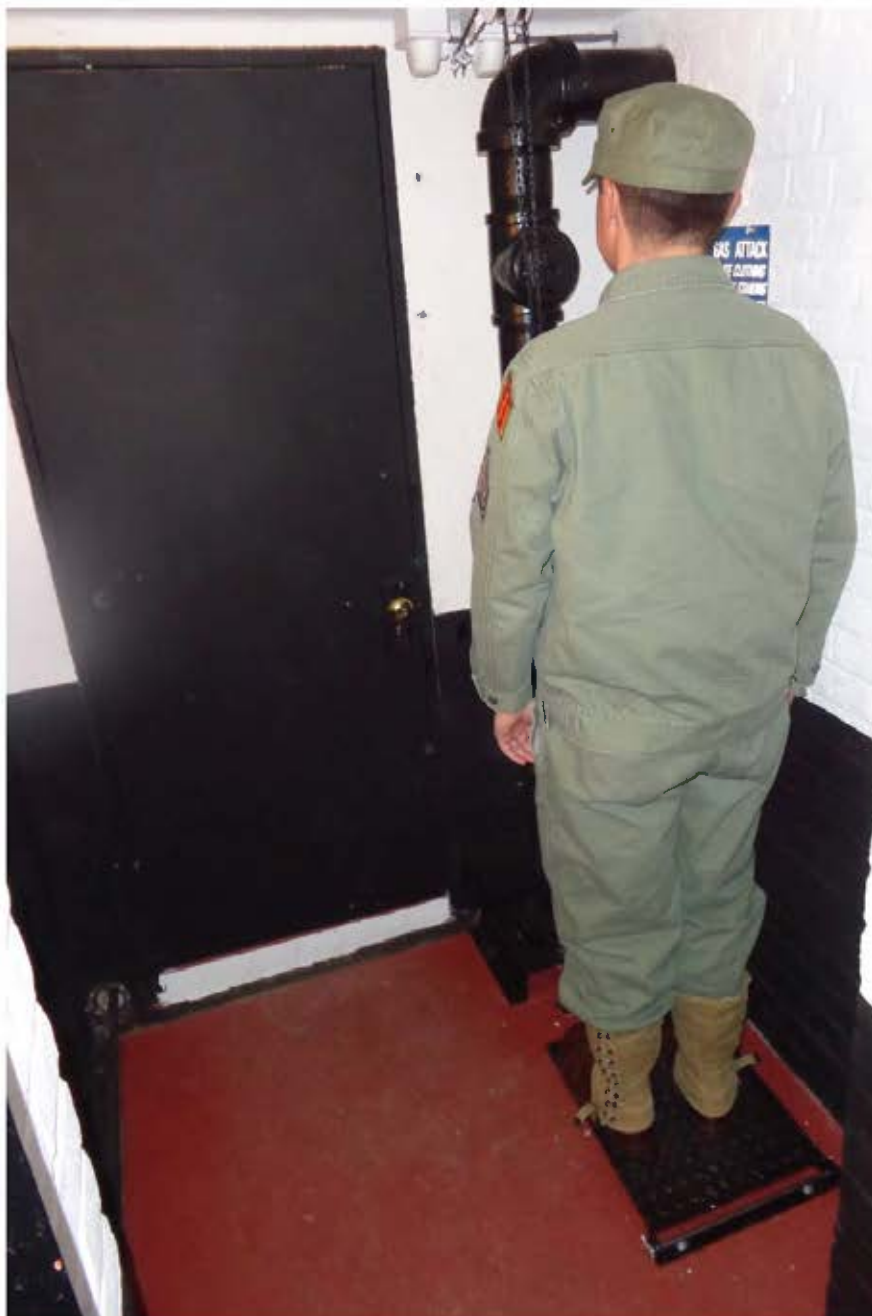
The photo on the left shows the entire decontamination chamber system installed. This includes stand pipe, pulleys, switches and their chains, treadle and treadle cables for the valve in the adjacent room. The photo to the right shows an AGFA member on the treadle as he would have stood to actuate the system. Notice the door into the plotting room is closed. Both doors into the decontamination chamber would have been closed during operation as the soldier decontaminated. The assumption was a non-persistent agent such as chlorine or cyanide would have been used. These agents can be blown off of clothing and equipment (theoretically) and exhausted out of the chamber without harm.

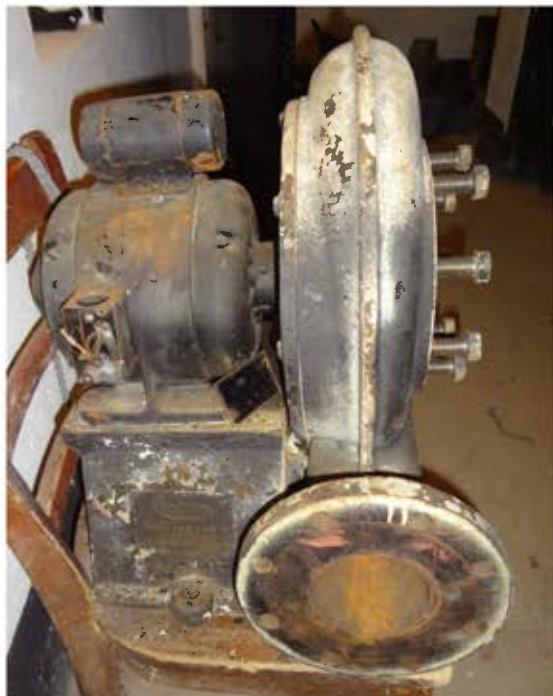
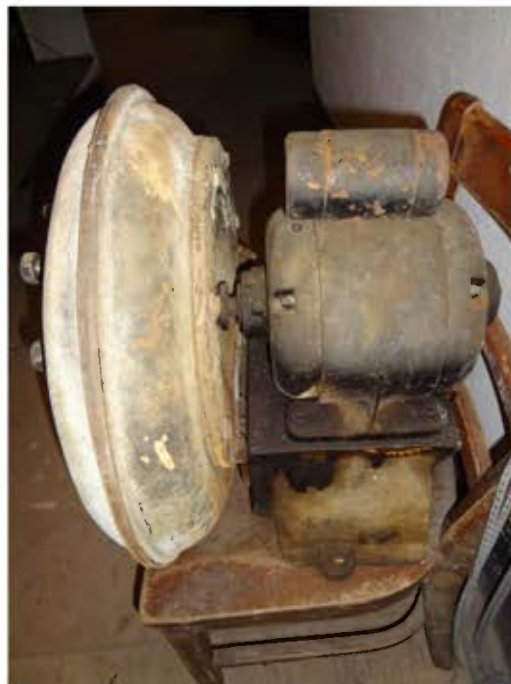
In 2016 AGFA located a complete blower and motor assembly. However, the motor was non-functional and required re-winding. The blower assembly was in good condition and easily restored. Most importantly, the impellor fan and closure plate were both in excellent condition.

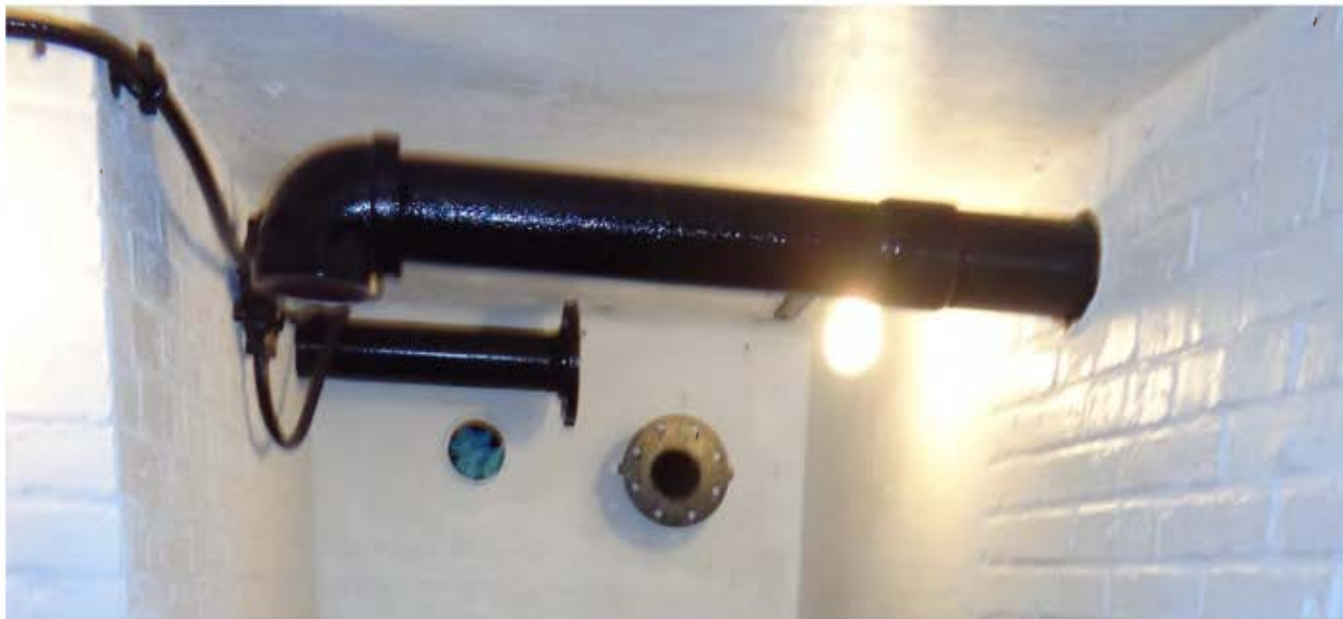
Installing the blower and motor for the decontamination chamber began in February 2017. The photo below shows the basic condition of the equipment room at the time AGFA began installation of the decontamination blower system.

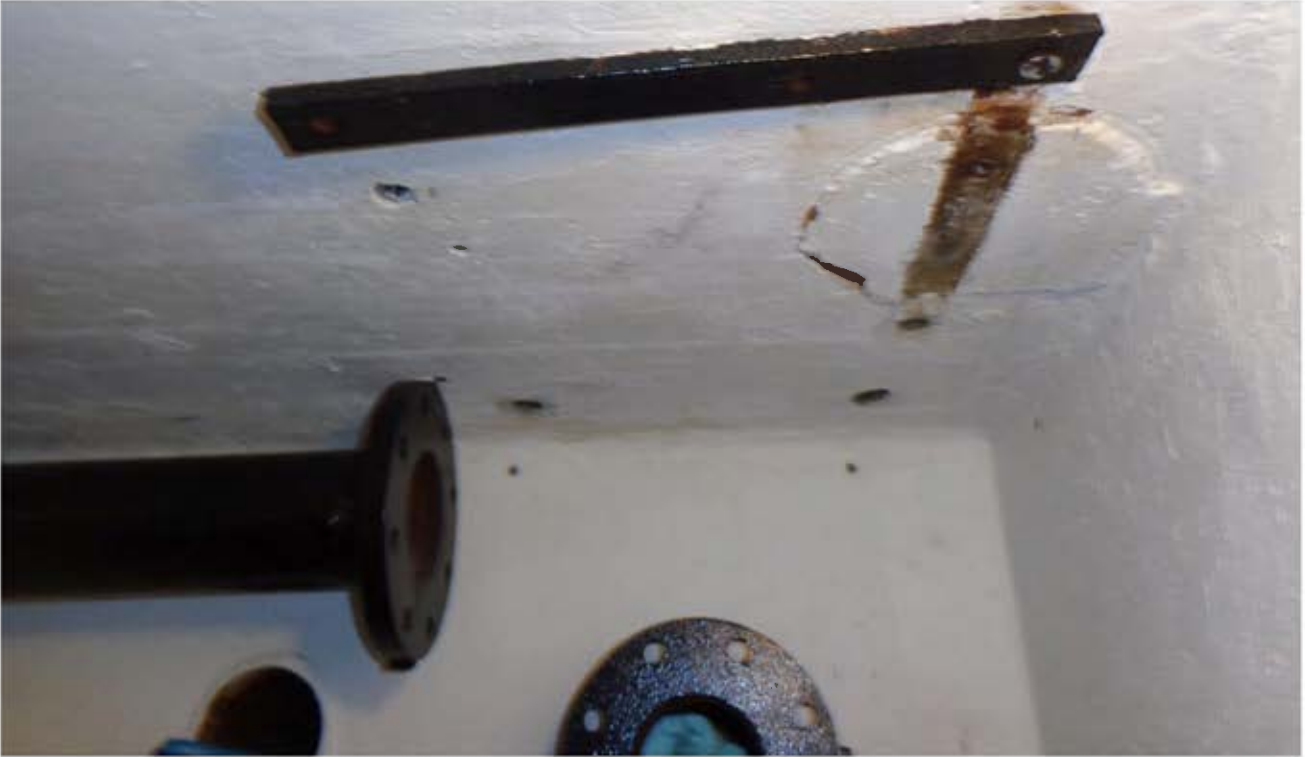
The blower for the decontamination chamber is suspended on threaded rod from the ceiling. In the photo below the four holes in the ceiling are shown.

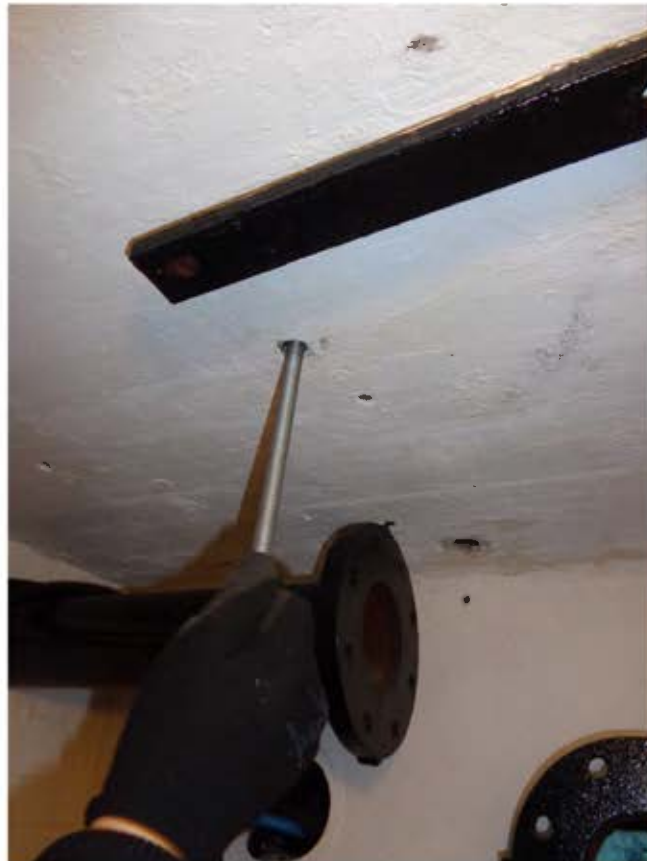
Each of the attachment points in the ceiling proved to be usable. They consisted of a large piece of threaded steel. A quick run with a tap and the mounts were ready to receive a threaded rod. A rod is being inserted as a test below.

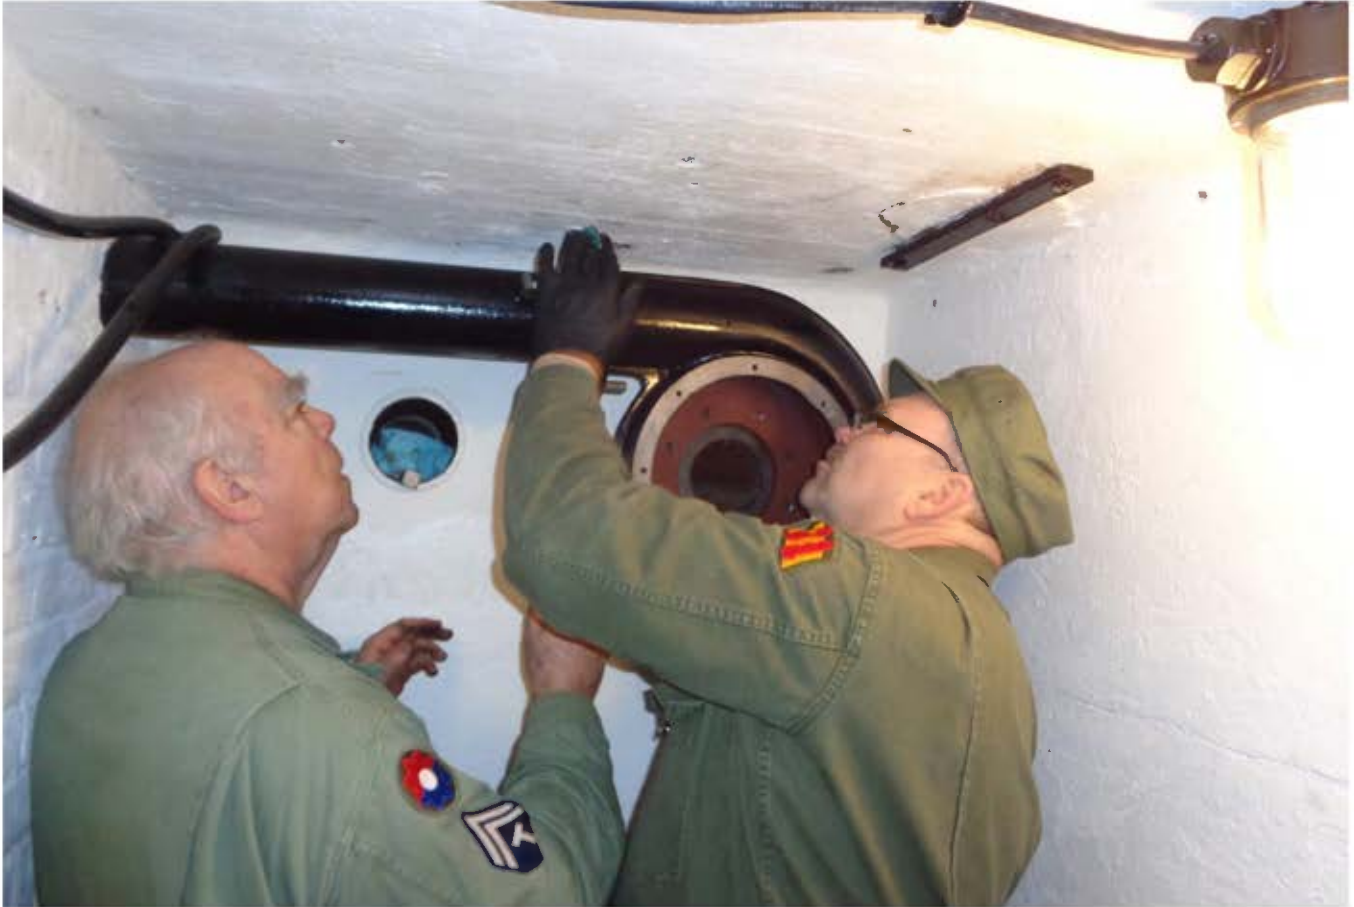
The decontamination blower housing was installed on 22 February 2017. Below the team adjusts and connects the blower housing to the decontamination pipe.

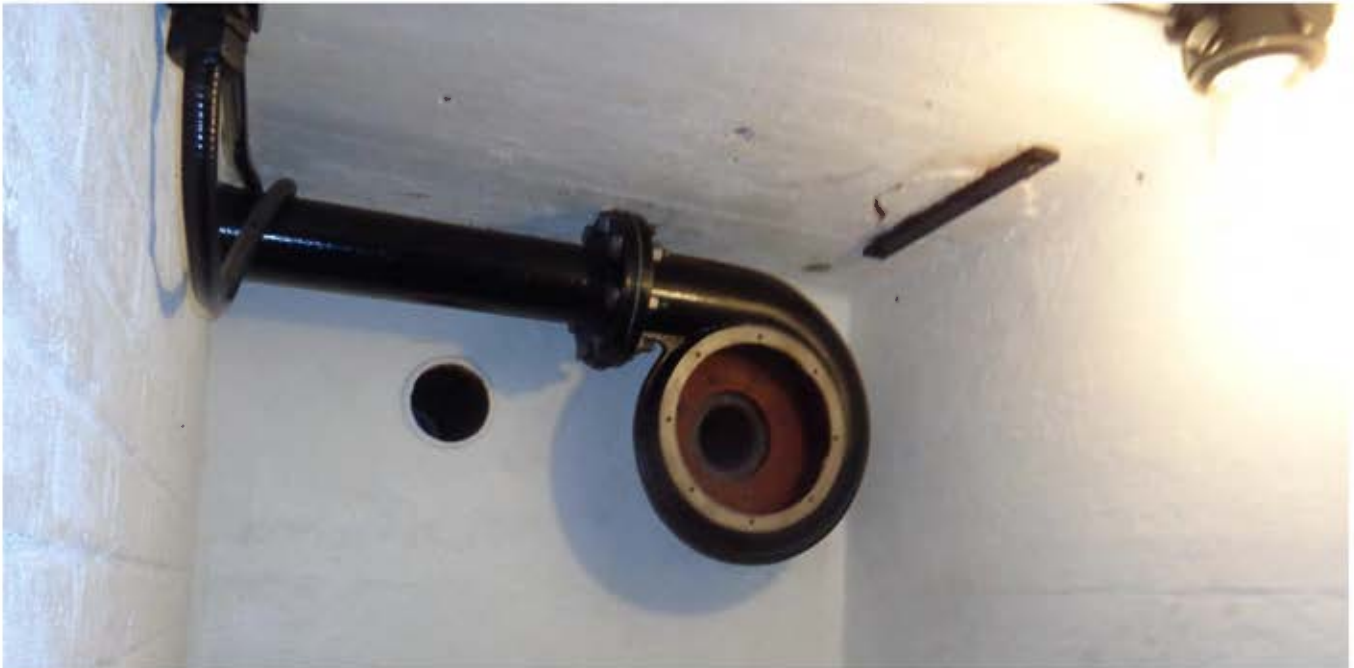
In the photo below the blower housing is fully installed, awaiting the motor and fan assembly.

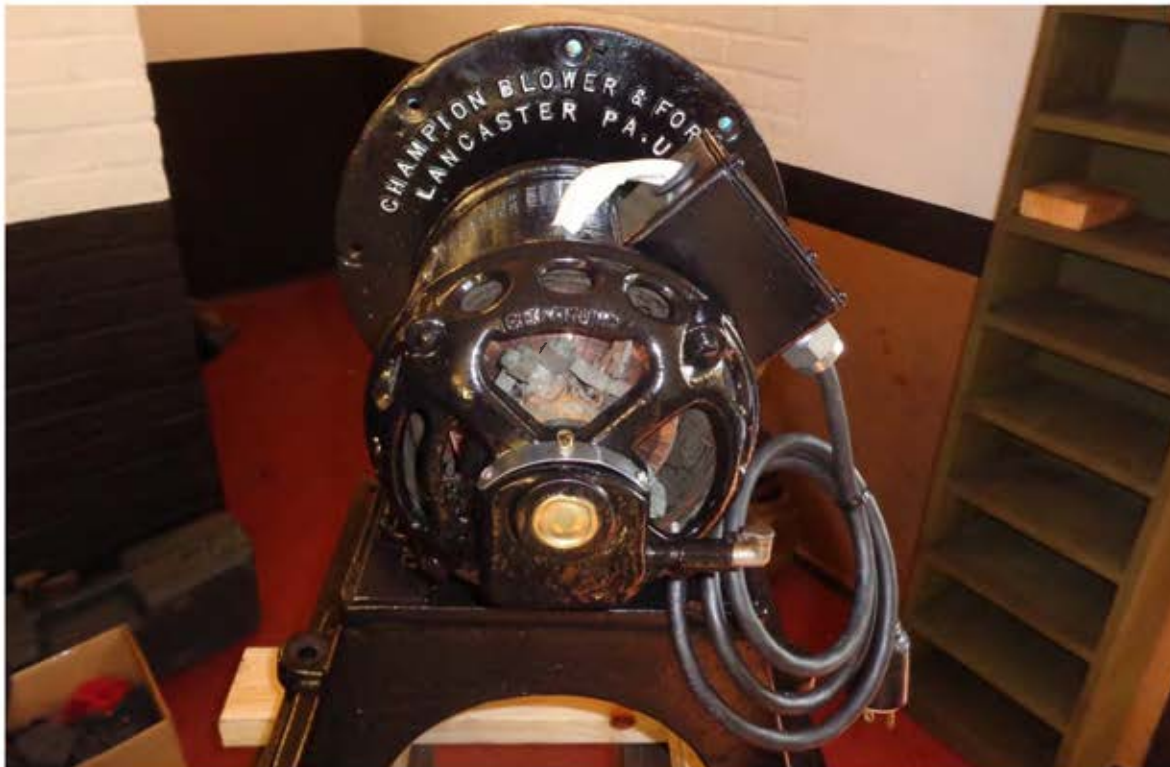
On 9 March 2017 the restored blower cover and fan, along with a 1,750 RPM AC motor and mount were brought to Battery Gunnison/New Battery Peck for installation. This particular motor was chosen because it was easily available and vintage - in this case - 1920s.

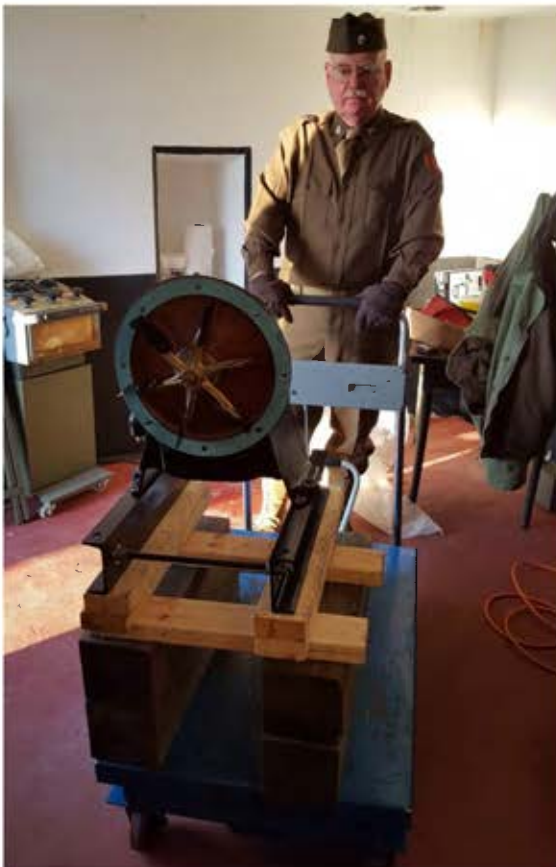
The entire assembly weighed over 100 pounds. The easiest way to install was to use a hydrolic lifting table.

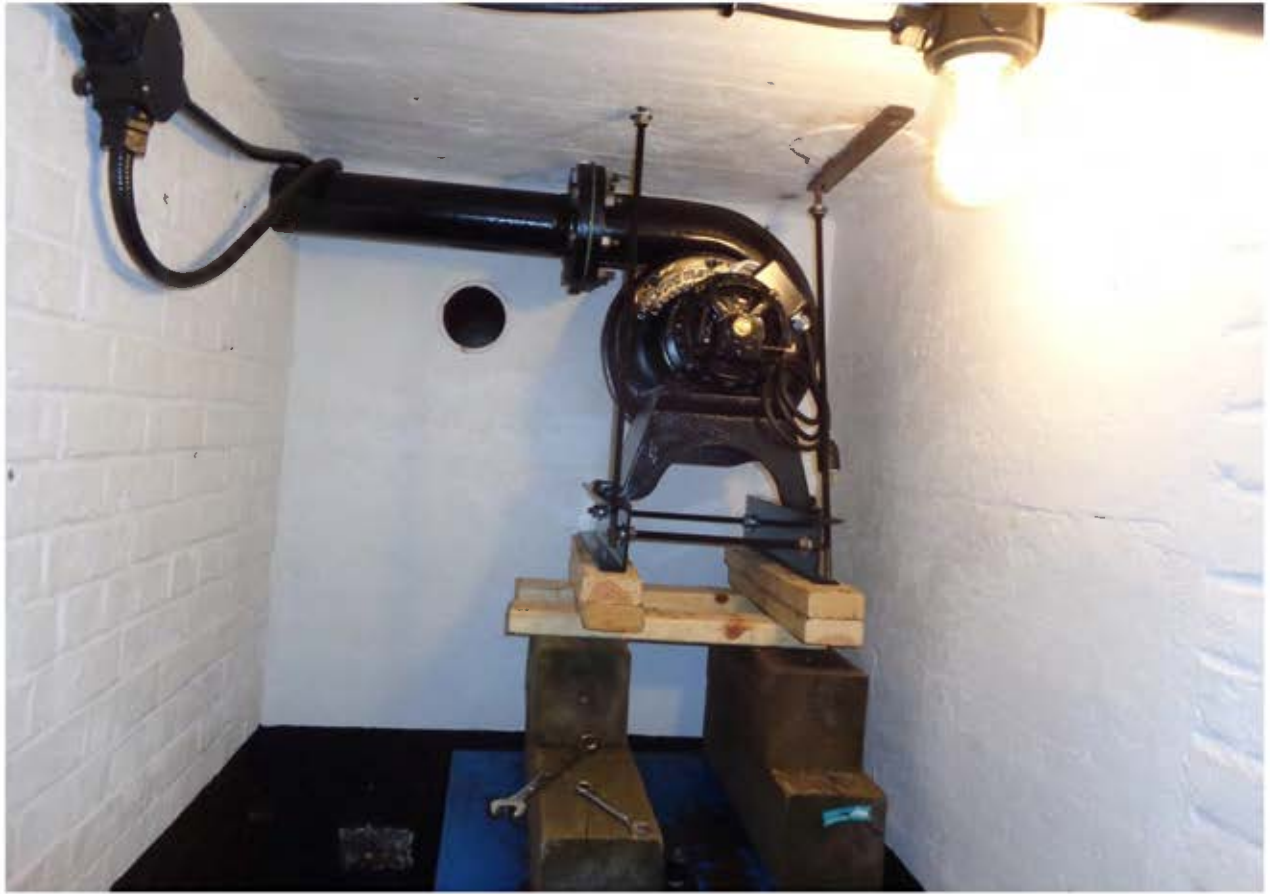
The photo below shows the motor, mount and blower cover being mounted on the blower proper. Two threaded rods are already installed.

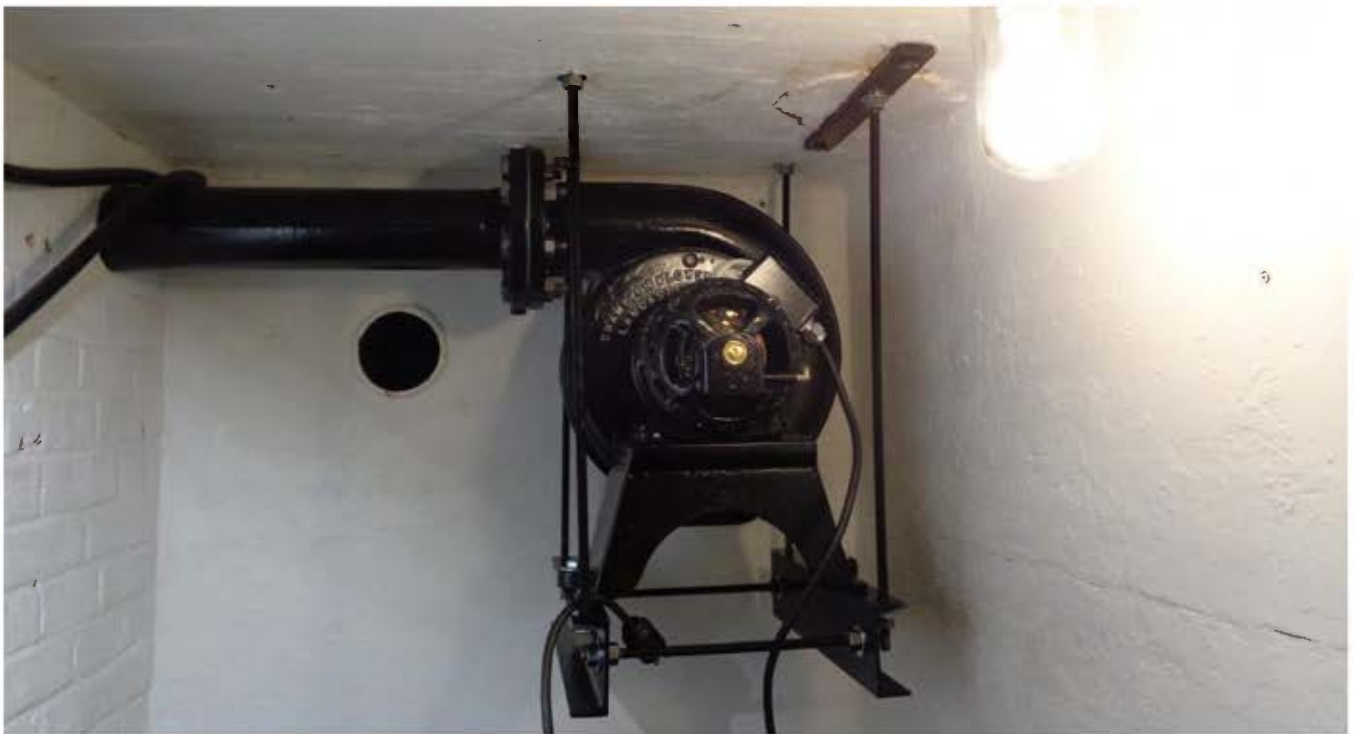
The photo below shows the blower and 1,750 rpm motor as installed April 2017.
