**Restoring Chemical Warfare M1 Collective Protector System**  
**Battery Gunnison/New Battery Peck**  
***Ft. Hancock, New Jersey***

In the spring of 2014, the Army Ground Forces Association began locating and fabricating the required materials to restore the M1A1 Collective Protector Chemical Warfare system in Battery Gunnison/New Battery Peck. During this time AGFA was able to obtain a very significant quantity of original chemical warfare equipment, to include a 3,500 rpm AC motor and blower, switches, valves, pulleys and ancillary materials. Most of this equipment was in good to excellent condition and well within the capabilities of the membership to restore to a functional condition.

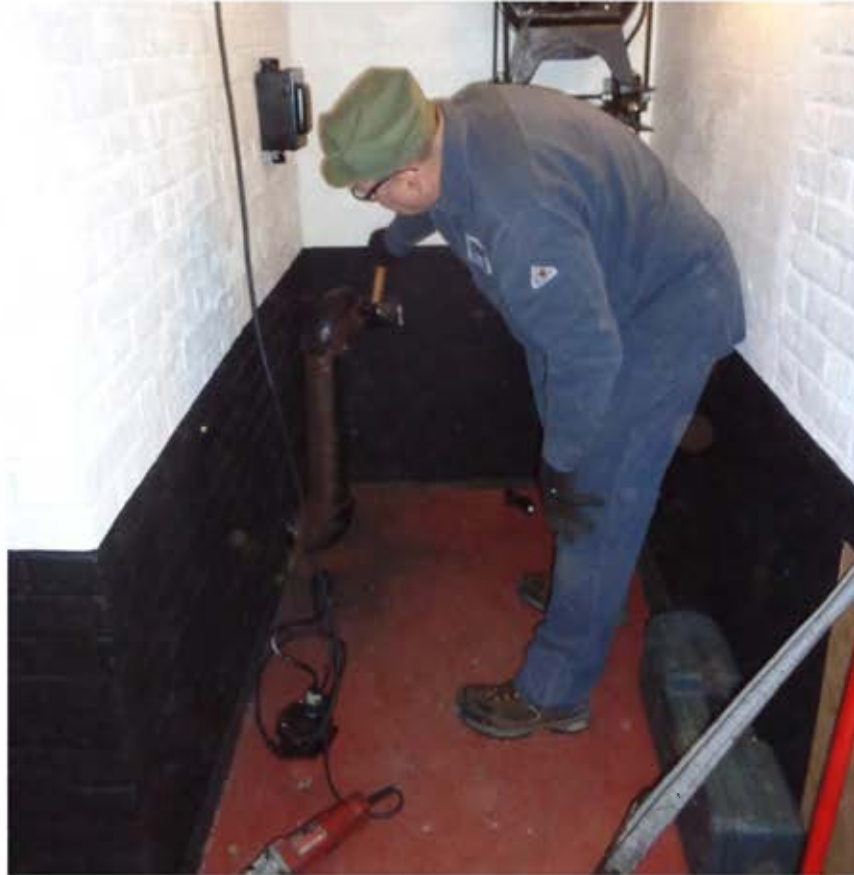
The existing pipe for the exhaust to the decontamination room had been pushed down onto the floor. It had to be raised, which required jacking equipment. Once it was raised, the valve for diverting the exhaust into the filter could be connected.

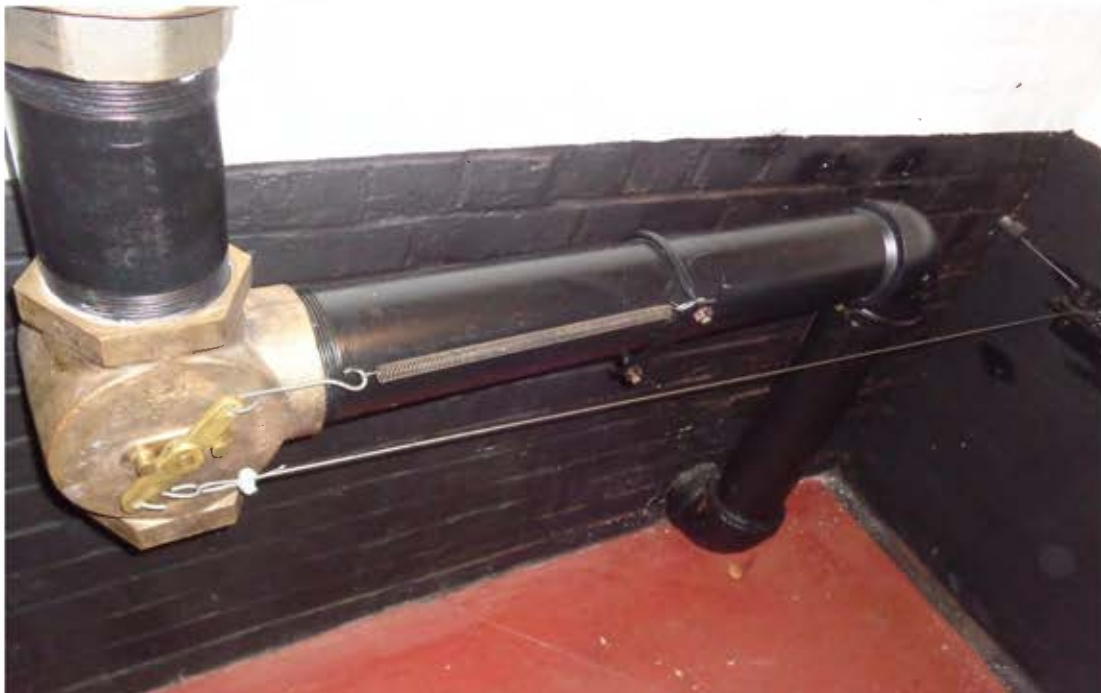
Below the pipe has been straightened to vertical, an elbow with horizontal pipe, three way valve and a connector to the vertical pipe that leads to the outside air intake. The second blower will be installed to the open end of the three way valve. The cable and spring assembly changes this valve so that it either takes air from the outside or from the decontamination chamber into the air filter.

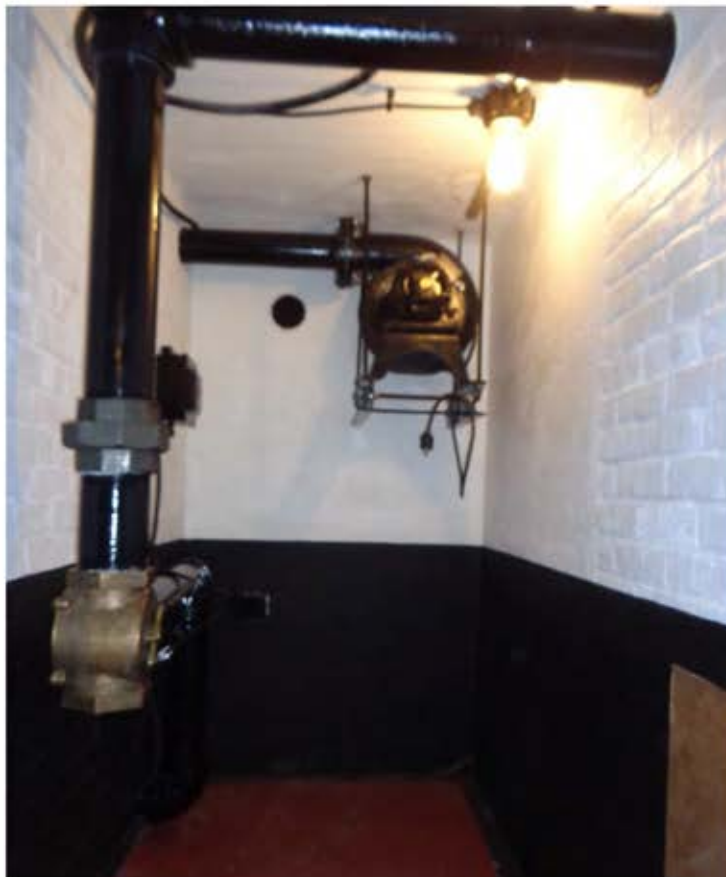
The photo below shows the entire assembly for the decontamination chamber's air valve completed.

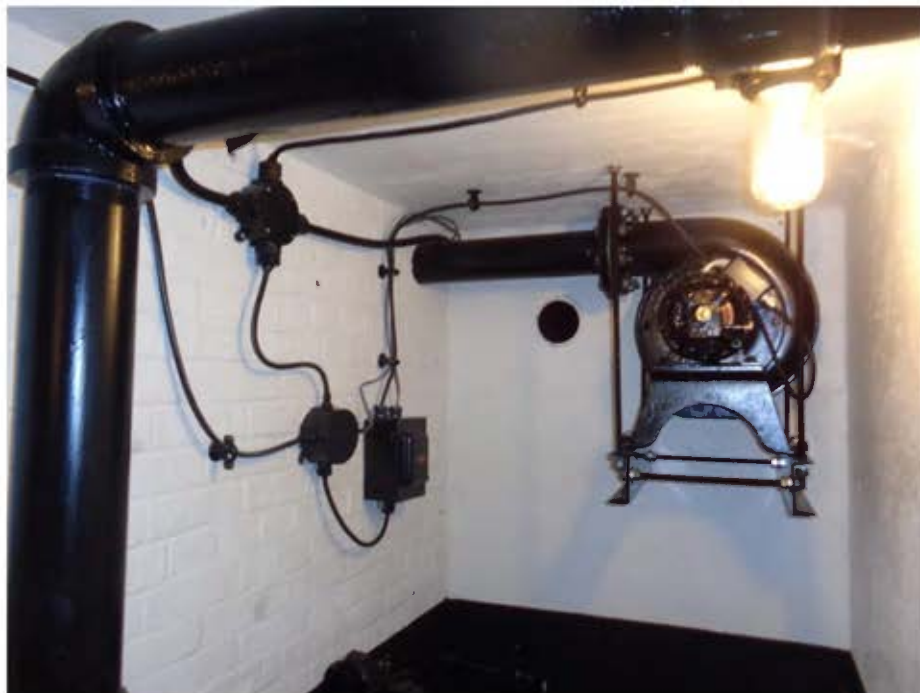
The photo below shows the decontamination blower system installed, electrical wiring and pipe horizontal pipe for the air intake to the three way valve. The motor in this instance is the 1,750 RPM motor from the 1920s.

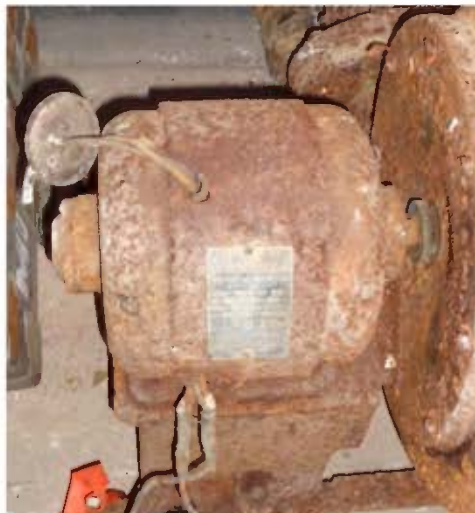
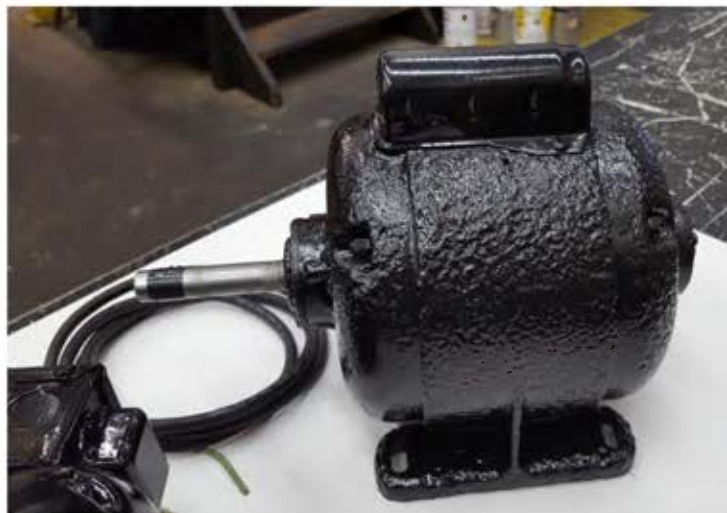
In January 2018, we were approached by the owner of Pilot Electric, Gene Pilot, who offered to restore both 3,500 rpm AC motors as a donation by Pilot Electric of Neptune, NJ (732-775-0121). These motors were returned to AGFA on 29 March. Both of these motors are now mounted within the system of Battery Gunnison/New Battery Peck. The most dramatic restoration is of the motor that was located in the mortar battery (shown below) south decontamination air lock. It was external to the air lock and severely exposed to the elements. Its restoration to working condition was quite unexpected. While the pitting on the exterior is quite extensive, the motor works as designed, and is quiet as well. The entire assembly was installed in Battery Gunnison/New Battery Peck in June 2018.

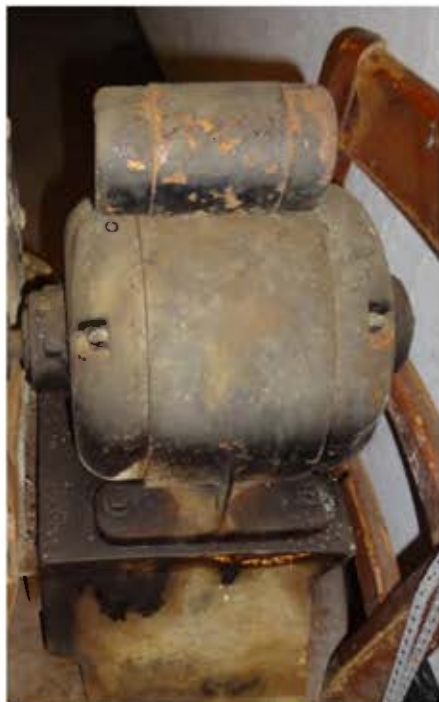
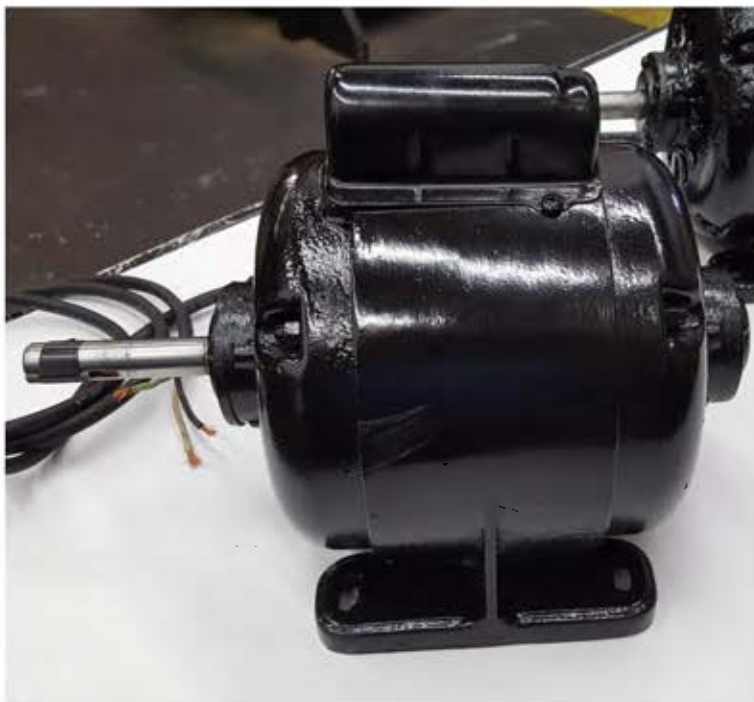
The first motor AGFA obtained (below) was in relatively good exterior condition. We actually had expected it to work, but, it did not. The inability to operate the motor is what triggered the search for an alternative and the purchase of a working vintage 1,750 RPM AC motor from the 1920s. While the 1,750 RPM motor operates well, it does not deliver the force of air associated with the original motors. Being relatively easy to replace compared to the 3,500 RPM motors, it can be used in more unforgiving locations (like the mortar battery). The 1,750 rpm motor for the decontamination chamber was replaced by the restored 3,500 rpm motor on 26 April 2018.

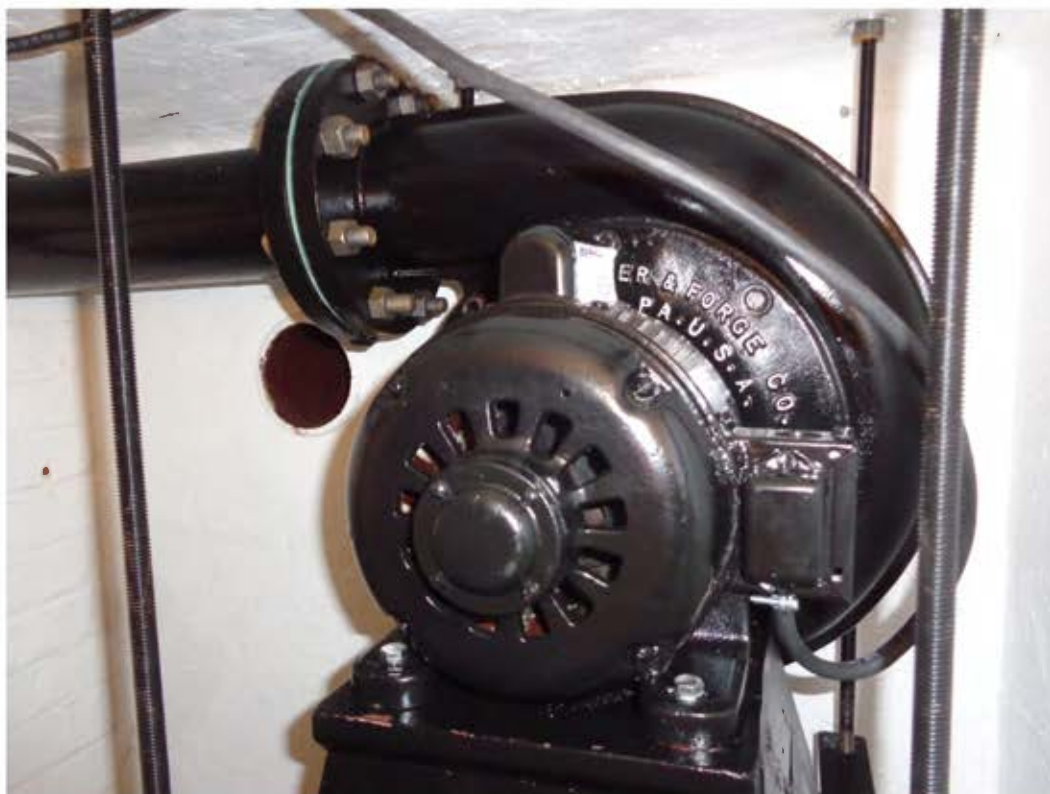
The photo below shows a close up view of the new 3,500 rpm late 1930s motor. This was the motor installed on this blower in the 1940s. It is fully restored with sealed bearings and completely new windings.

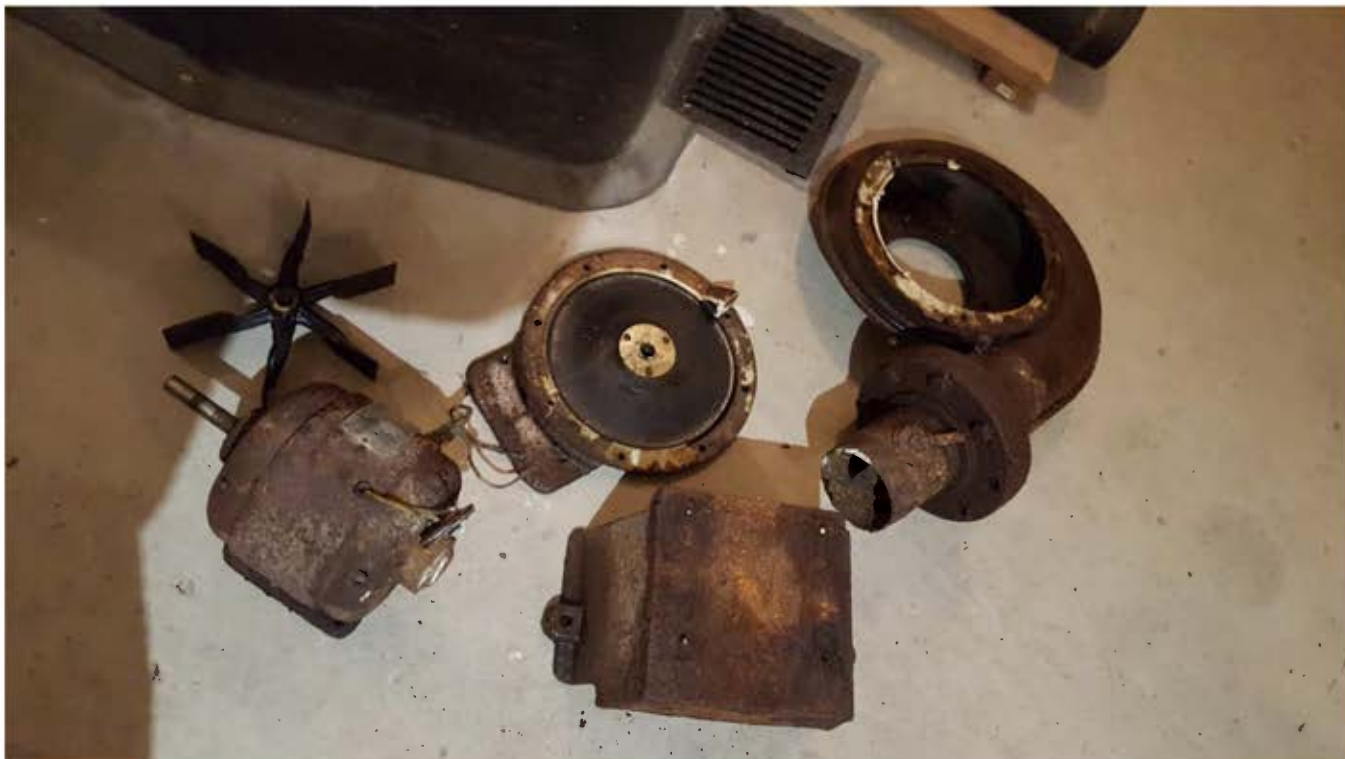
Below, the blower and motor assembly removed from the south air lock location in Battery McCook/Reynolds (mortar battery) is shown disassembled prior to rewinding and refinishing the motor. The blower assembly was refurbished. The motor and blower are now mounted inside Battery Gunnison/New Battery Peck.

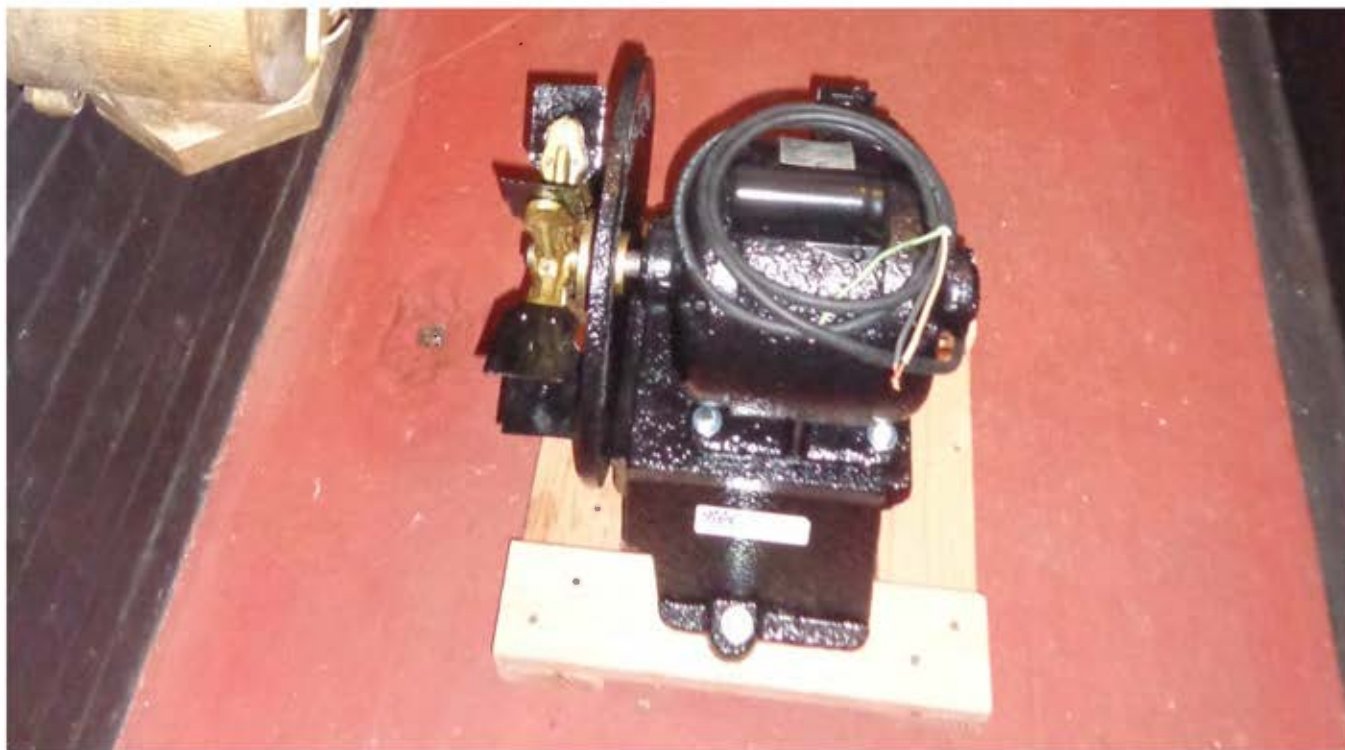
The photo below taken on 26 April 2018 shows the blower fan blades, closing plate and motor fully restored and awaiting installation to power the overpressure system for the plotting room.

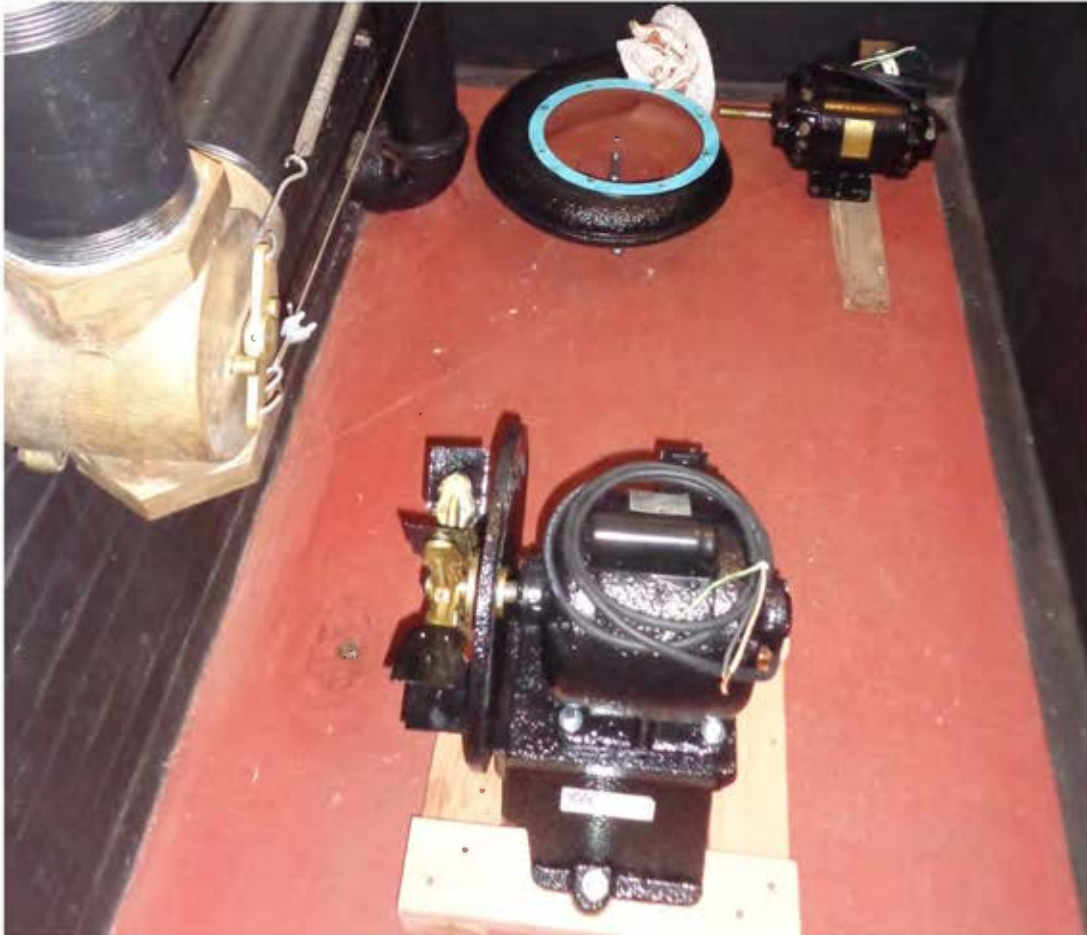
The photo below shows the 3,500 rpm motor (with fan blades) and the blower (upper left corner) prepared for installation on the brass pipe valve. The small motor to the right is the 1,750 rpm motor that was temporarily installed on the decontamination blower. It has been exchanged for the original 3,500 rpm motor and is awaiting installation in the mortar battery north decontamination air lock.

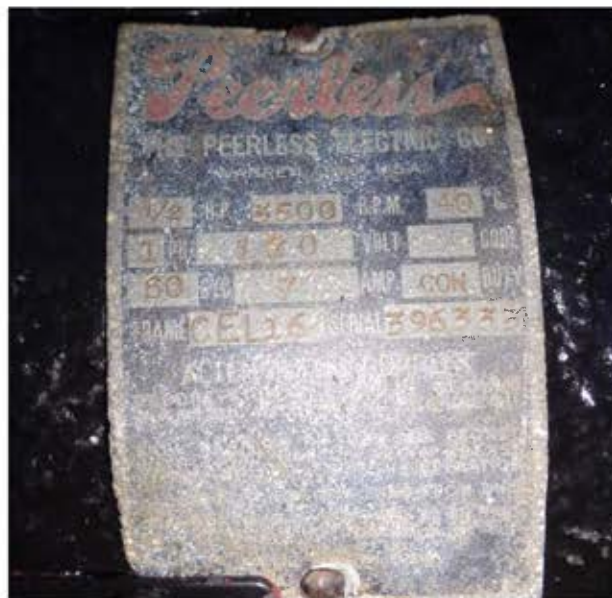
The photo below shows the data plate for the restored motor that will be installed on the blower for the plotting room in the Chemical Warfare room above.

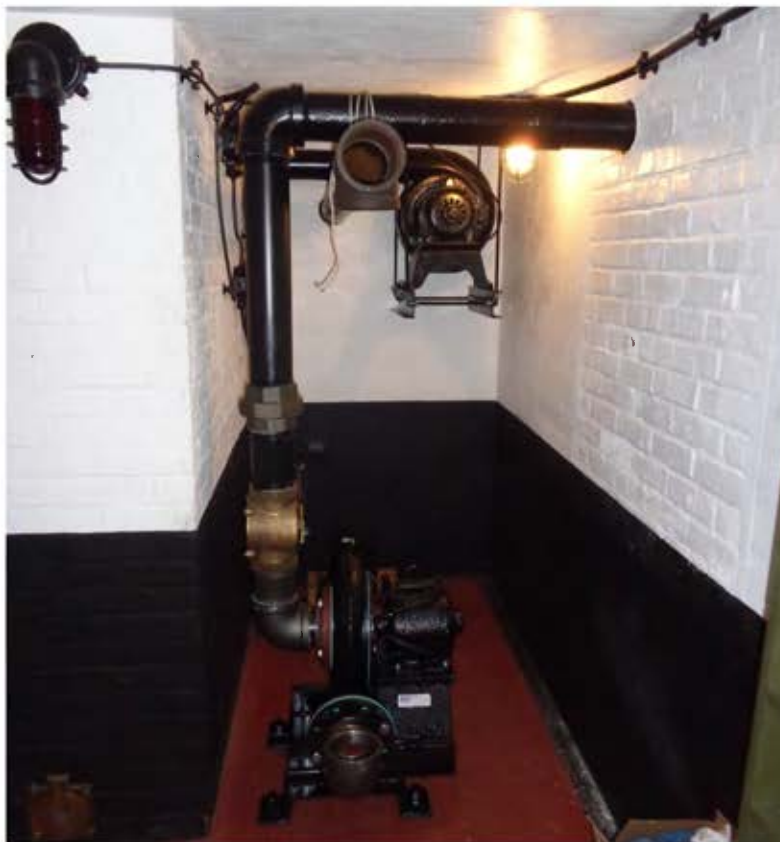
The photo below from June 2018 shows the plotting room overpressure blower and motor mounted to the external air intake pipe and air intake and thee decontamination room exhaust pipe. The pipe from the filter to the plotting room is inserted into the wall sleeve and roped to the air intake pipe above the blower and motor assembly.

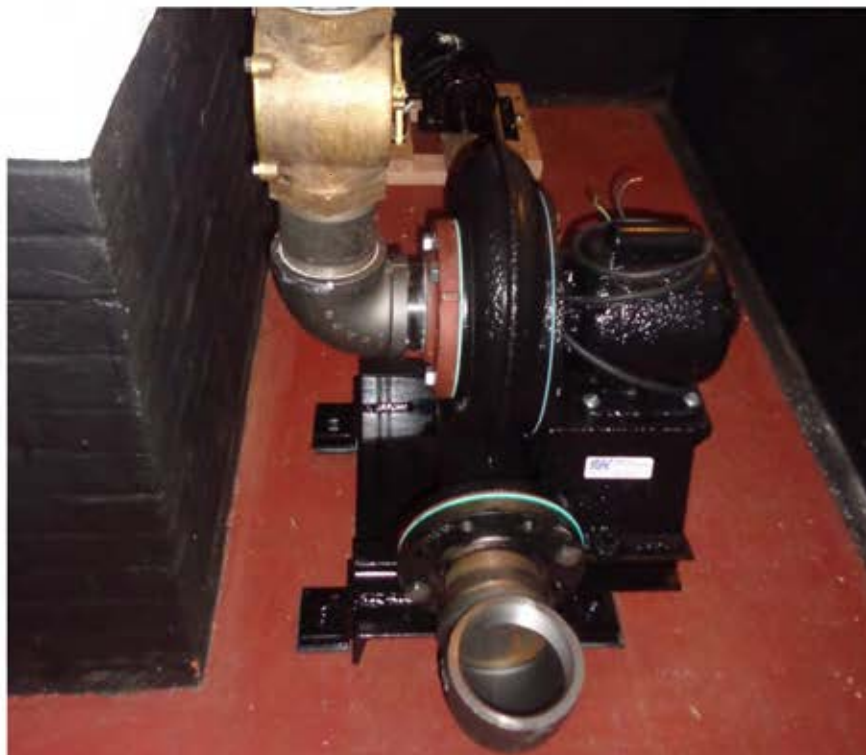
The photo below shows the motor and blower proper.

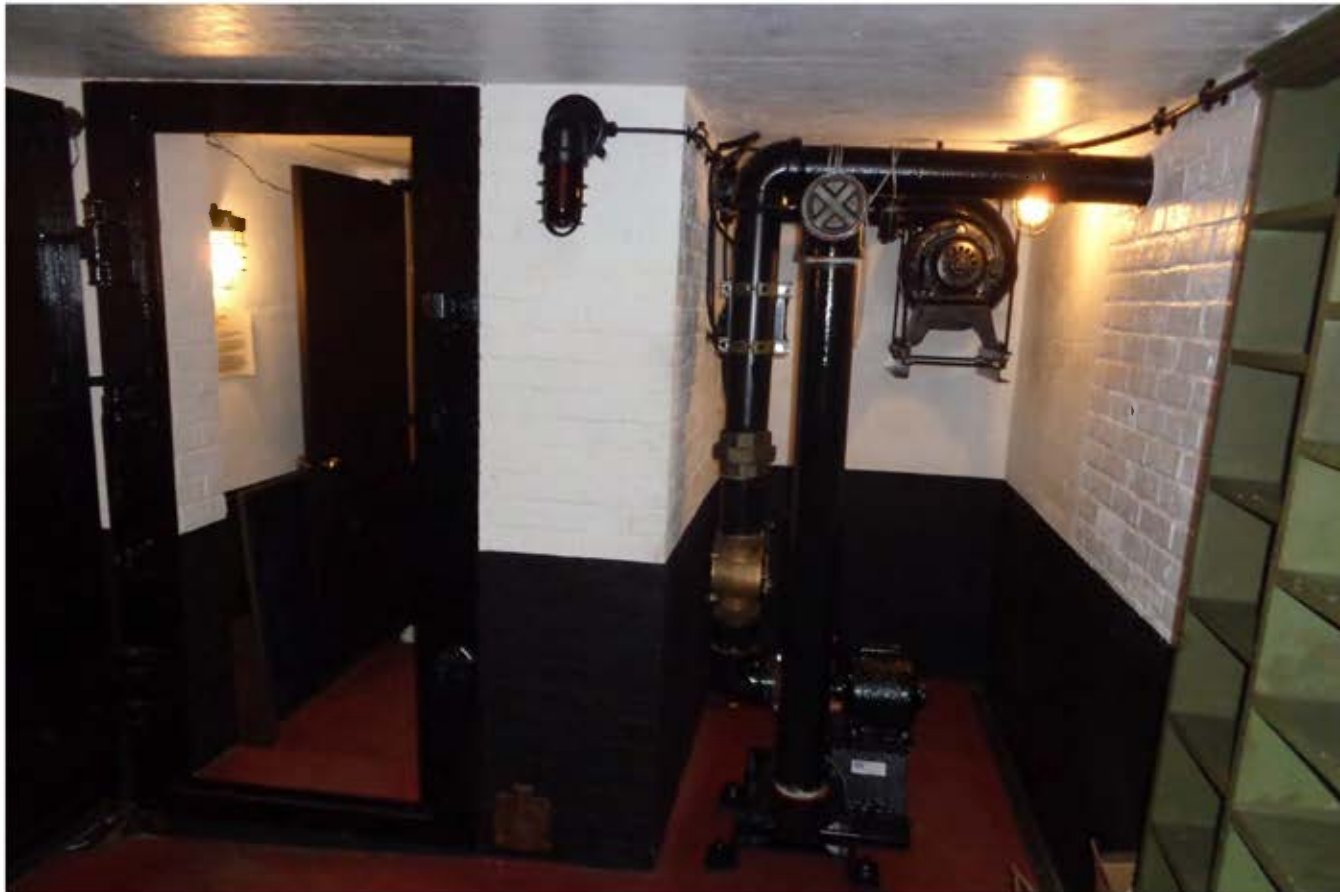
The photo below shows the system, minus the filter assembly and bypass valves, in place in the mechanical niche.

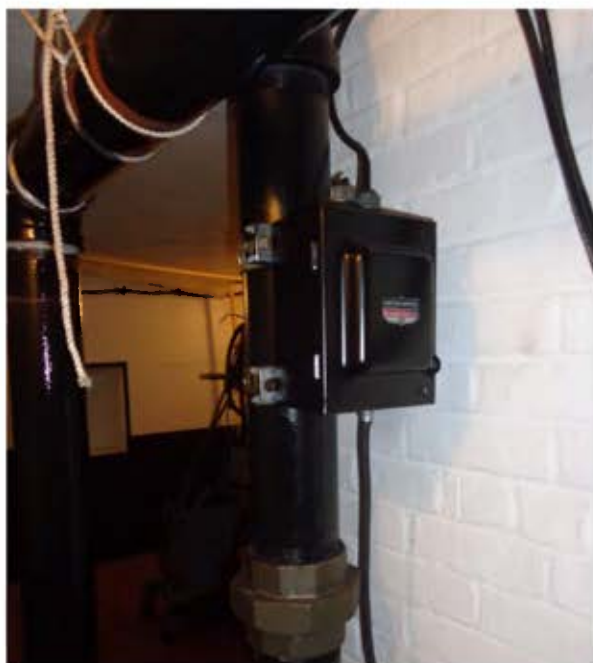
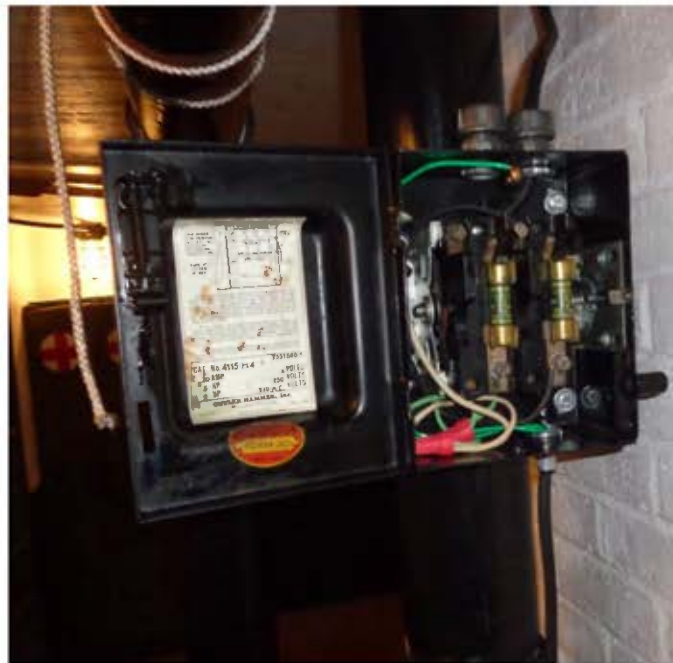
Below are two photos of the Cutler-Hammer Type A safety box for the plotting room over pressure blower motor fully wired and in place. There is a need for a "starter switch" which once procured will be installed at a future date.

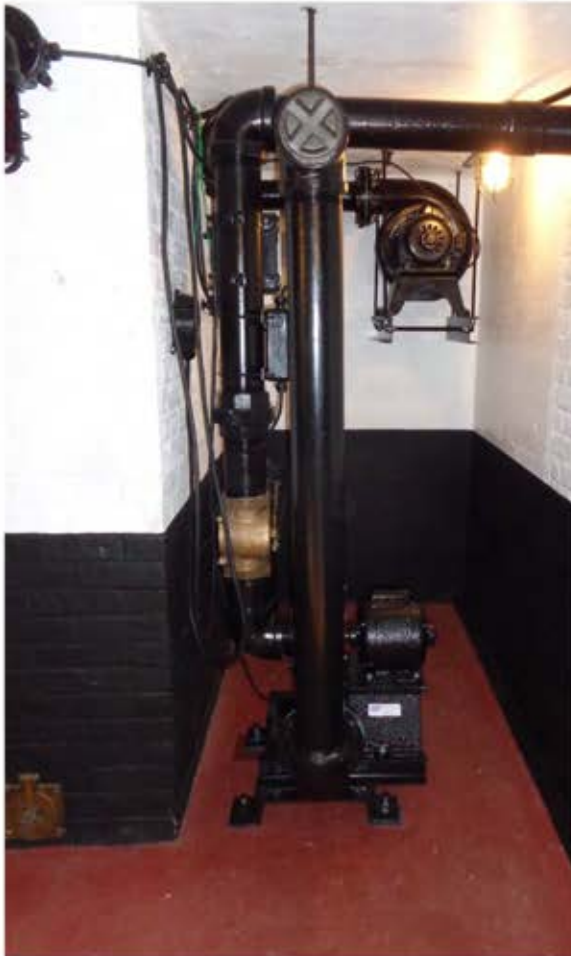
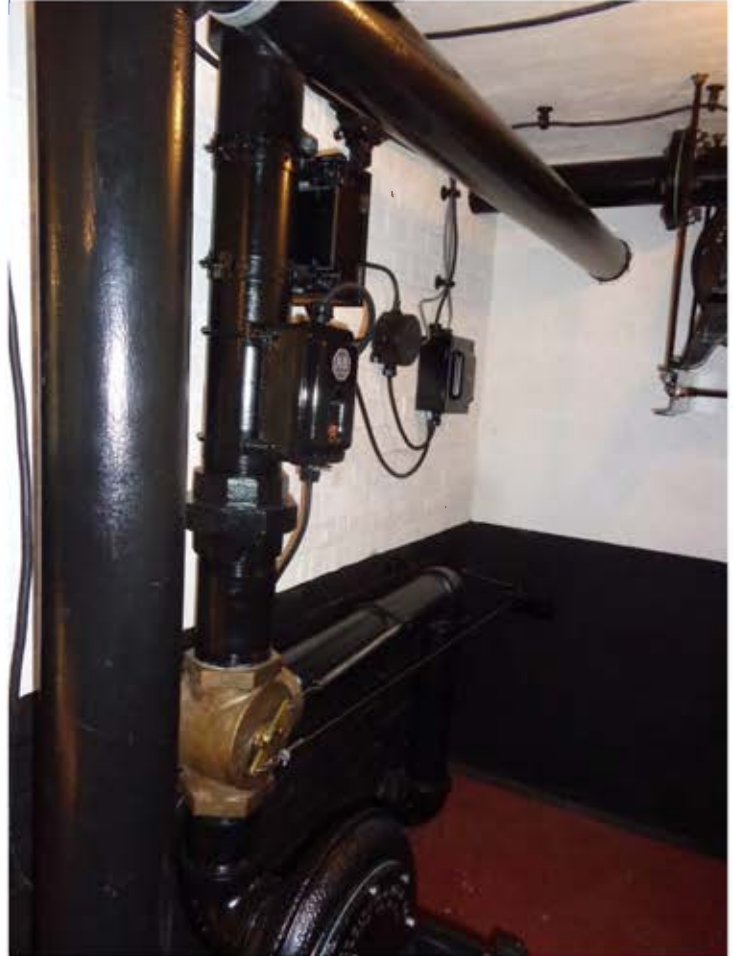
The two photos below show the entire installation as of 15 Sept 2018. The cut out switch and the Allen-Bradley starter switch are in place for the Plotting Room over pressure blower motor.

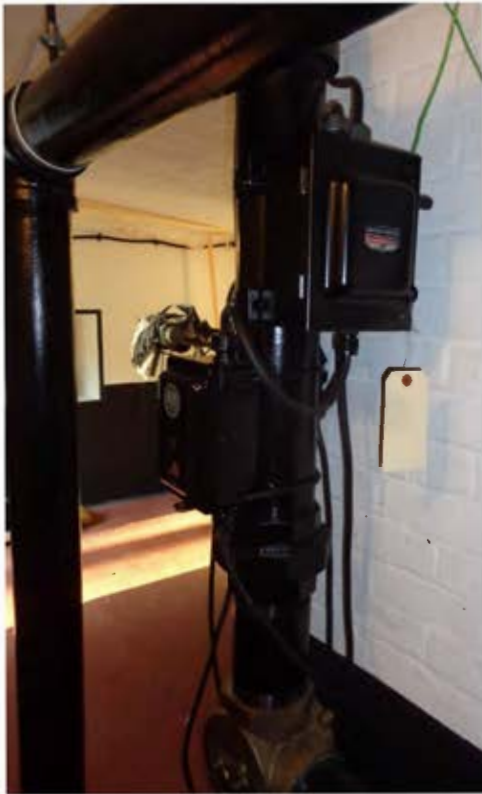
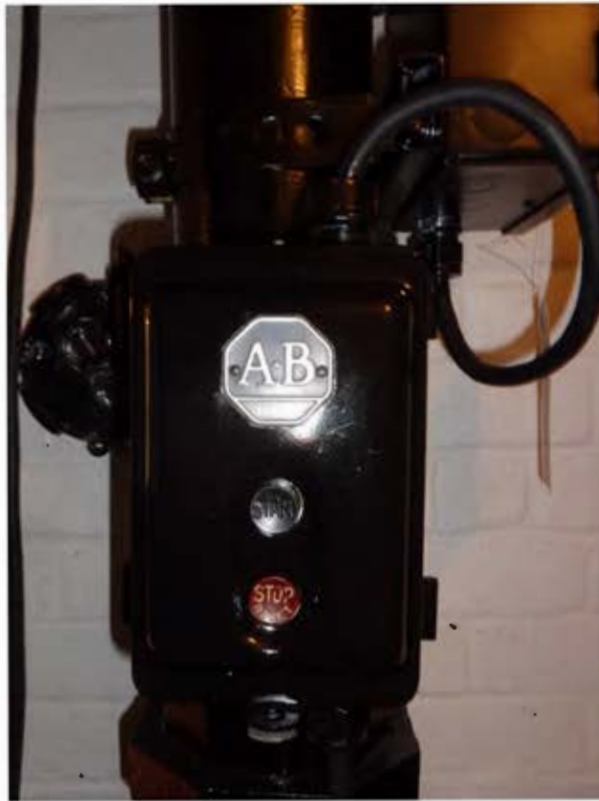
The two photos below show a more complete view of the blower motor Allen-Bradley starter switch, the Cutler-Hammer cut-out switch and a vintage receptacle (hanging on the wall behind the A-B switch).

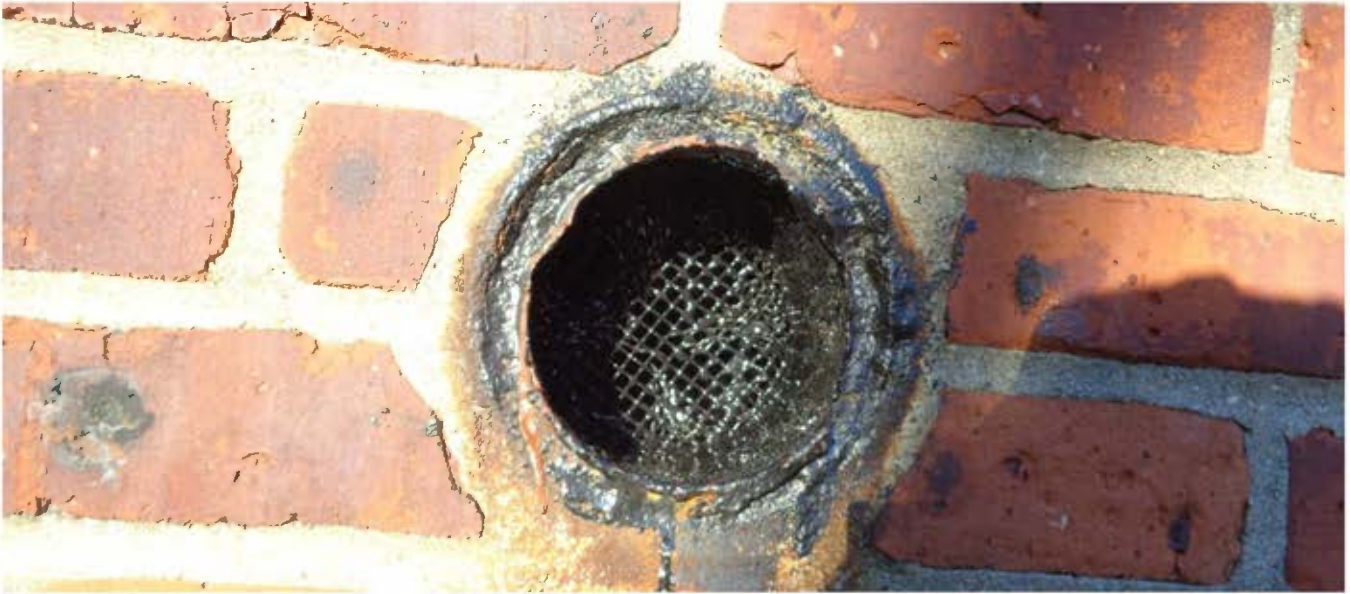
The photo below shows the outside air intake as of 28 June 2018. The inside of the pipe has been cleaned, primed and painted. A stainless steel mesh has been affixed inside the opening to keep the blower from ingesting foreign matter.

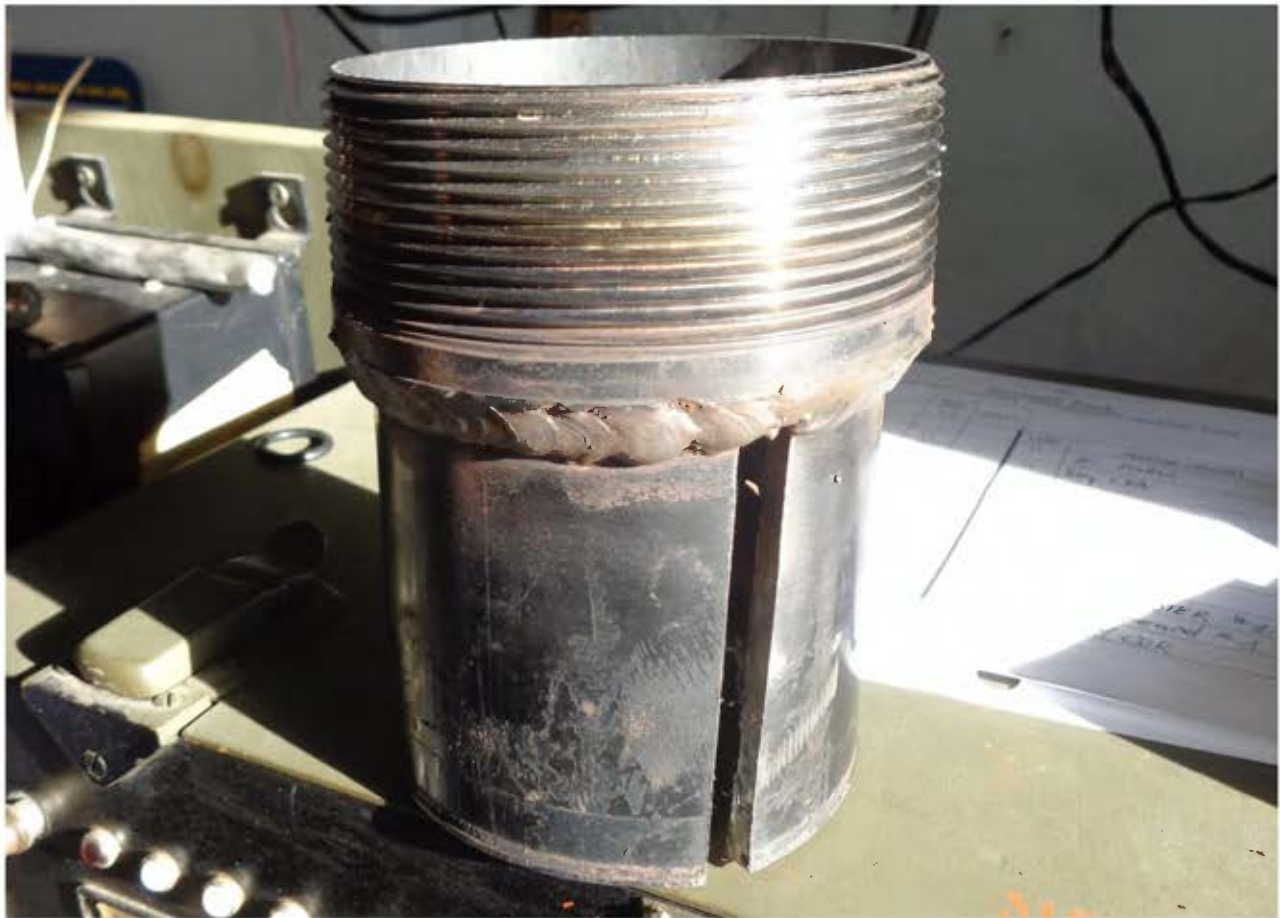
The fixture below will be inserted into the air intake hole when the exterior air intake system is installed. This fixture will enable connection of a 90 degree elbow which then connects to a "T" fixture for the two horizontal intake pipes.

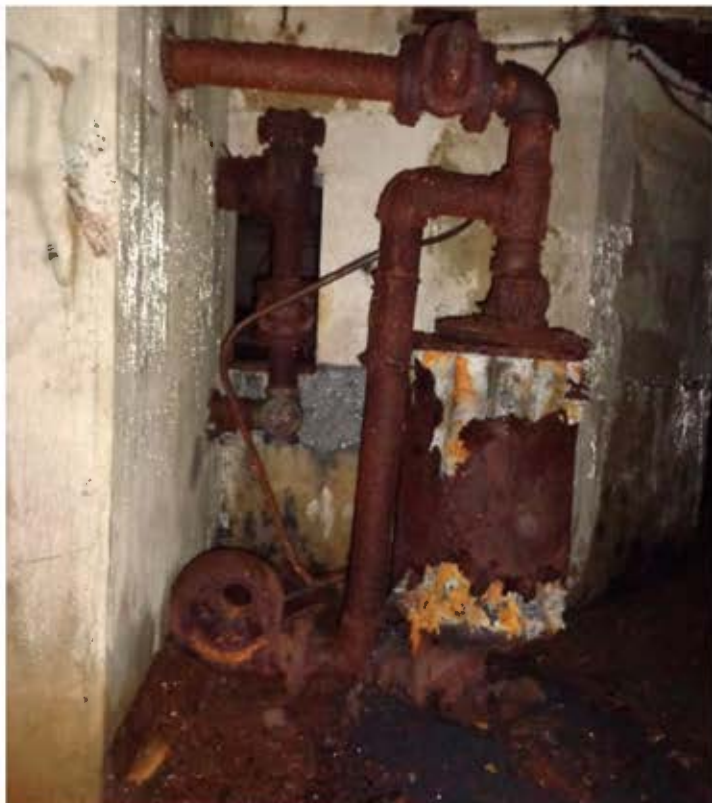
The photo below was taken on 6 September and shows the northern M1A1 Collective Protector for the north plotting room (#1) at Battery Kingman. After deliberations between AGFA members, Pete McCarthy and Pete's consultation with other NPS professionals, this unit was selected for valve recovery. The advanced level of decay is very noticeable in the photo below. The grey matter on the floor is the charcoal particles from the filter. Research by the Homeland Defense & Security Information Analysis Center determined that no hazardous materials were used in filters of this model and vintage. The filter composition was comprised of 60 percent charcoal and 40 percent green soda lime.

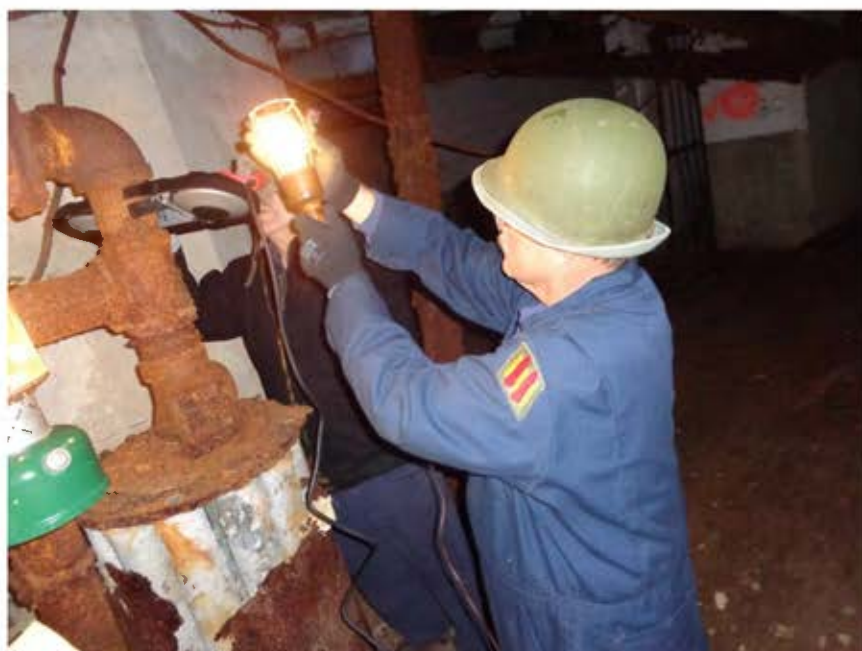
The basic plan for recovery was to cut the top pipe and lower the entire assembly onto the floor inside the battery. Valve components would then be removed.

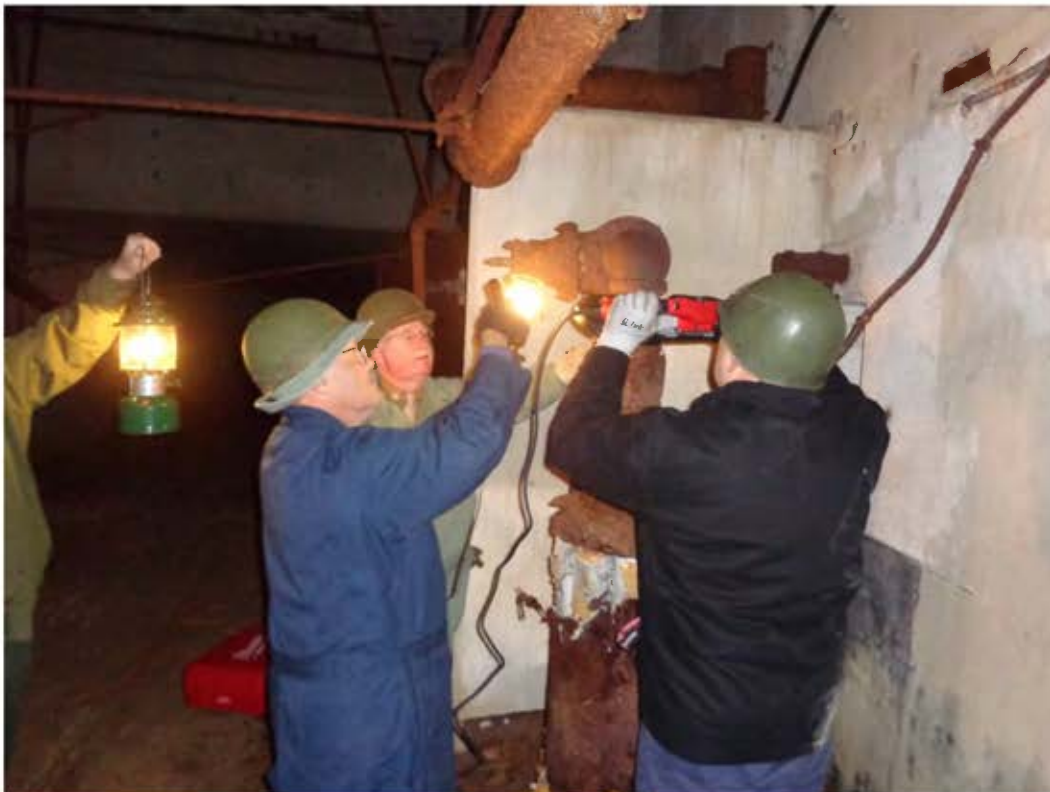
Cutting the assembly loose was time consuming. It took a few minutes to make the cut, then to lower the assembly for dismantling. Below AGFA members Wally Tunison and Doug Ciemniecki cut the pipe and Shawn Welch holds the electric light. NPS site manager Pete McCarthy holds the 1936 Army purchased Coleman 220 lantern.

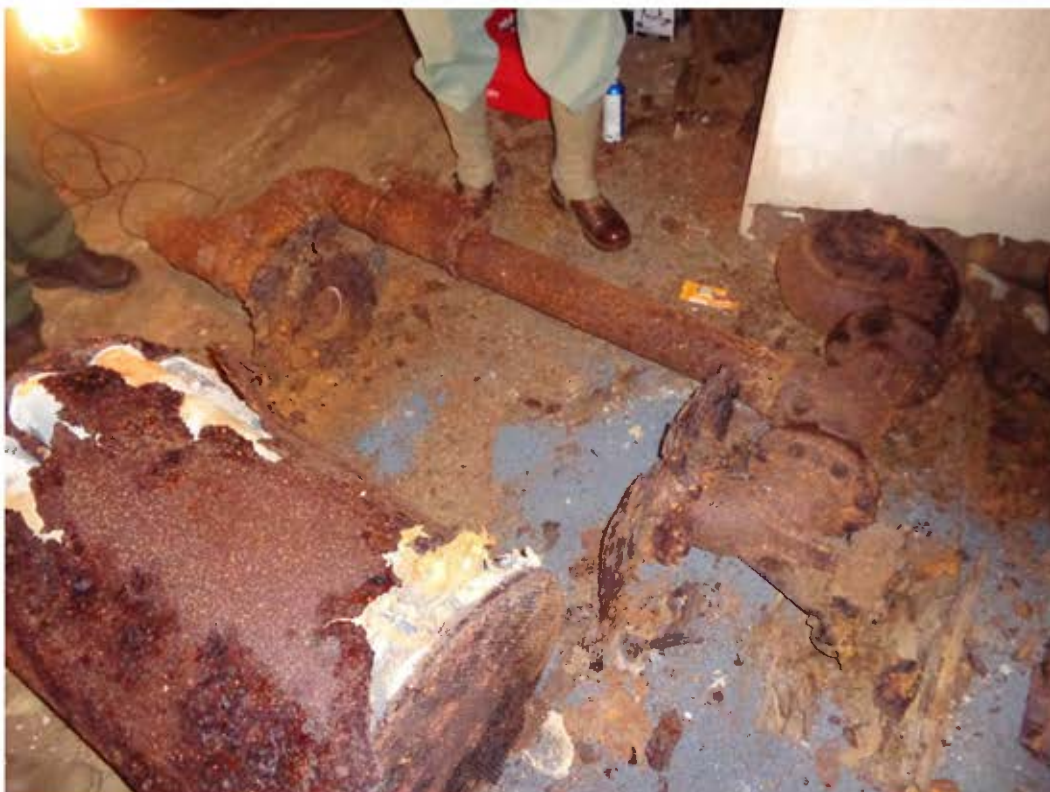
The photo below shows the filter, two valves, and blower assembly on its side. The filter was not connected and quickly rolled to the side.

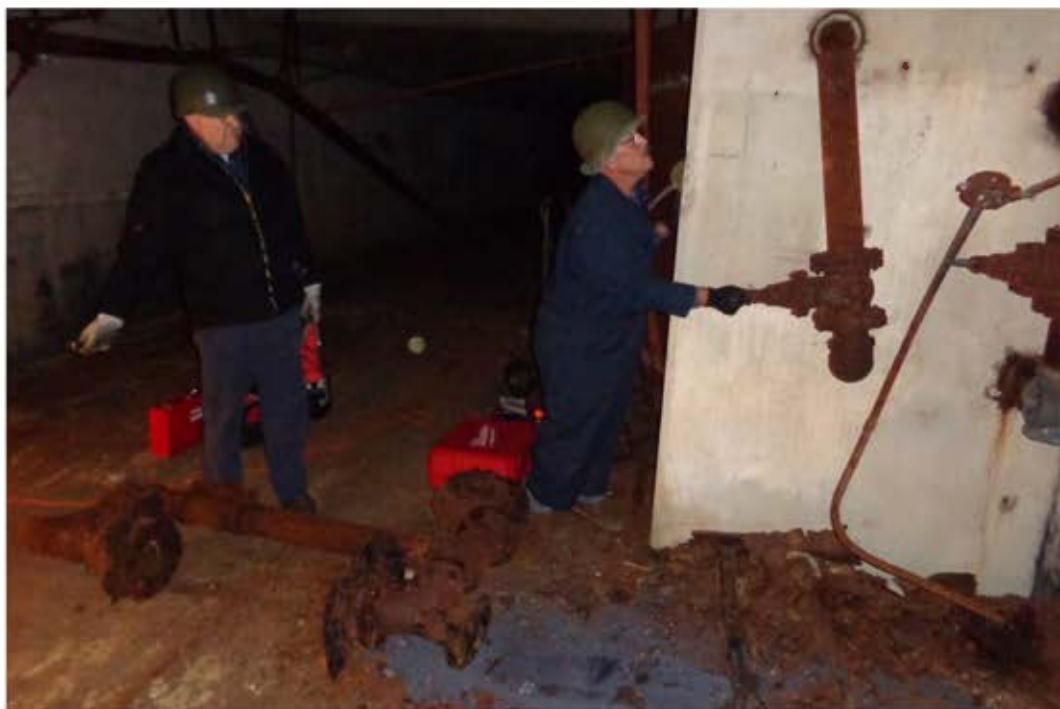
As we prepared to move the assembly to disassemble it, the horizontal pipe connecting the filter to the decontamination chamber collapsed. In the photo AGFA member Wally Tunison removes the broken pipe assembly as AGFA member Doug Ciemniecki looks on.

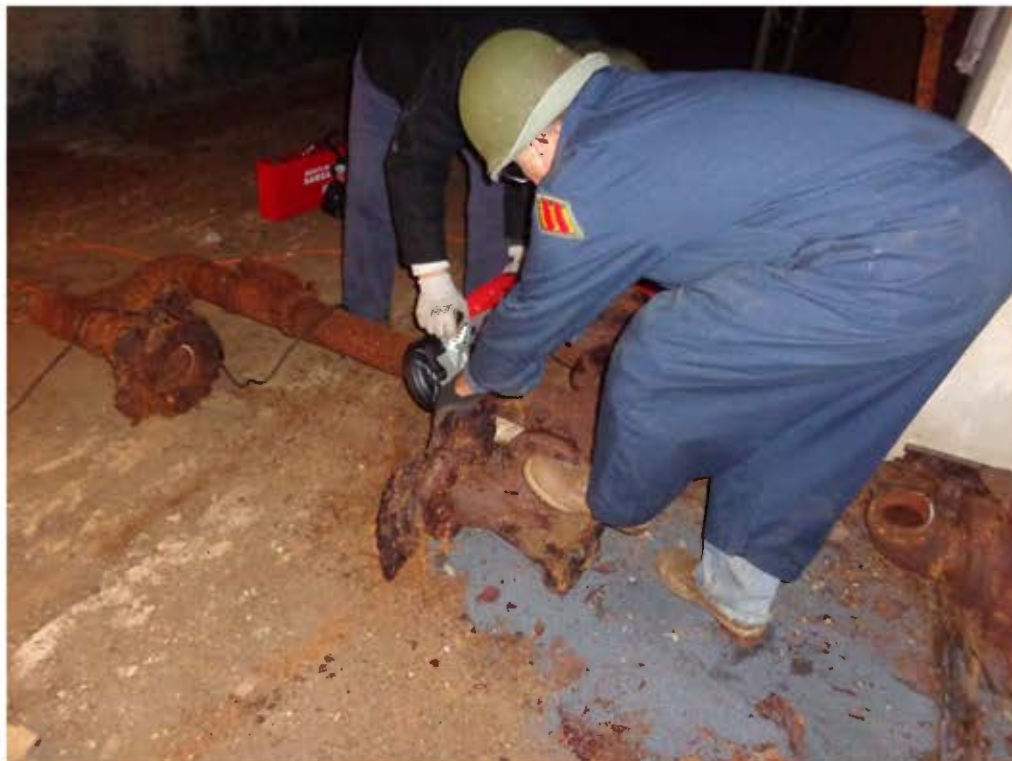
Below AGFA members begin the process the remove the components of the system. The "grey" charcoal is quite apparent on the floor in this photo. The brown material all over the concrete floor of Battery Kingman is rust from the overhead ammunition service equipment.
