**Restoring Chemical Warfare M1 Collective Protector System**  
**Battery Gunnison/New Battery Peck**  
***Ft. Hancock, New Jersey***

In the spring of 2014, the Army Ground Forces Association began locating and fabricating the required materials to restore the M1A1 Collective Protector Chemical Warfare system in Battery Gunnison/New Battery Peck. During this time AGFA was able to obtain a very significant quantity of original chemical warfare equipment, to include a 3,500 rpm AC motor and blower, switches, valves, pulleys and ancillary materials. Most of this equipment was in good to excellent condition and well within the capabilities of the membership to restore to a functional condition.

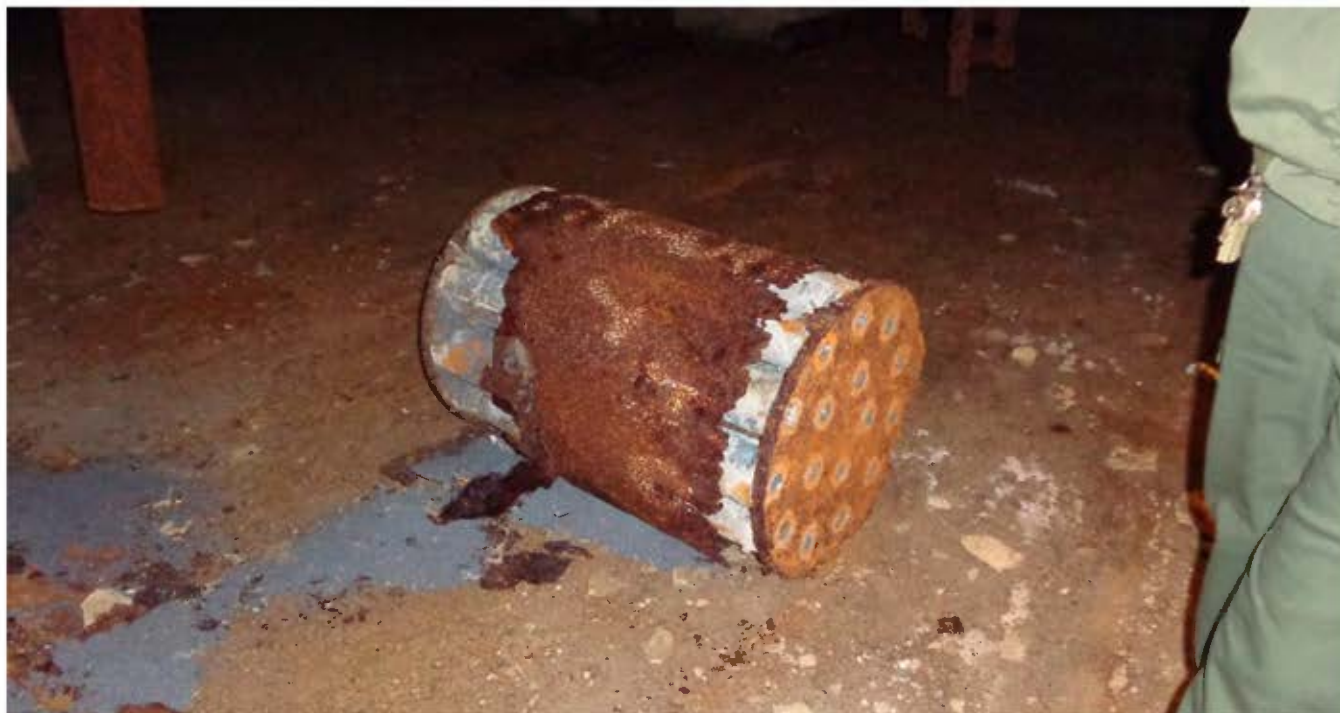
The photo below shows the air filter on its side. Most of the casing has disintegrated and the charcoal is no longer contained within the filter.

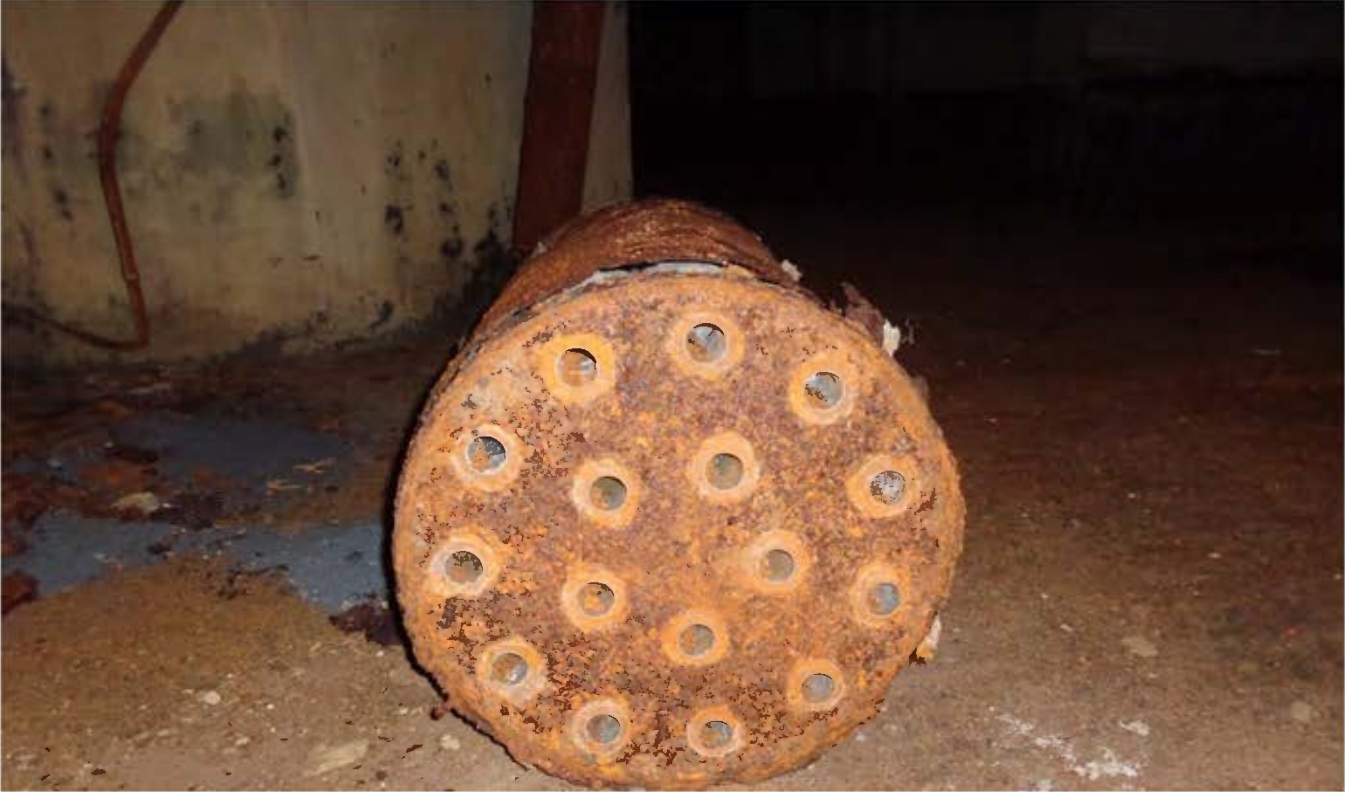
The view below shows the filtration pipes inside the filter very clearly. The air was pushed into these pipes and then through the charcoal filters surrounding these pipes.

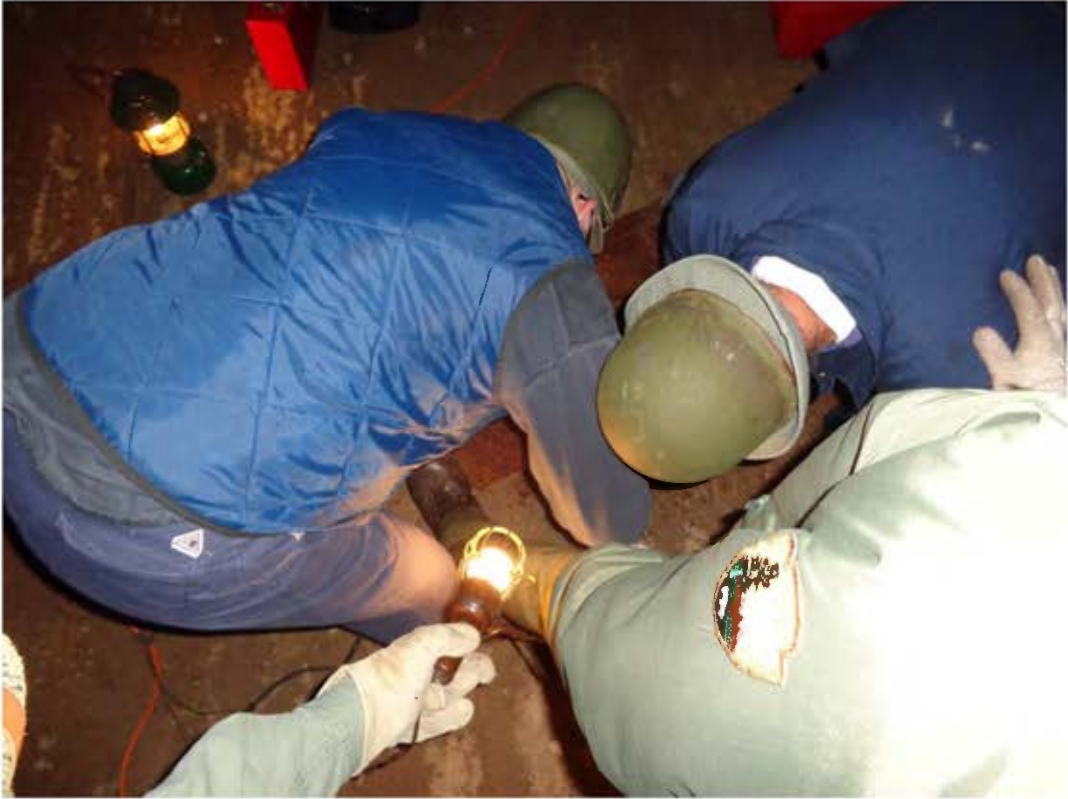
Below the upper valve is being removed from the filter assembly.

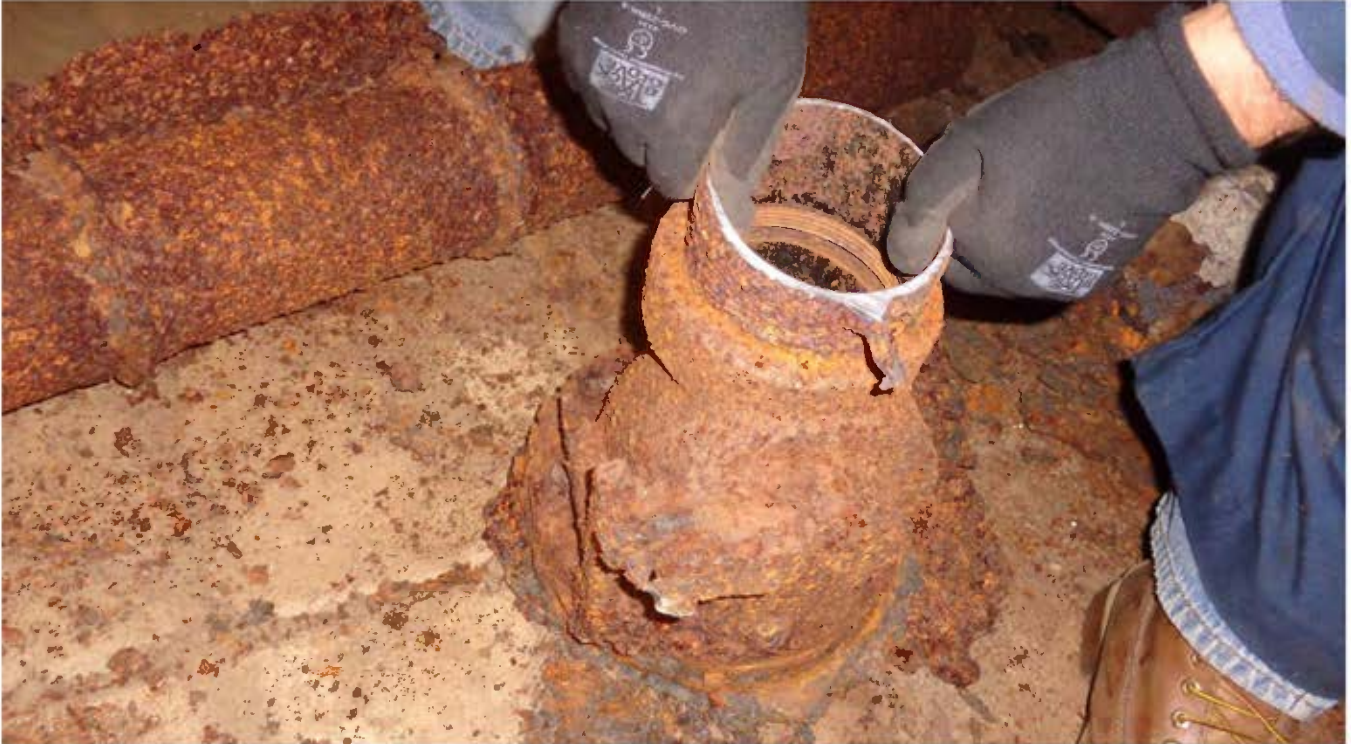
The upper valve is shown below - it appears to be in much better condition than the valve we already have on hand for restoration.

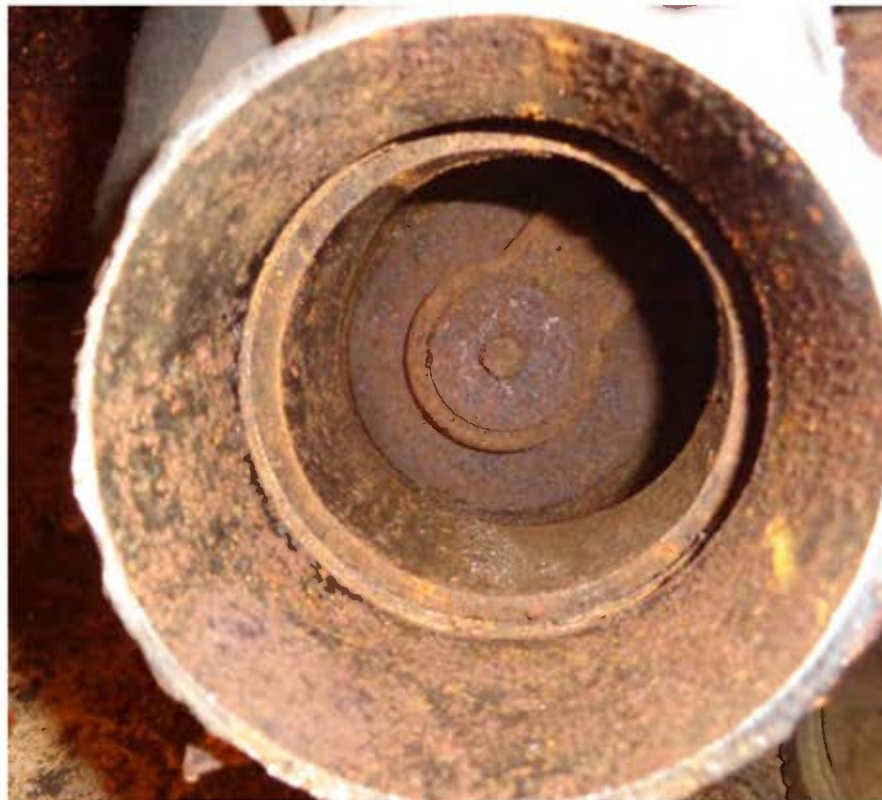
Most importantly, a look down inside the valve housing shows the flapper (closure) intact and operational. This is a major achievement and will result in a fully functioning valve set.

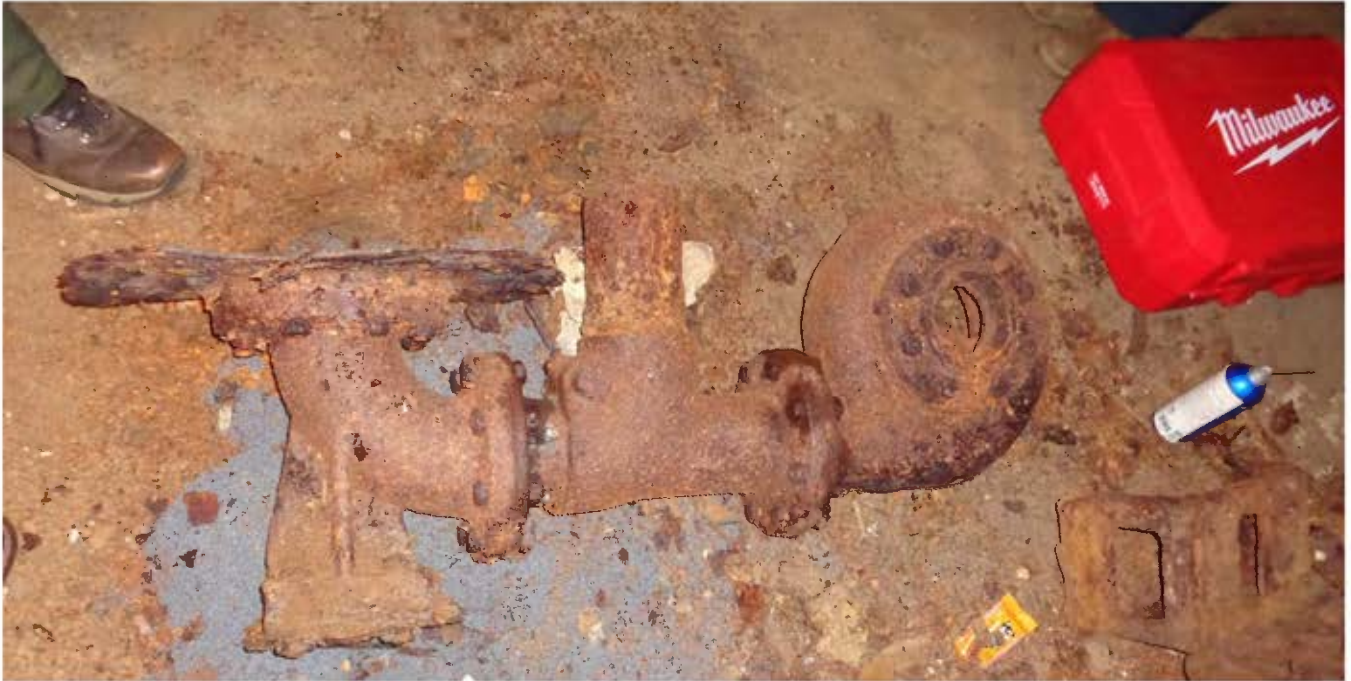
The filter support, lower valve and blower housing are shown connected below.

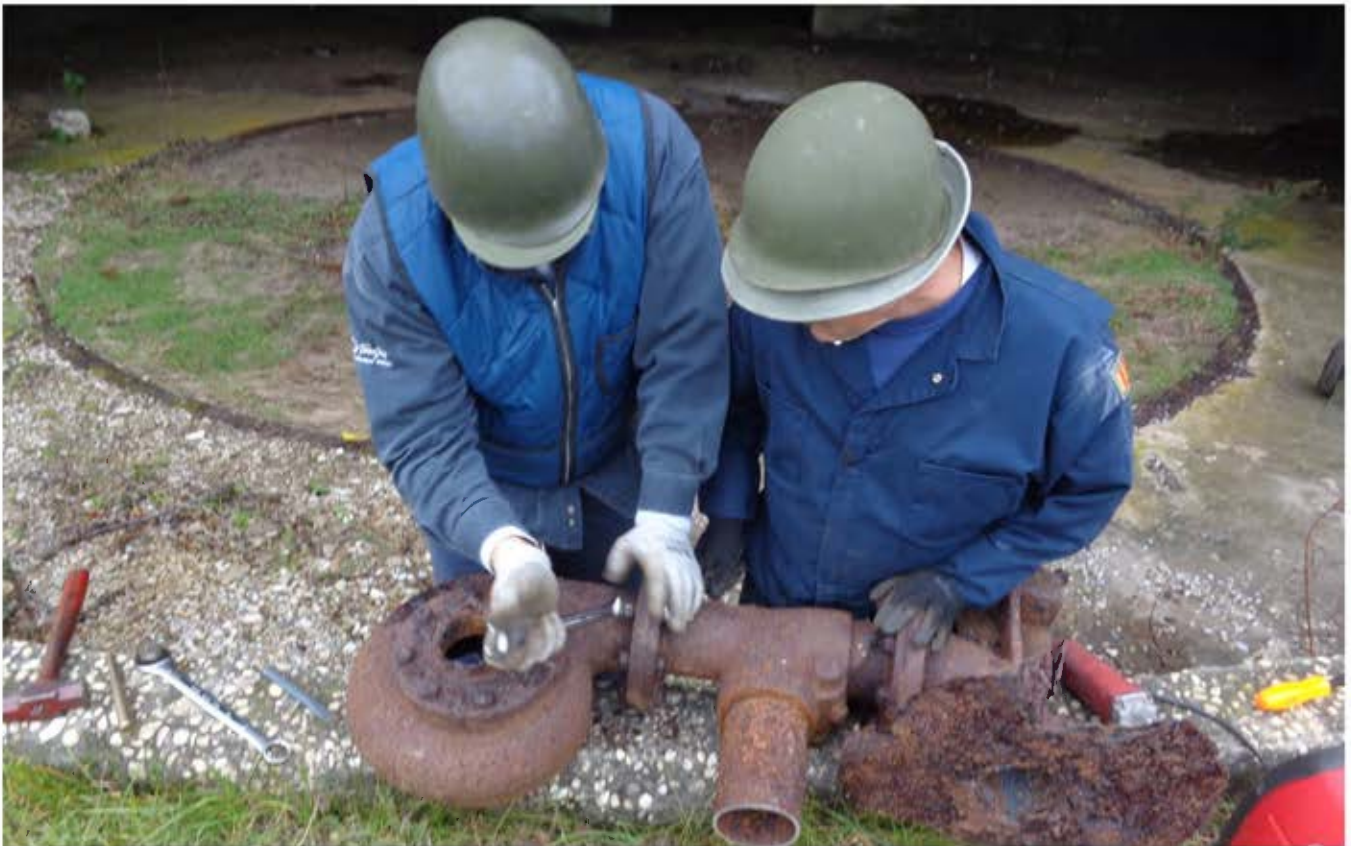
Once relocated outside, the team began the process of removing the blower housing. All the bolts and nuts were able to be removed - some by simply applying a wrench and some "elbow grease".

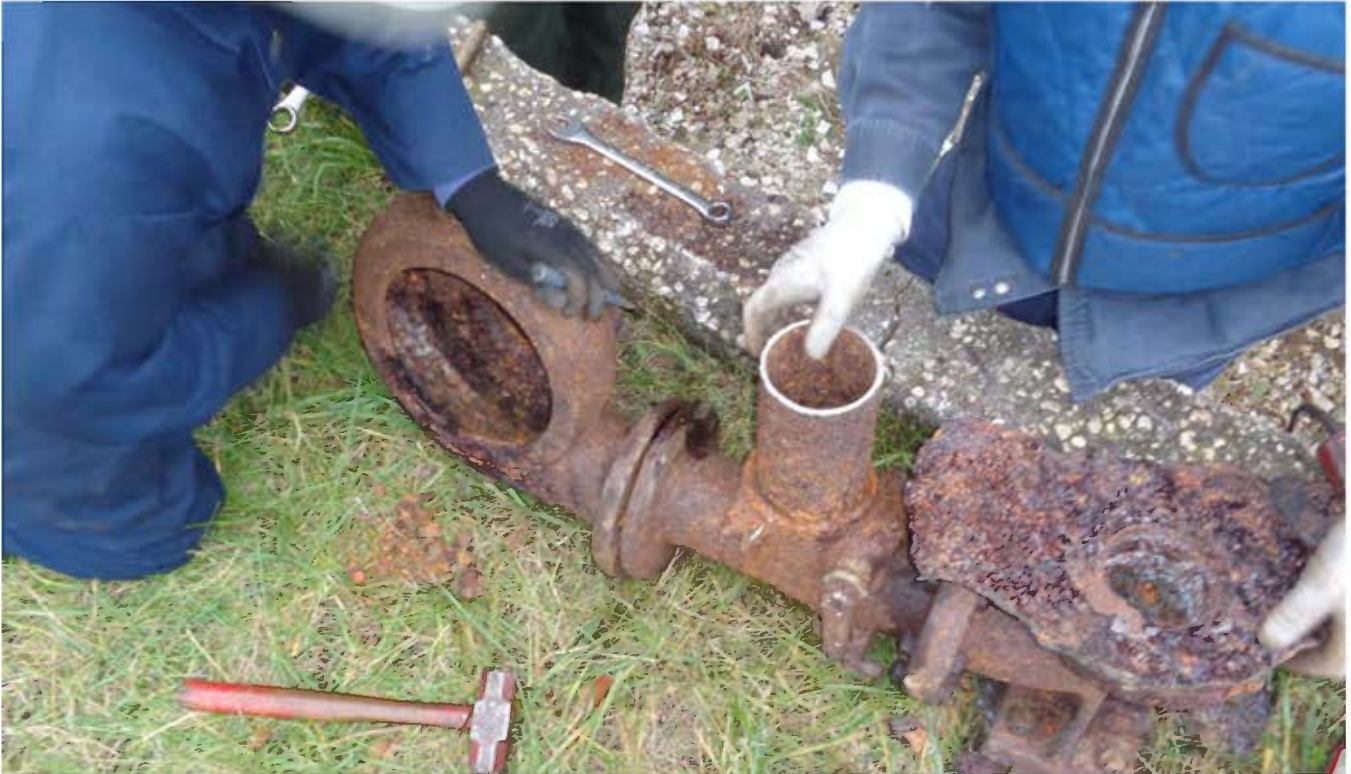
Below shows the blower in final stages of removal.

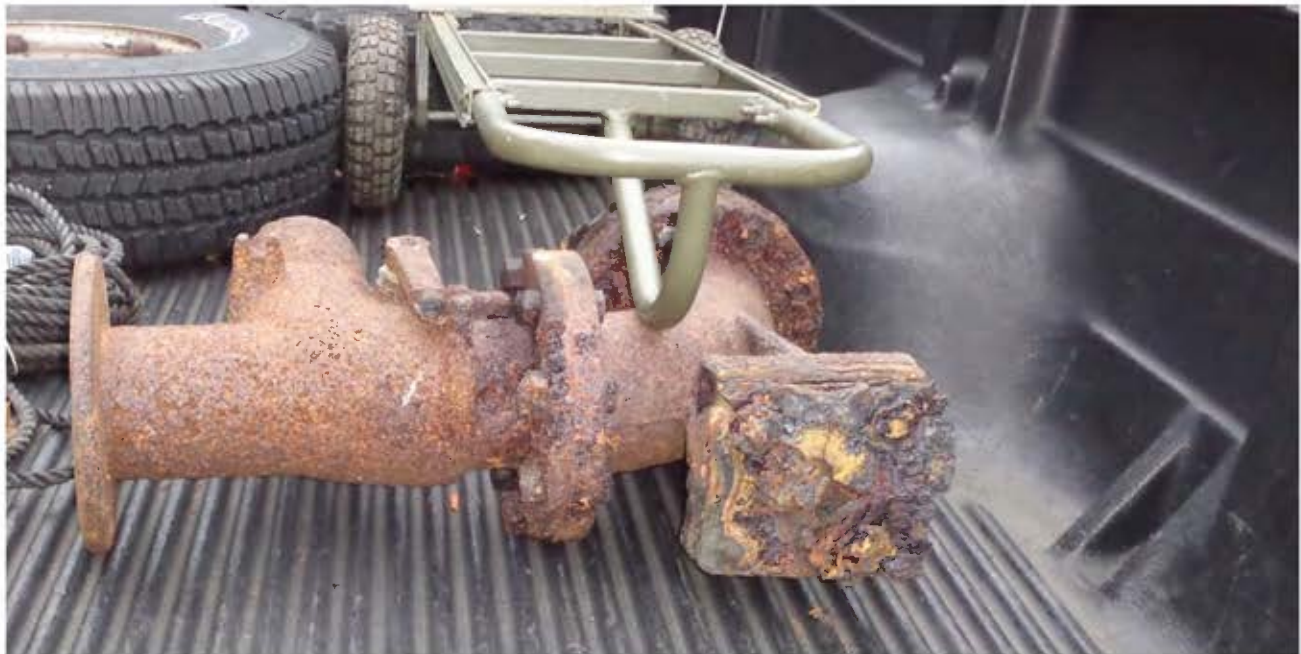
The lower valve and the filter support are shown below on their way to Battery Gunnison.

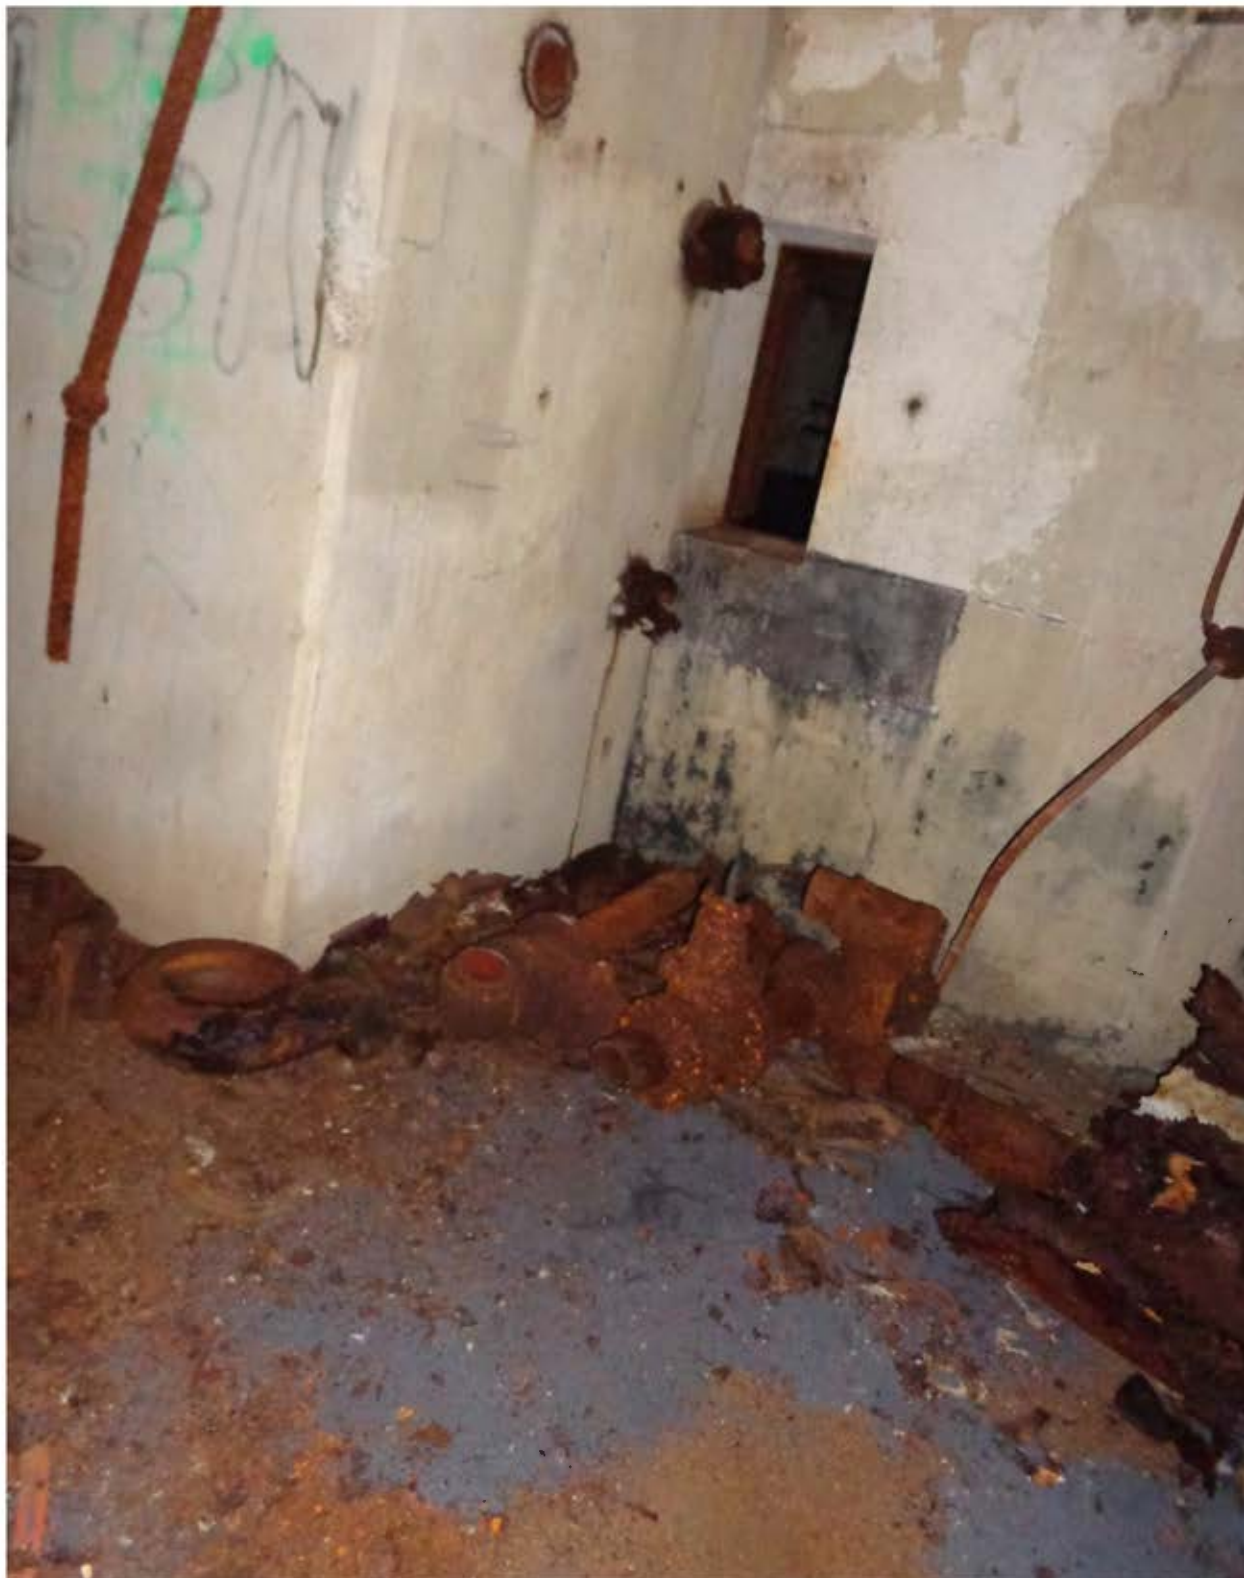
The photo below shows the remaining parts on the floor of Battery Kingman. The angle concrete walls are the exterior of the north plotting room's chemical decontamination room. The two pipe holes in the wall are the remnants of two short horizontal air pipes that collapsed during the removal process. All of these remaining components are on the floor in this photo. Most of these components are too far deteriorated to be considered for restoration.

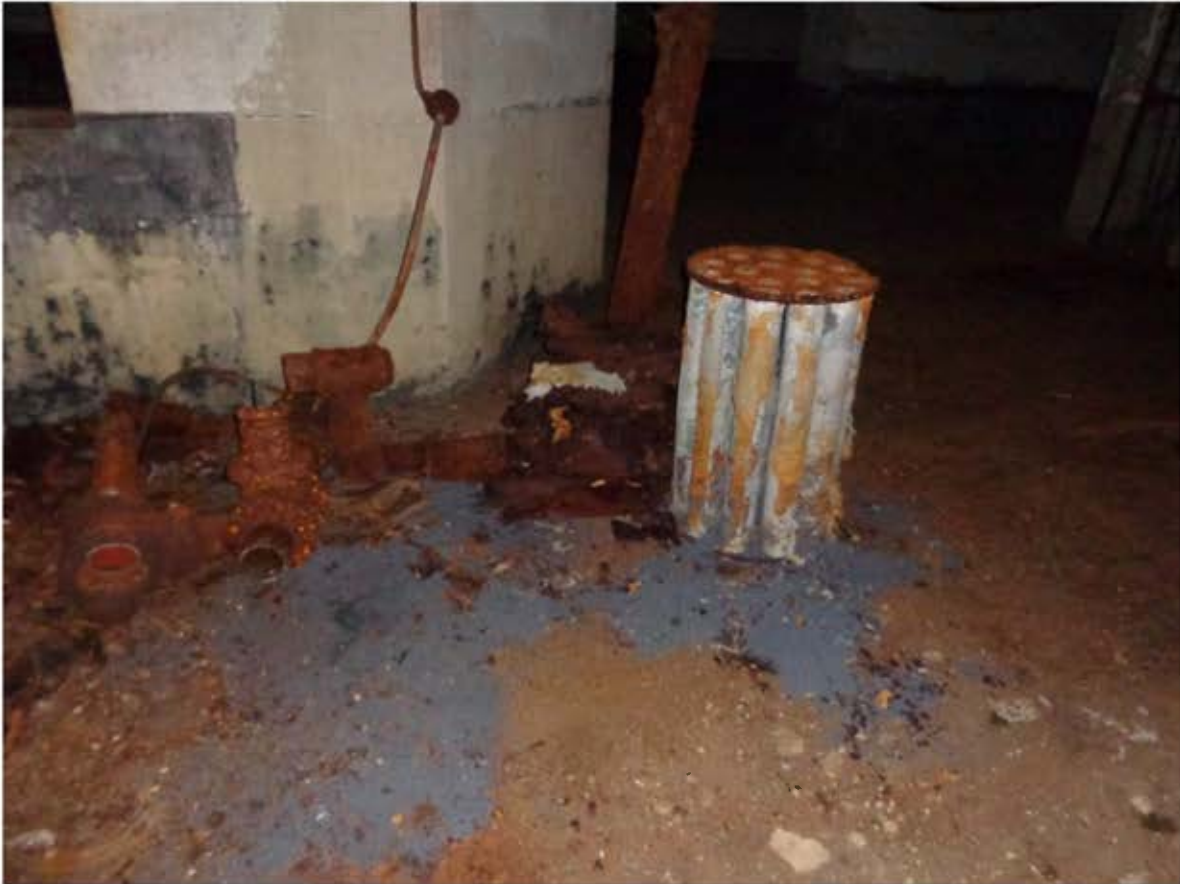
Once all the materials were removed for restoration, the remaining items were stacked back in the corner area where the original filter assembly was located. The photo below shows the filter on end, and the parts to the left of the filter. The grey matter on the floor is the charcoal from the filter and the brown matter on the floor is all flaked rust from the pipe system and the overhead ammunition railings.

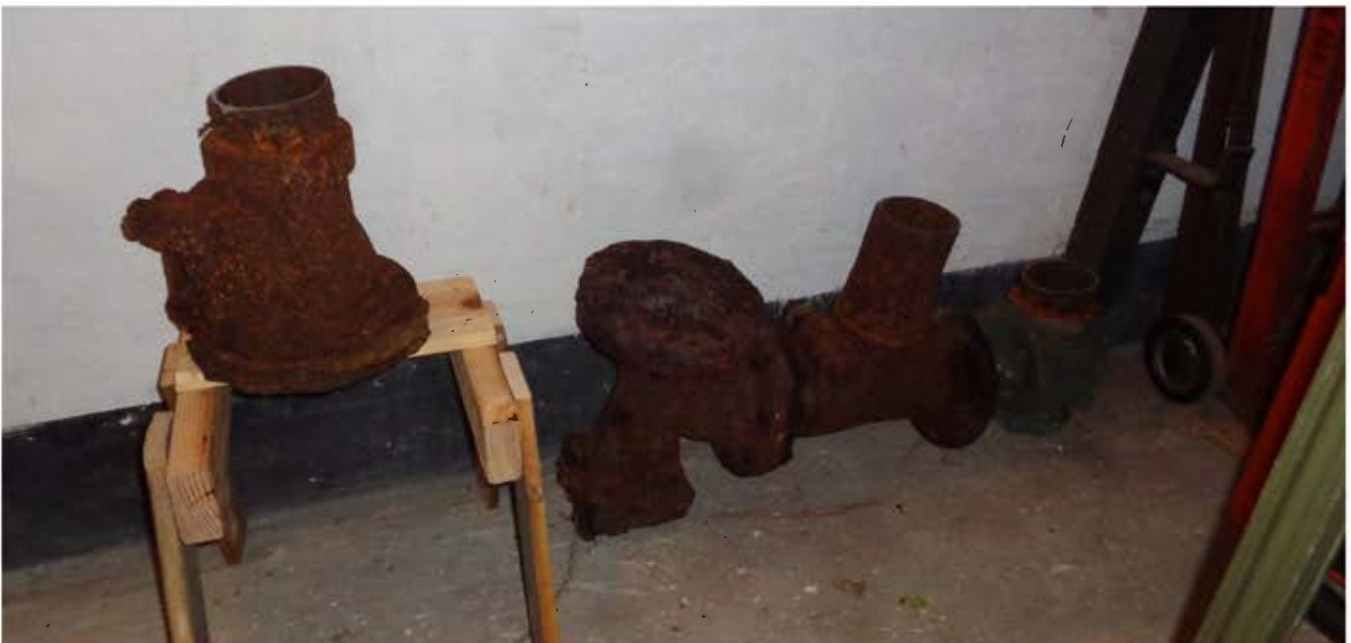
As of 13 November, the two valve assemblies are located in the powder passage of Battery Gunnison/New Battery Peck. These items will be cleaned and restored over the next six months.

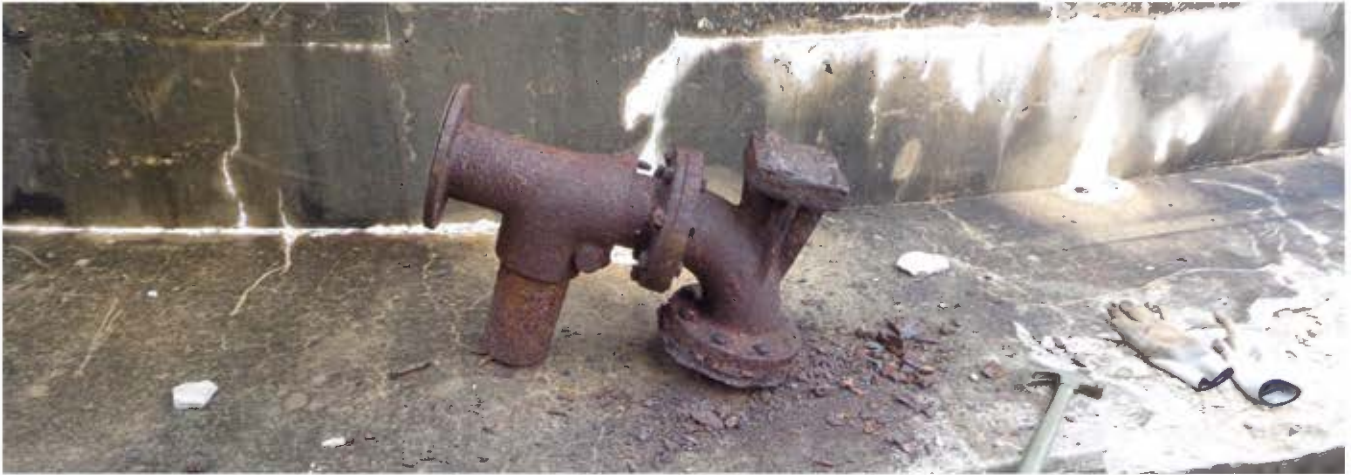
The restoration of the valves began the weekend of 19-20 April 2019. In the picture below the bottom valve and stand (inverted) is being prepared for disassembly.

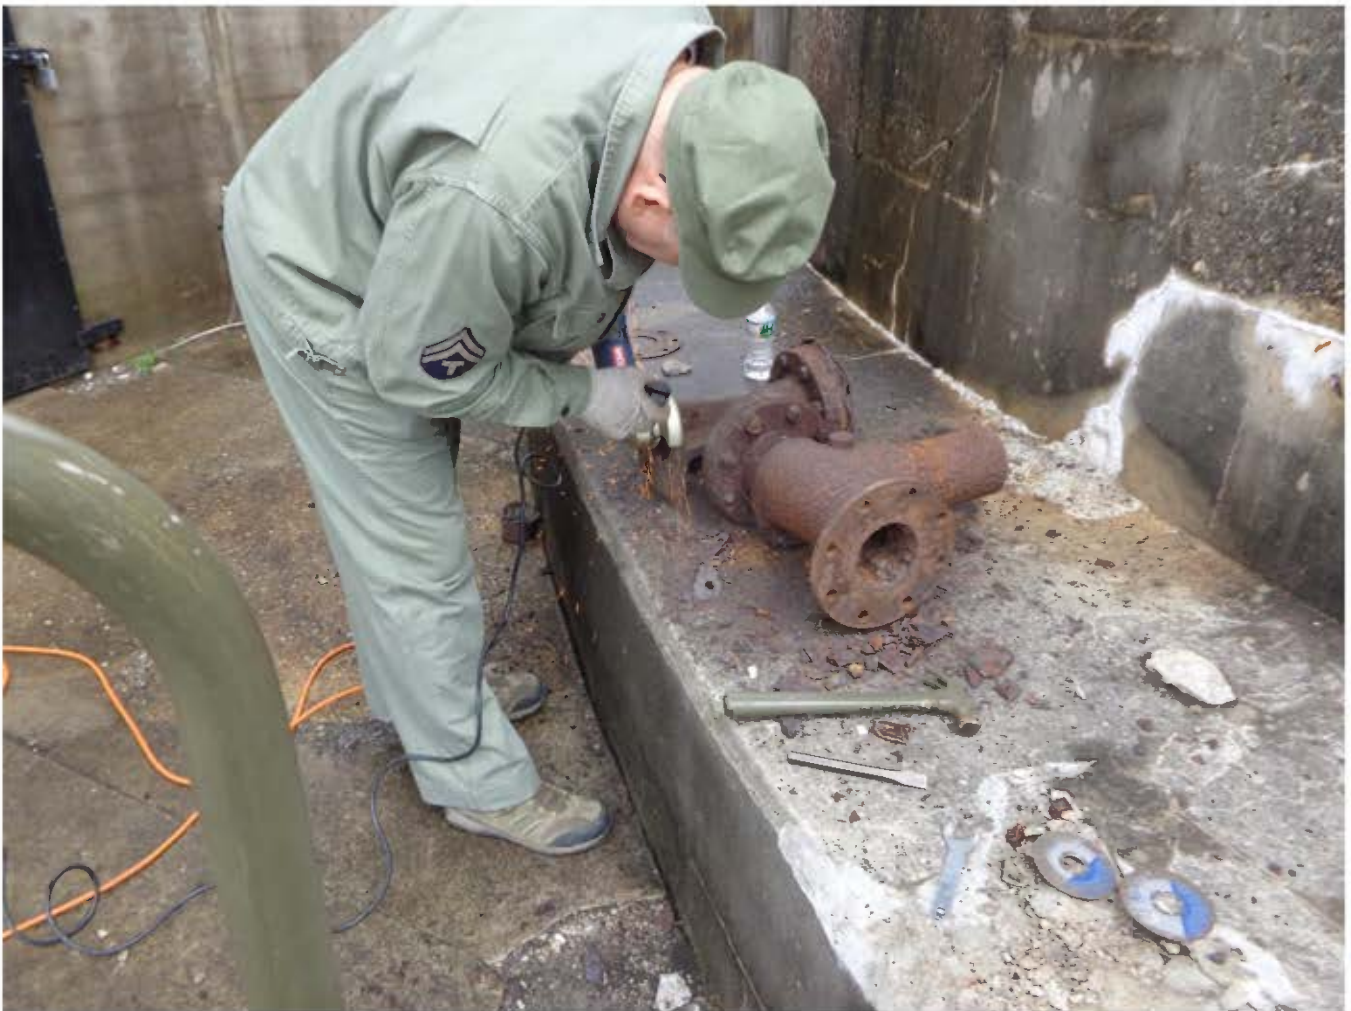
In the photo below excessive scale and rusted bolts are being removed from the areas around the nuts to the bolts.

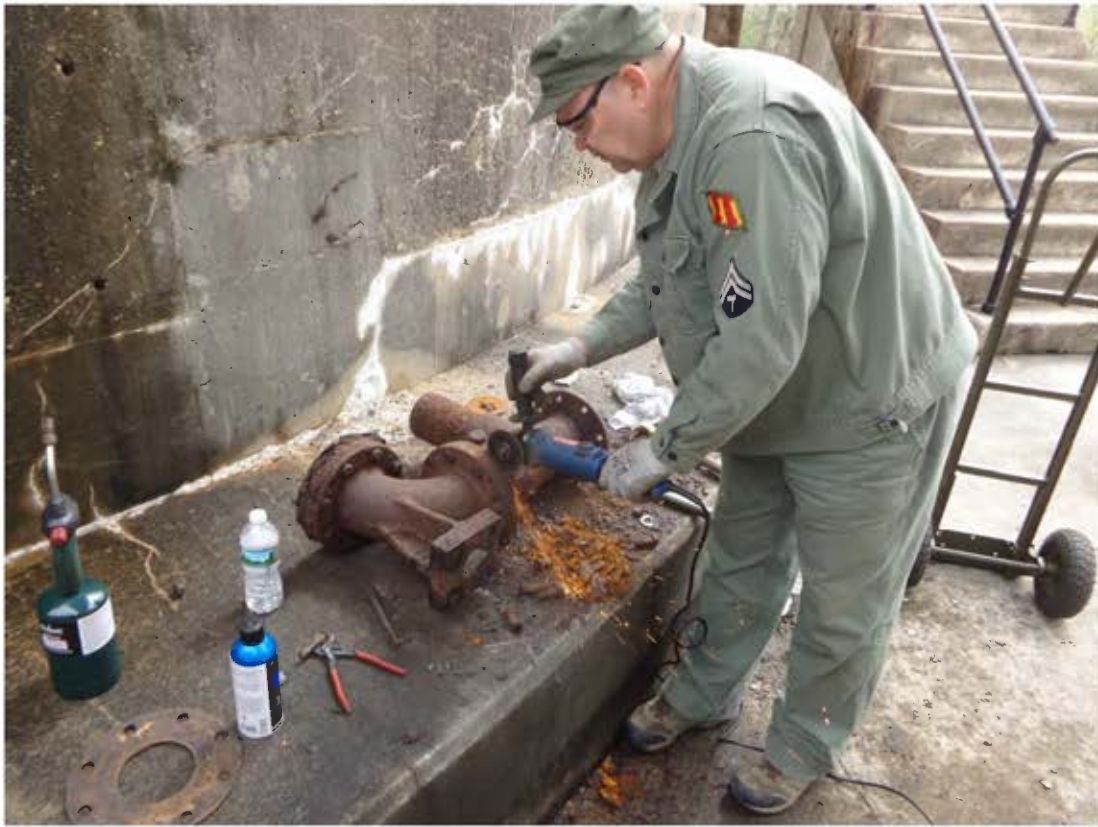
The lower valve assembly was separated from the 90 degree stand by cutting the nuts that were rusted onto the bolts. This was a delicate operation to ensure the fixture proper was not marred in any way.

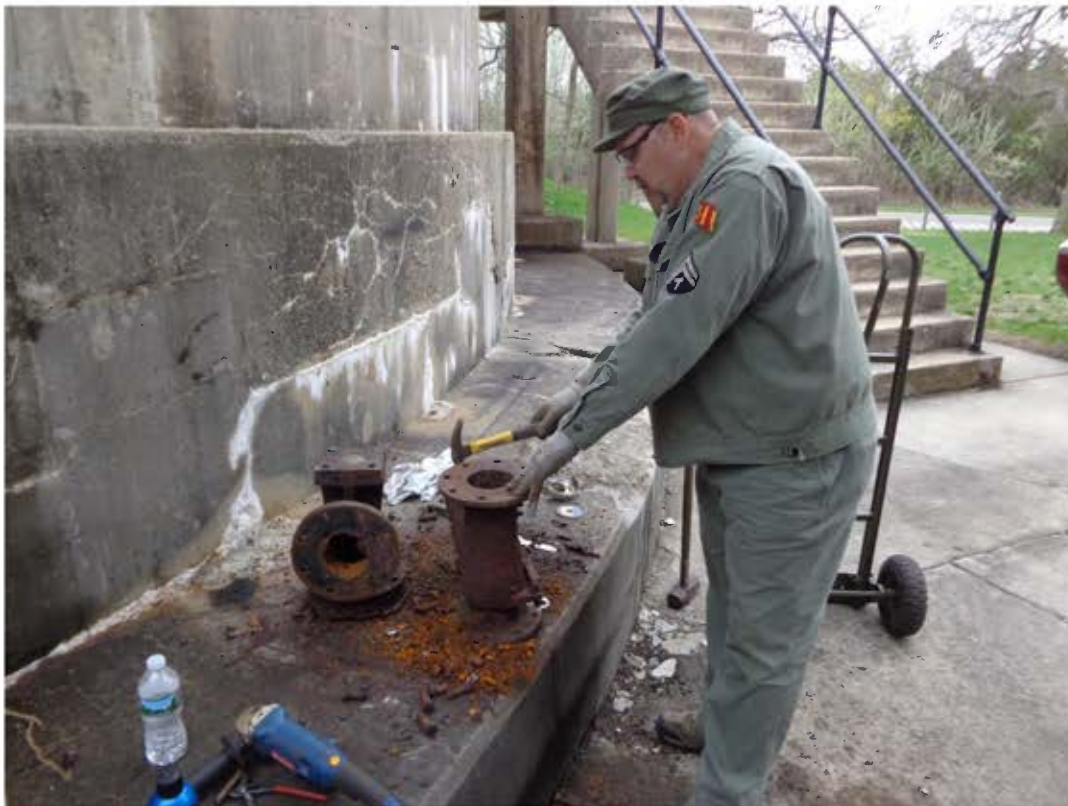
Once the nuts were cut off, the assemblies were separated.

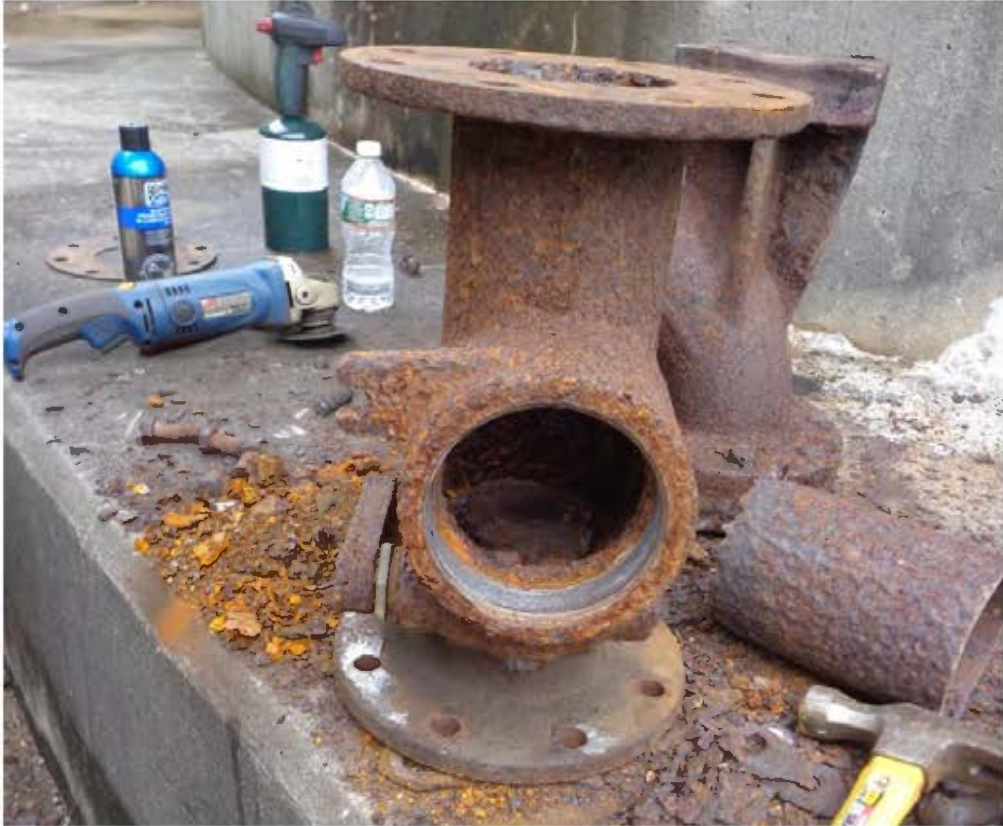
After separation, the threads for the pipe were cleaned as shown below. The silver threads indicated rusted and broken threads were removed.

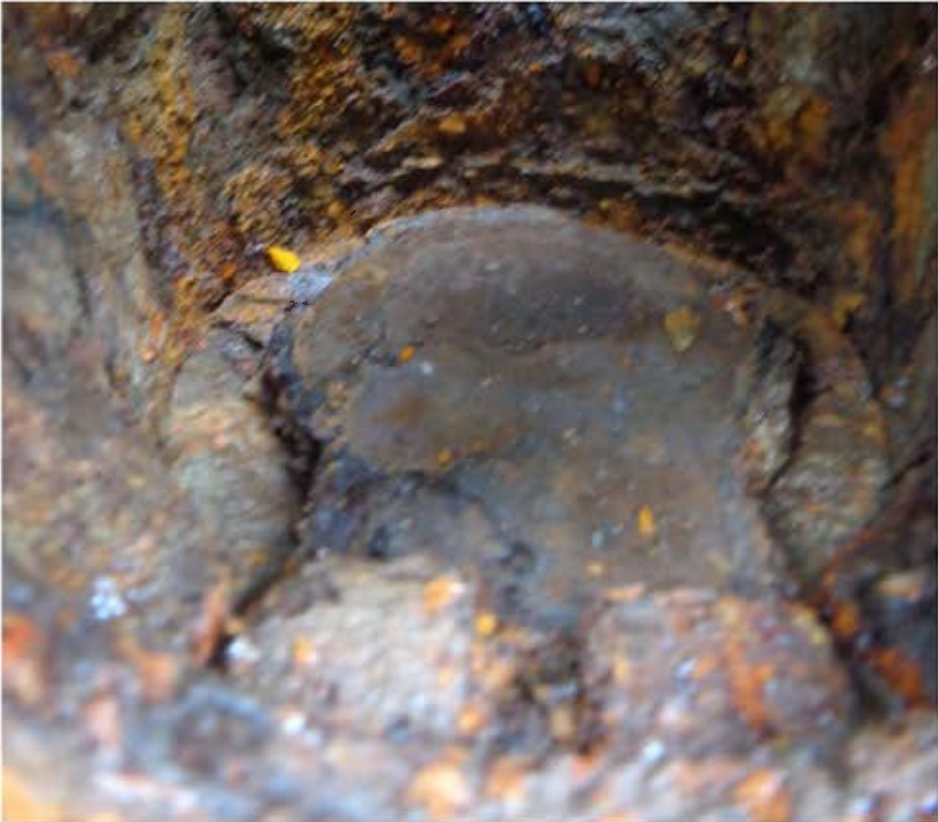
The photo below shows the inside of the valve with the valve flapper frozen into place. This took several months to gently remove the rust and free the mechanism.

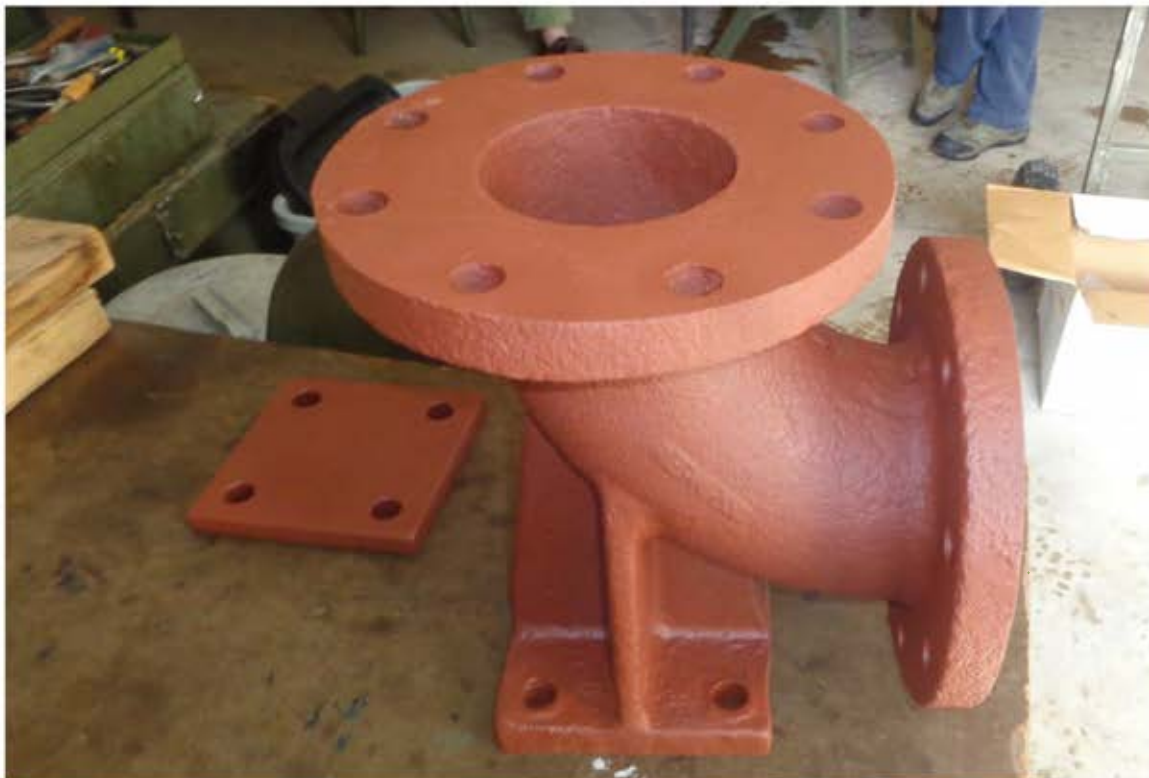
Throughout the months of May and June, the valve and 90 degree elbow stand were progressively cleaned, taken apart, primed, painted, and reassembled. The photo below shows the 90 degree elbow and filter stand cleaned and primed.

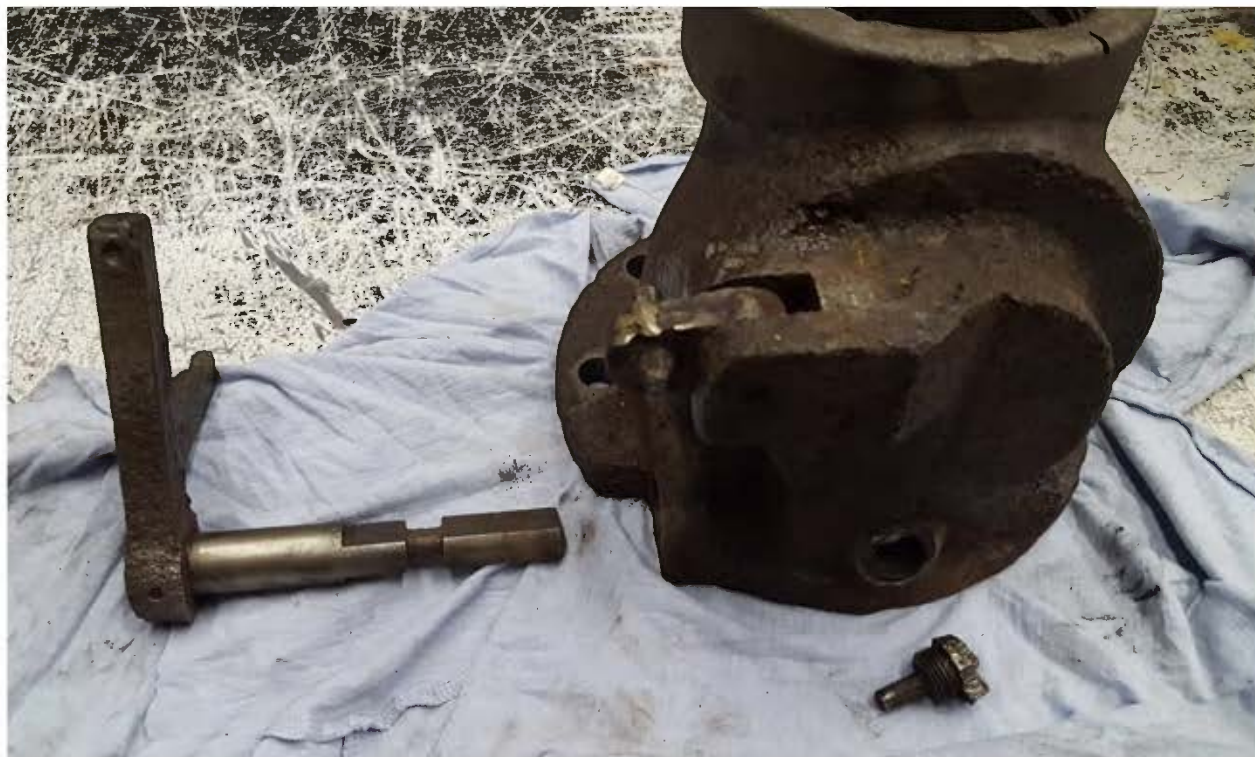
In April the upper valve was given an electrolysis rust removal treatment. The valve assembly was frozen solid but after a long soak in penetrating oil it eventually was able to be taken apart. Notice how clean the shaft for the valve arm is. The screw in the lower right of the photo had clean threads, but the head was badly decomposed. The lower valve assembly's retention screw was also badly deteriorated.

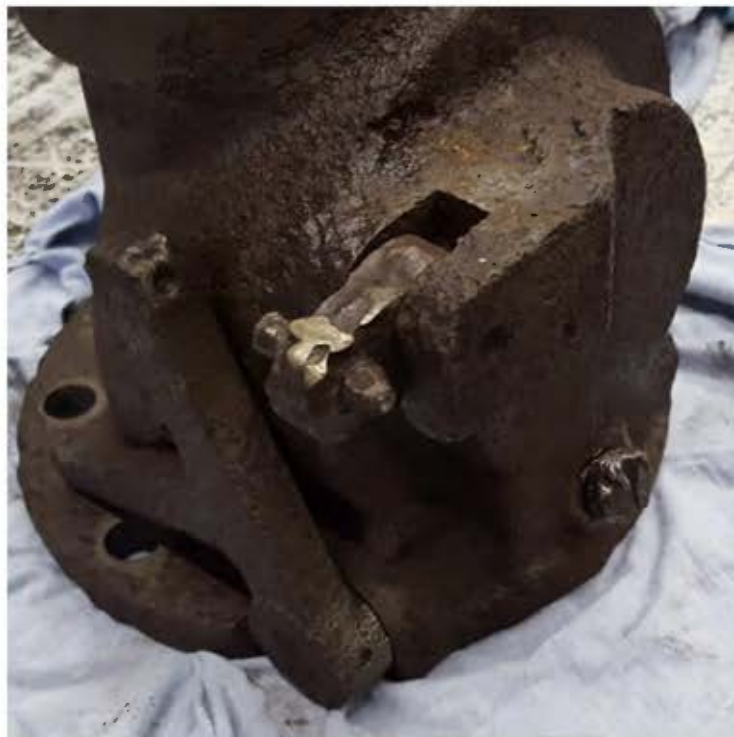
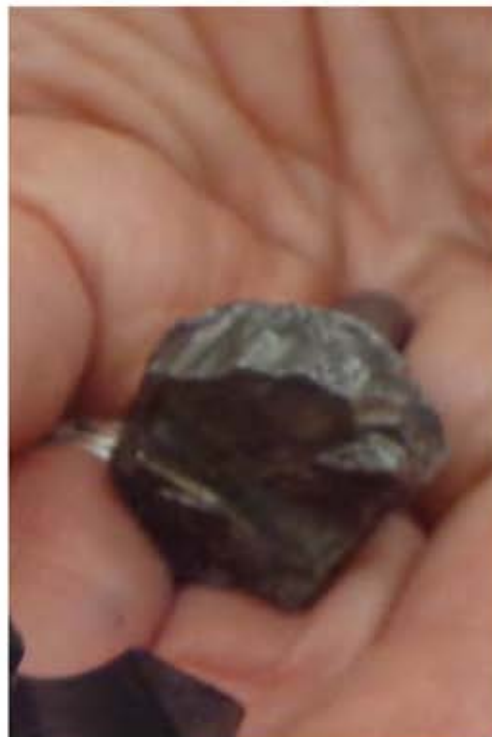
The photo below (left) shows the valve arm actuator assembly reassembled into the valve housing. Notice the badly damaged screw head in the lower left on the valve assembly. That same screw is shown in the photo on the right.

The answer to badly deteriorated screws was to make new screws. The two screws on the left below are replacements for the badly deteriorated screw shown on the right. These screws were made on site in the Machinshop at Battery Gunnison/New Battery Peck. The photo on the right shows the final measurements being taken on one of the new screws in the Battery Machine Shop. The lathe where the screws were cut to size is in the right of the picture. These screws are critical to the correct functioning of the valves. Without these screws, the flappers are not held in place which prevents the seal from being achieved.

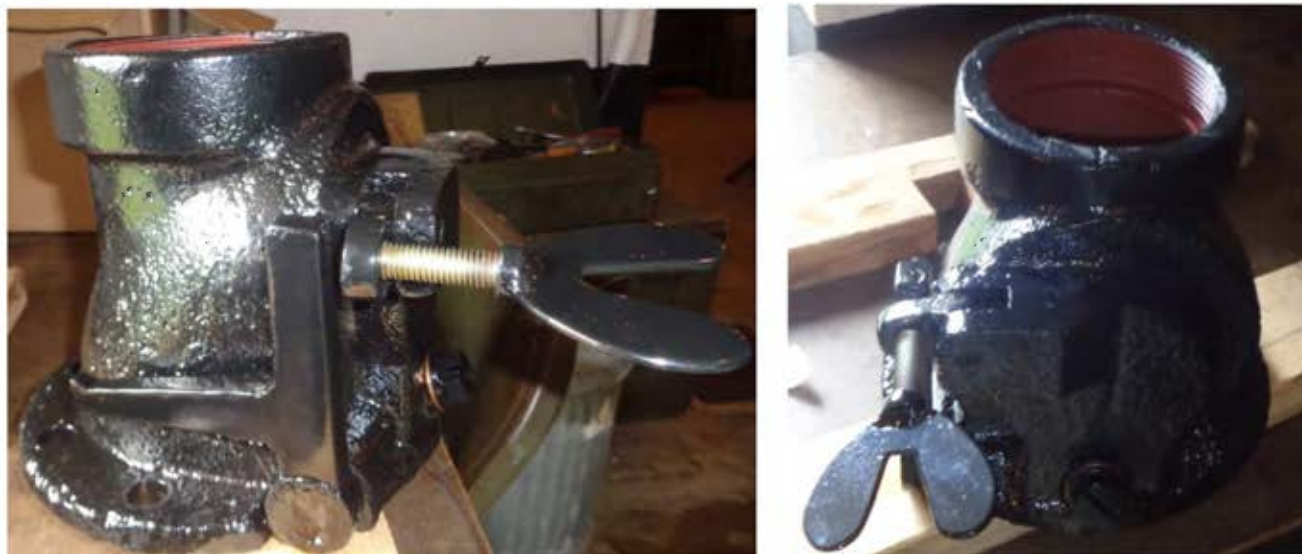
The photo below provides another view of the top valve. Notice the large butterfly screw - a custom made screw to replace the badly decomposed original. The valve housing required the aggressive cleaning and re-threading of the top pipe threads.
