**Restoring Chemical Warfare M1 Collective Protector System**  
**Battery Gunnison/New Battery Peck**  
***Ft. Hancock, New Jersey***

In the spring of 2014, the Army Ground Forces Association began locating and fabricating the required materials to restore the M1A1 Collective Protector Chemical Warfare system in Battery Gunnison/New Battery Peck. During this time AGFA was able to obtain a very significant quantity of original chemical warfare equipment, to include a 3,500 rpm AC motor and blower, switches, valves, pulleys and ancillary materials. Most of this equipment was in good to excellent condition and well within the capabilities of the membership to restore to a functional condition.

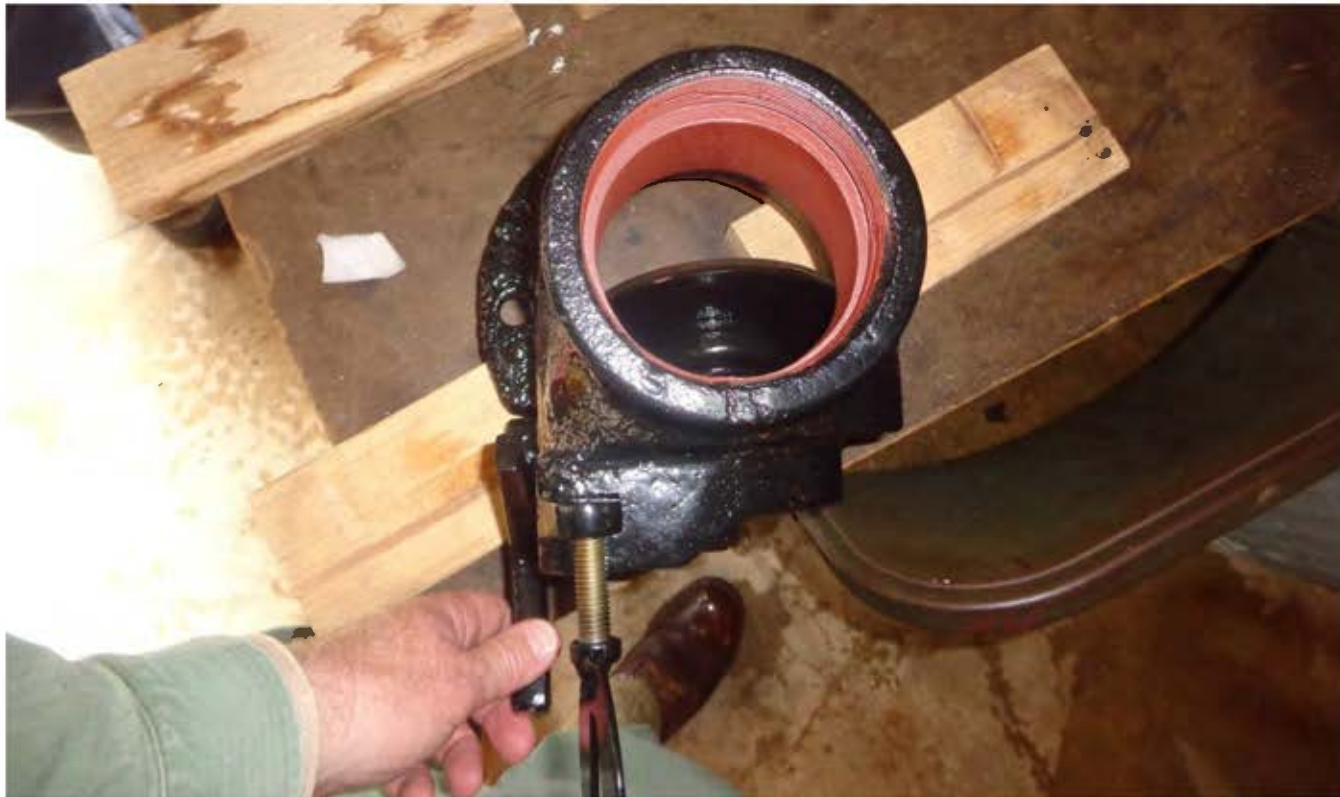
The Upper Valve is shown below with the valve flapper open from the top looking down.

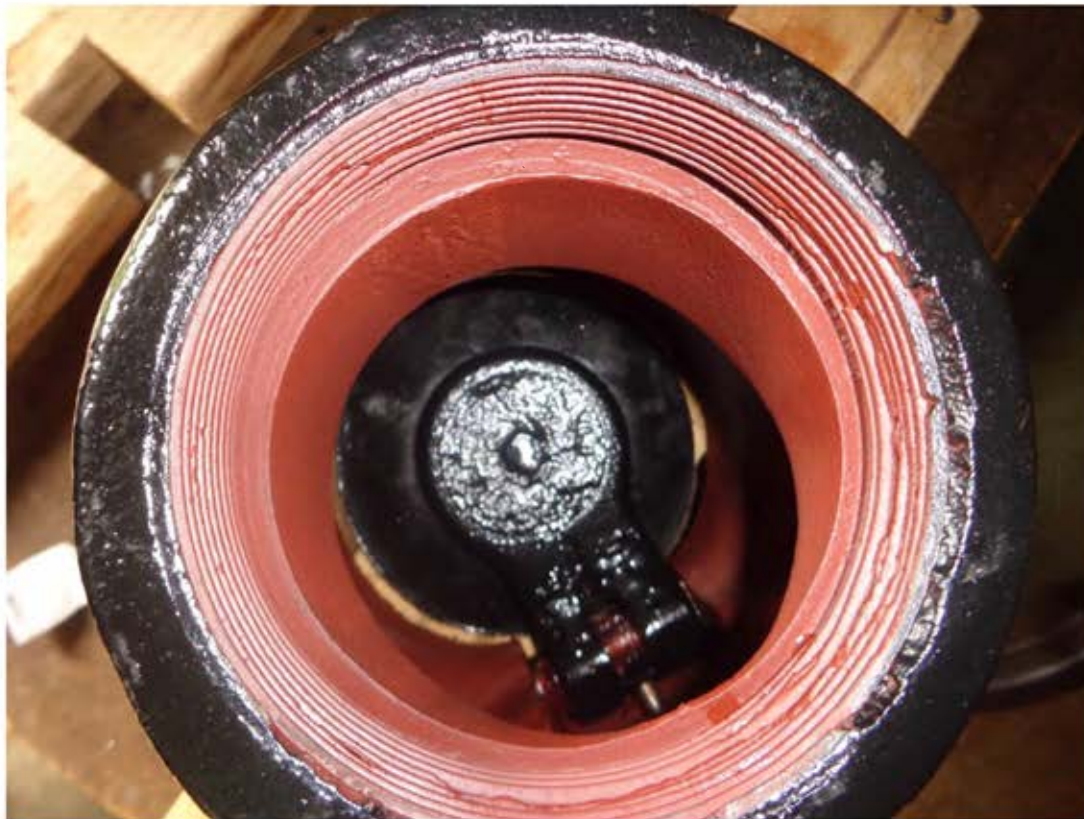
The photo below shows the upper valve flapper closed from the top looking down.

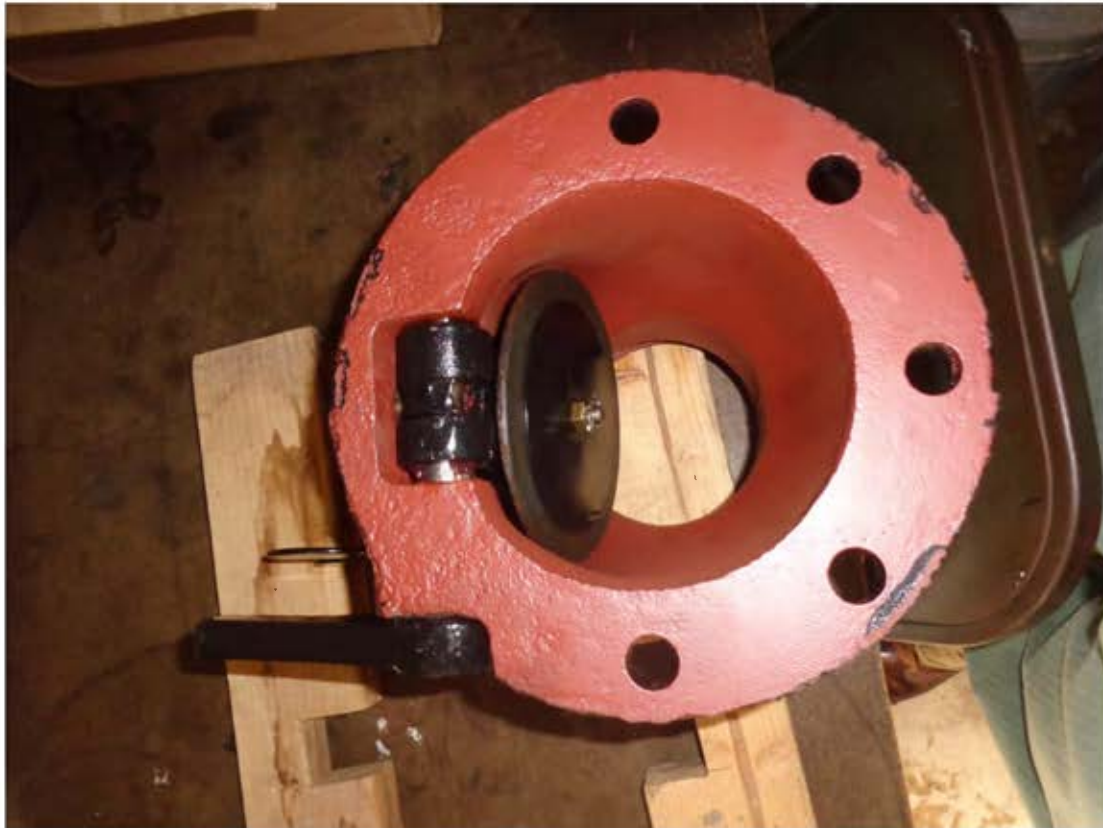
The photo below shows the upper valve with the flapper open looking from the bottom (filter) side looking "up" into the outflow pipe.

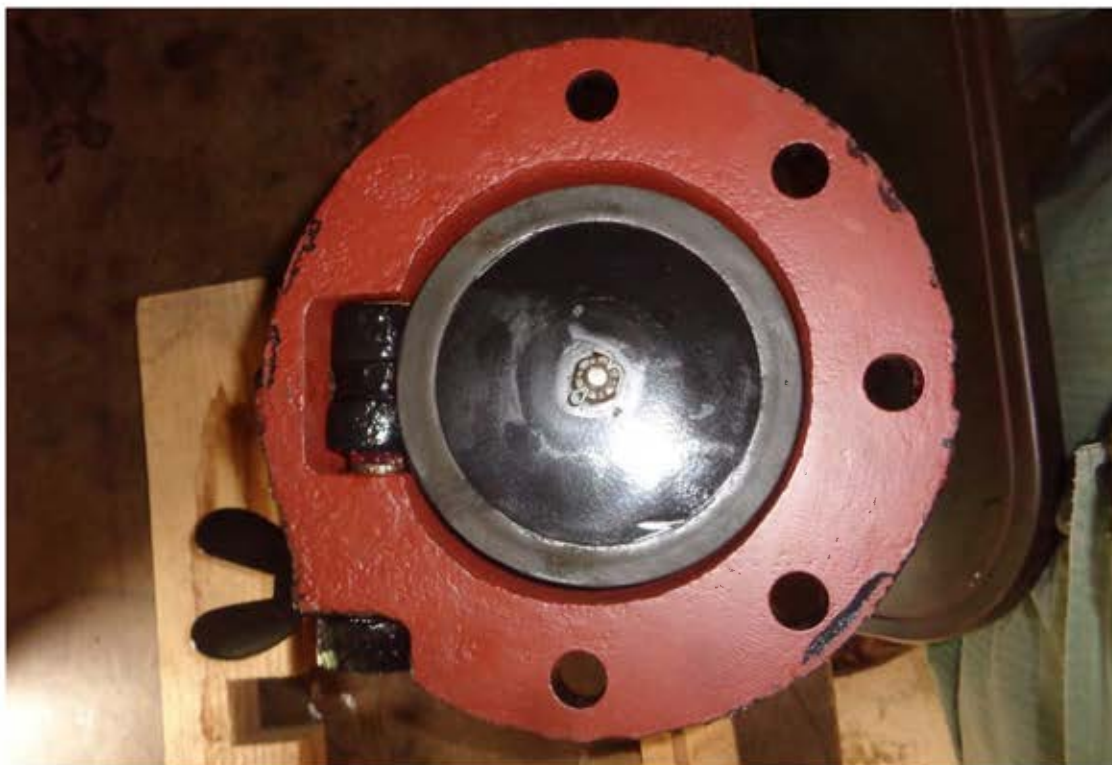
The photo below shows the flapper closed as it would be on the opening into the filter assembly.

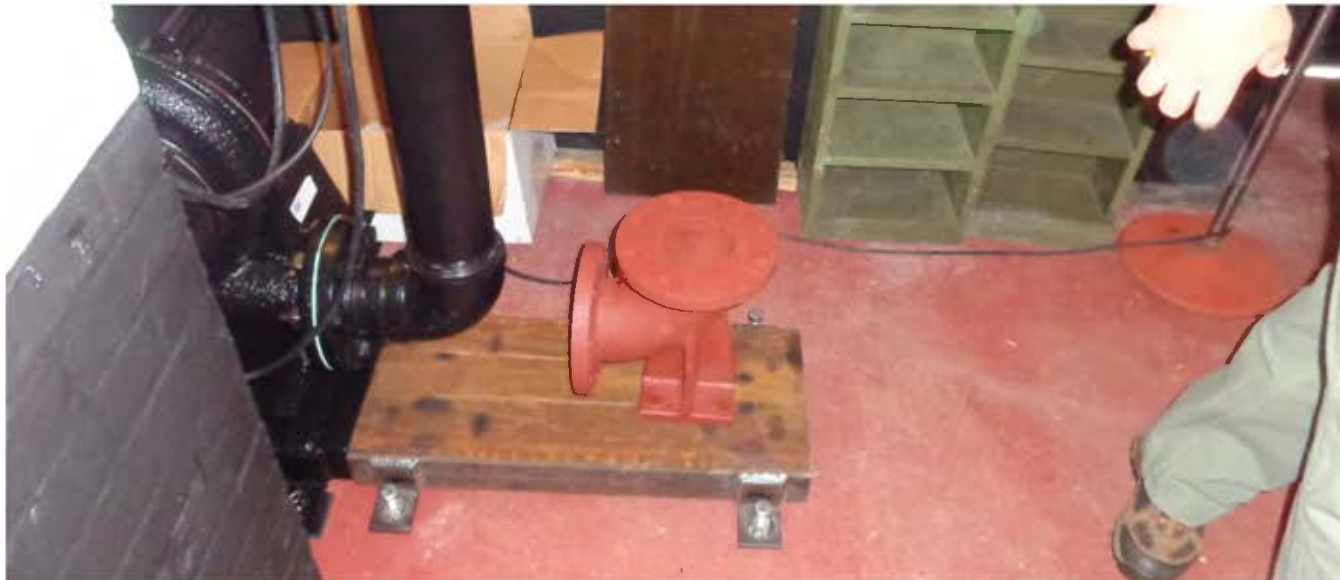
In September 2019 we began the process of installing the second half of the mounting platform. The photo below shows the 90 degree platform resting on the platform plate assembled to the motor/blower plate. The black elbow will be removed and the lower valve assembly will be put its place and connected to all three - blower, vertical pipe and 90 degree elbow

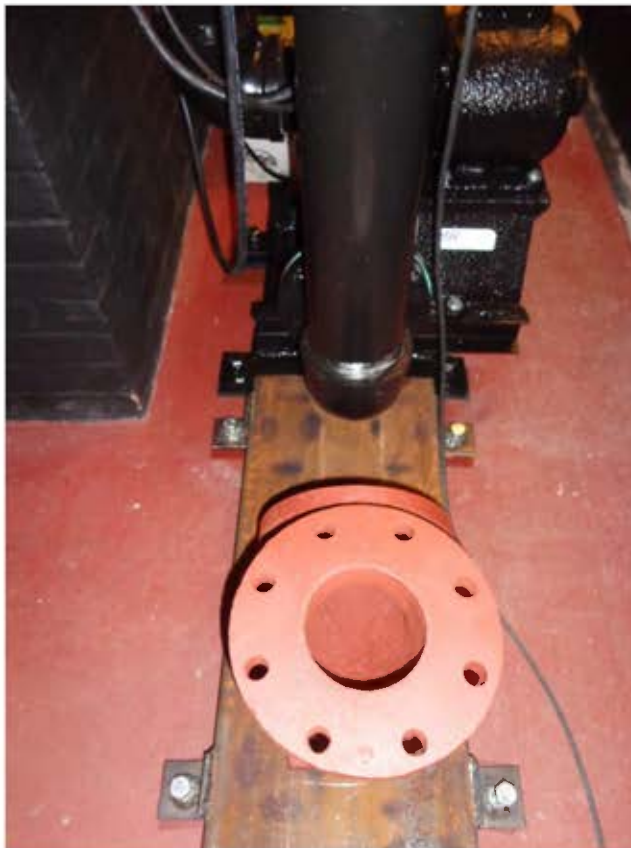
The photo below shows another view of the platform and the 90 degree elbow.

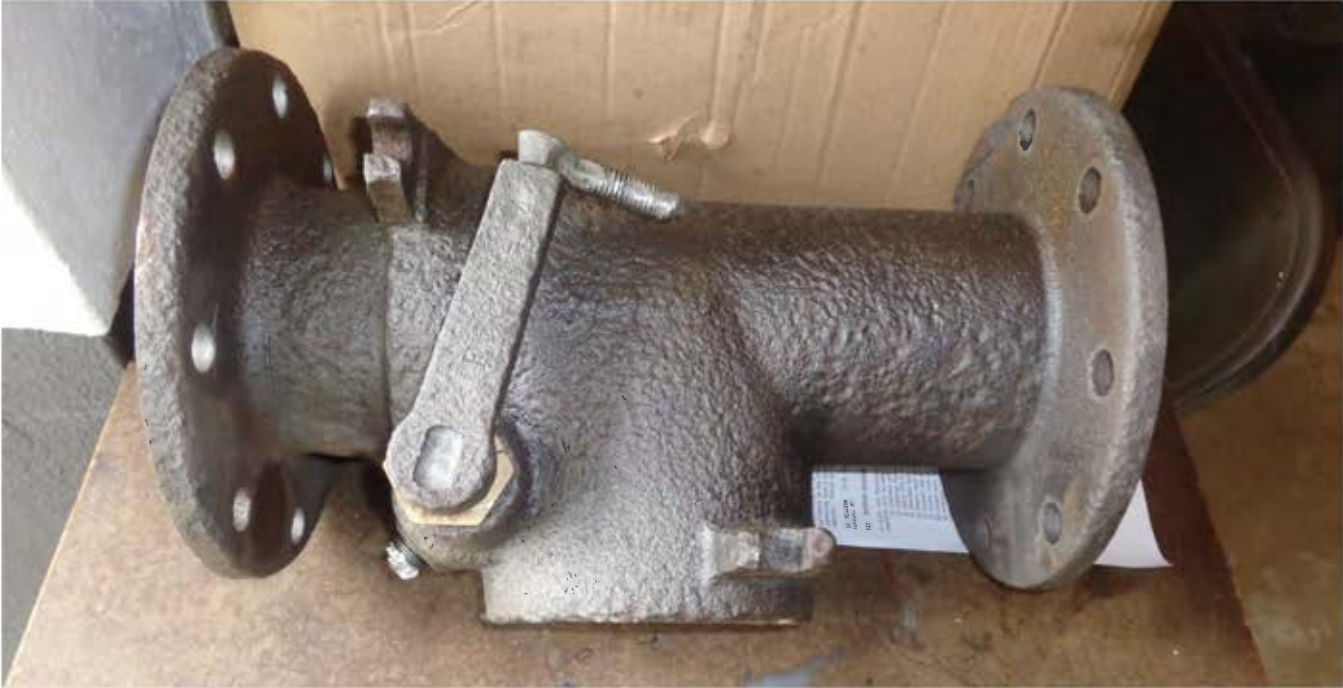
The lower valve was also under restoration. The photo below from 14 Sept 2019 shows the lower valve with the valve arm open.

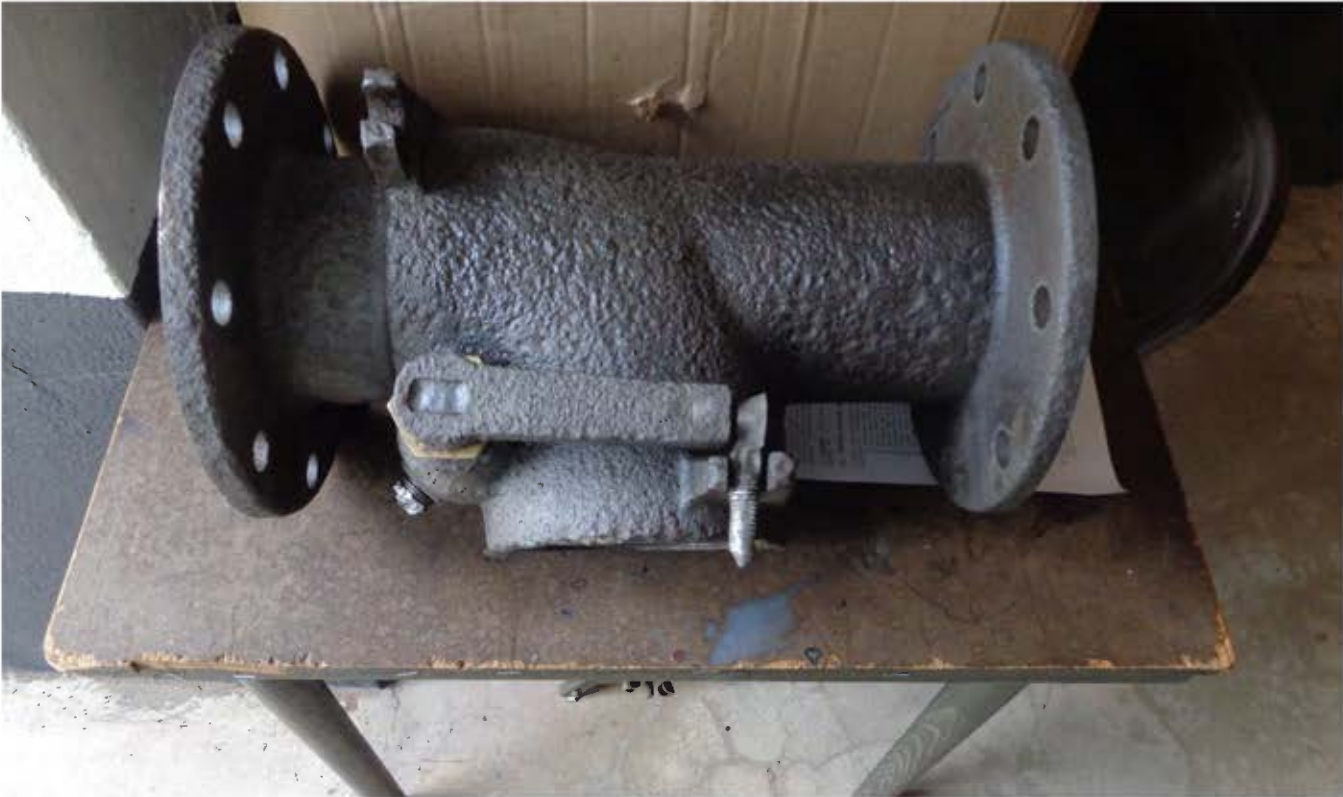
In the photo below the valve arm is shown in the closed position.

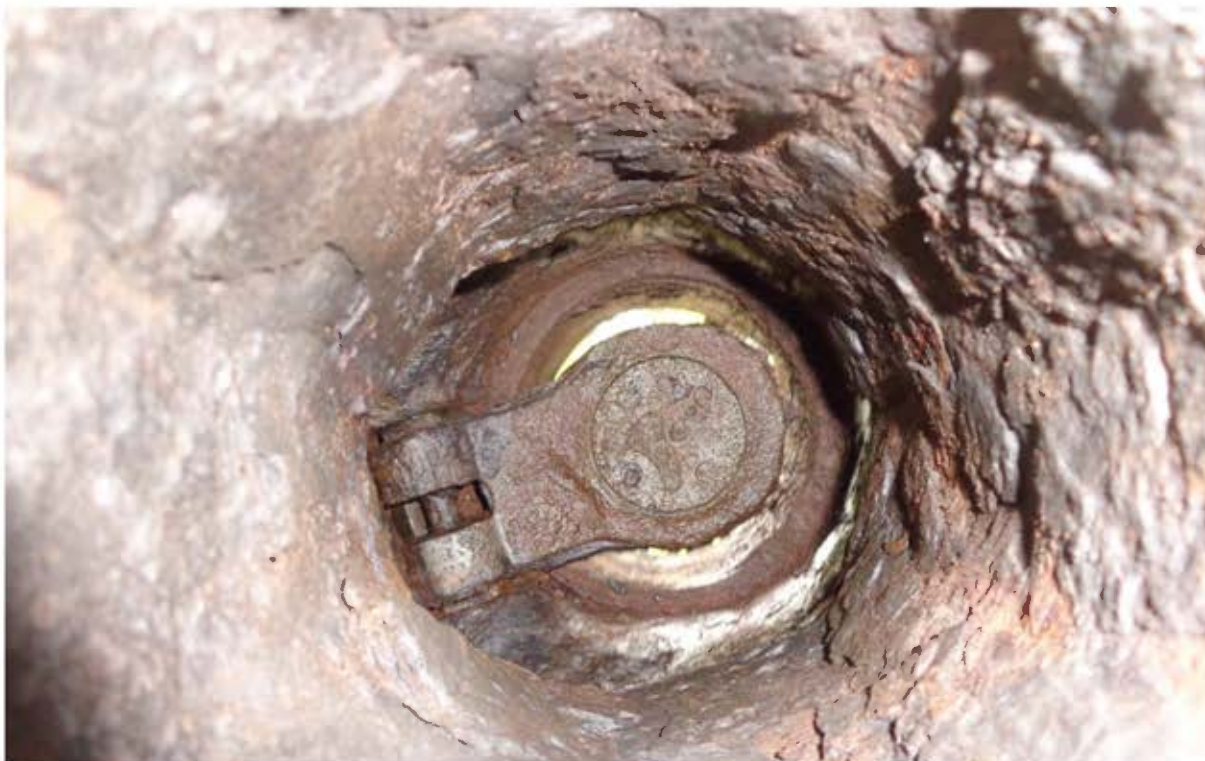
The photo below shows the valve (before final restoration) in the closed position. The rubber flapper is missing at this stage of restoration. Notice the heavy scaling and rust inside the pipe.

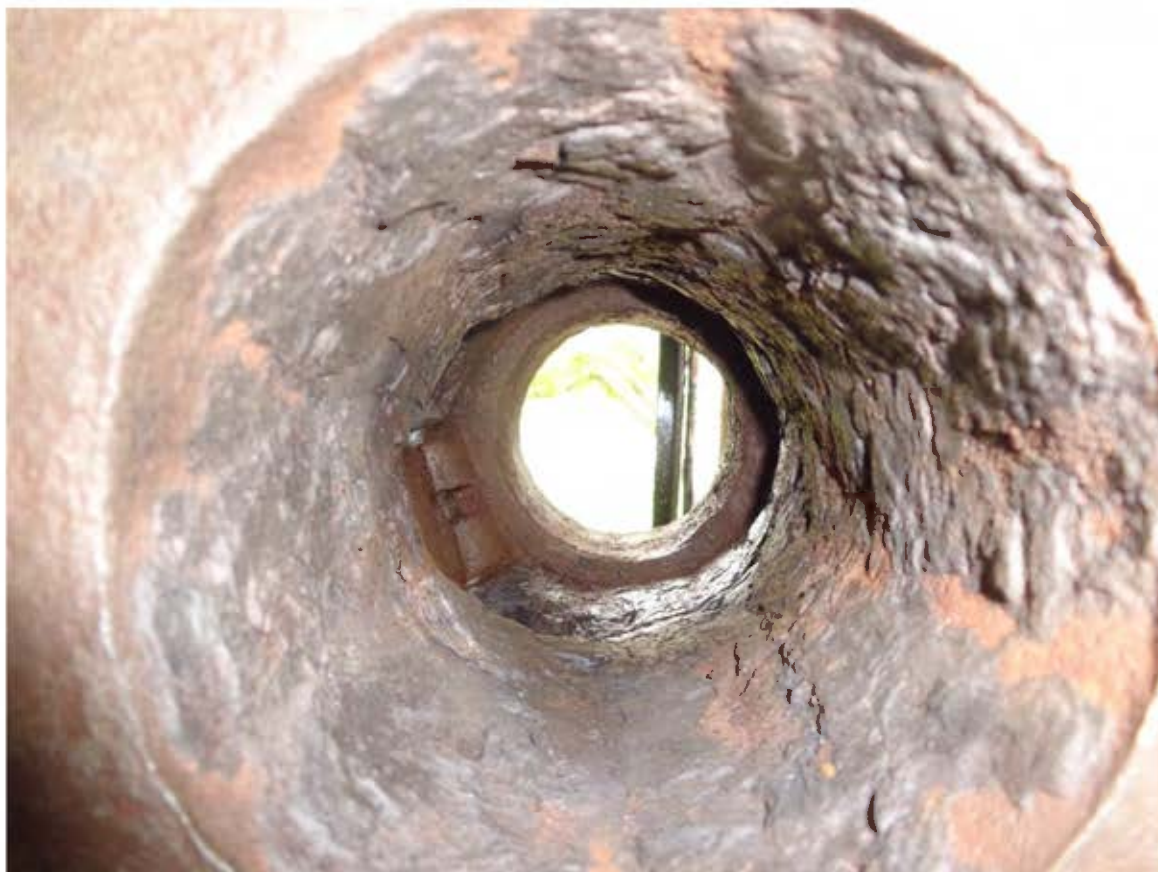
The photo below shows the valve fully opened into its recess.

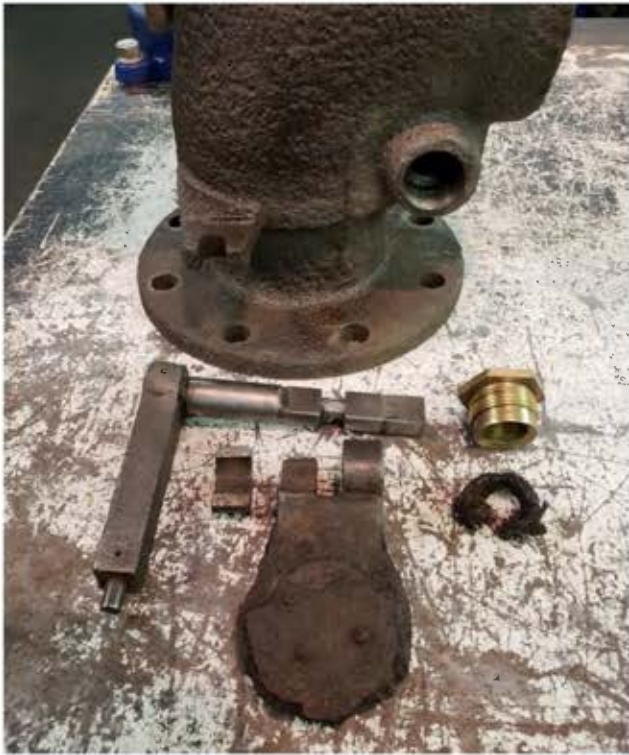
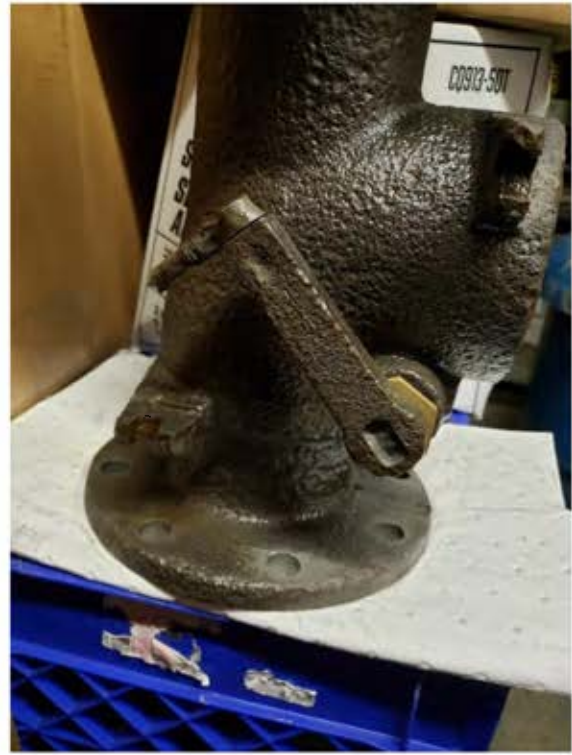
The lower valve assembly pictures below show the parts of the valve actuator removed (left) and assembled (right). The broken hinge part on the flapper was welded back into place and the entire assembly is reassembled (right picture).

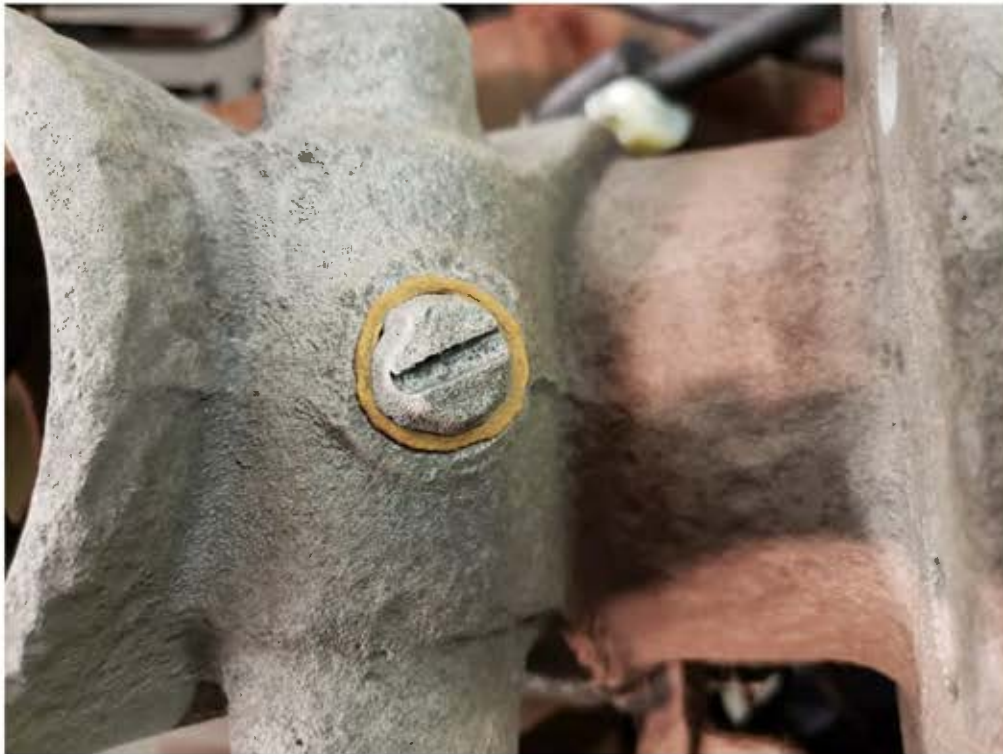
The badly deteriorated screw head on the lower valve is shown below. That screw was replaced by one of the newly made screws shown earlier on page 46.

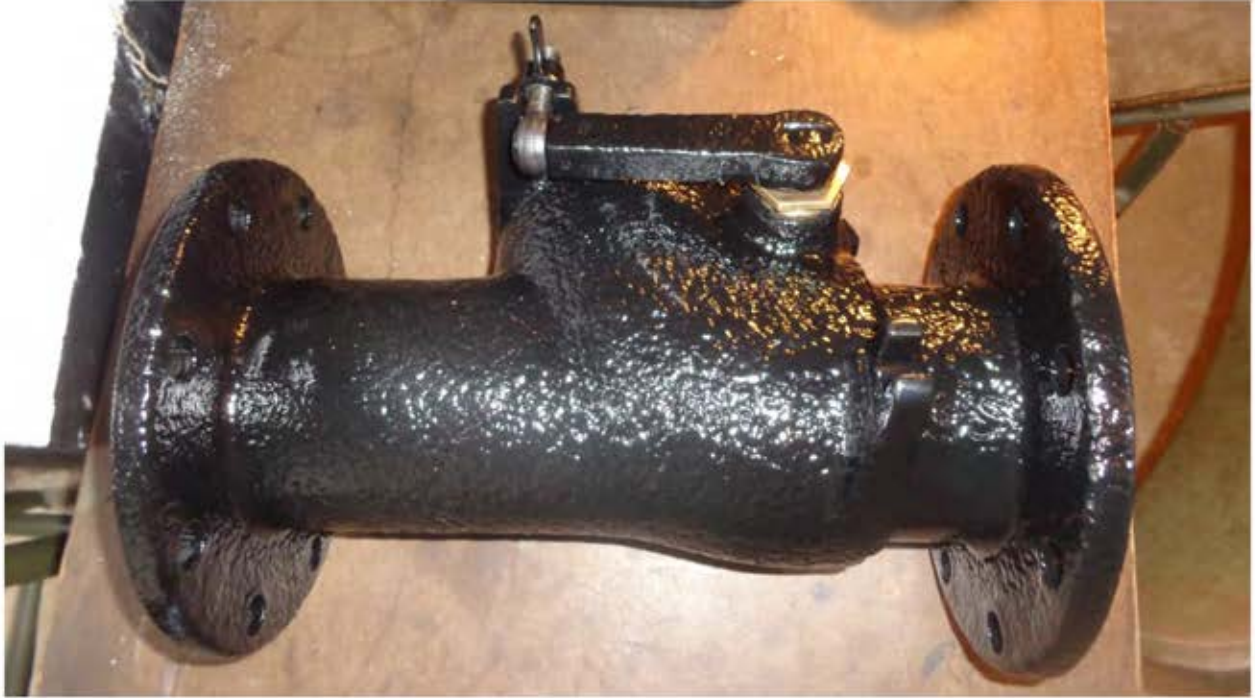
In February 2020 the lower valve assembly was completed. The photo below shows the valve from the underside.

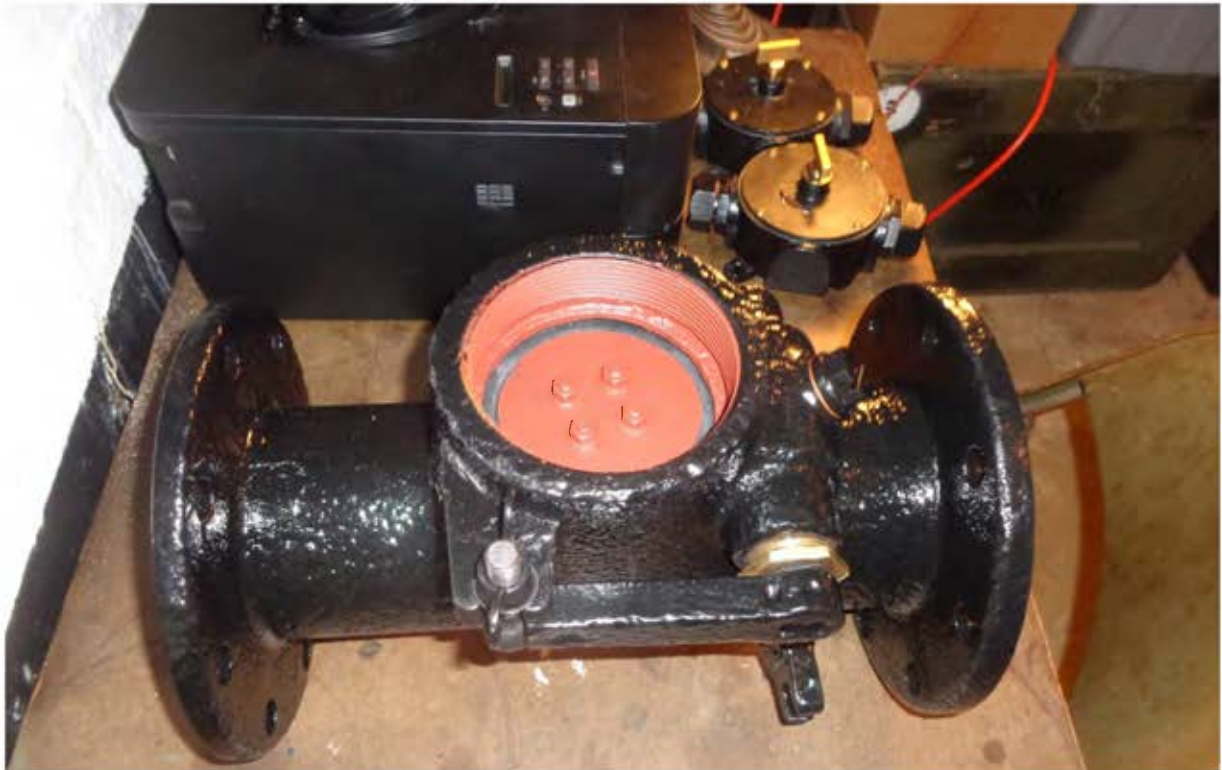
The photo below shows the lower valve from the top looking down with the flapper in the "closed" position for the "bypass" pipe. This would actually put air through the filter. To the upper right of the photo are two 1915 Corps of Engineers Standard light switches. These electrical boxes contain ceramic single pole "snap switches". The switch handles were fabricated in the machine shop at Battery Gunnison/New Battery Peck.

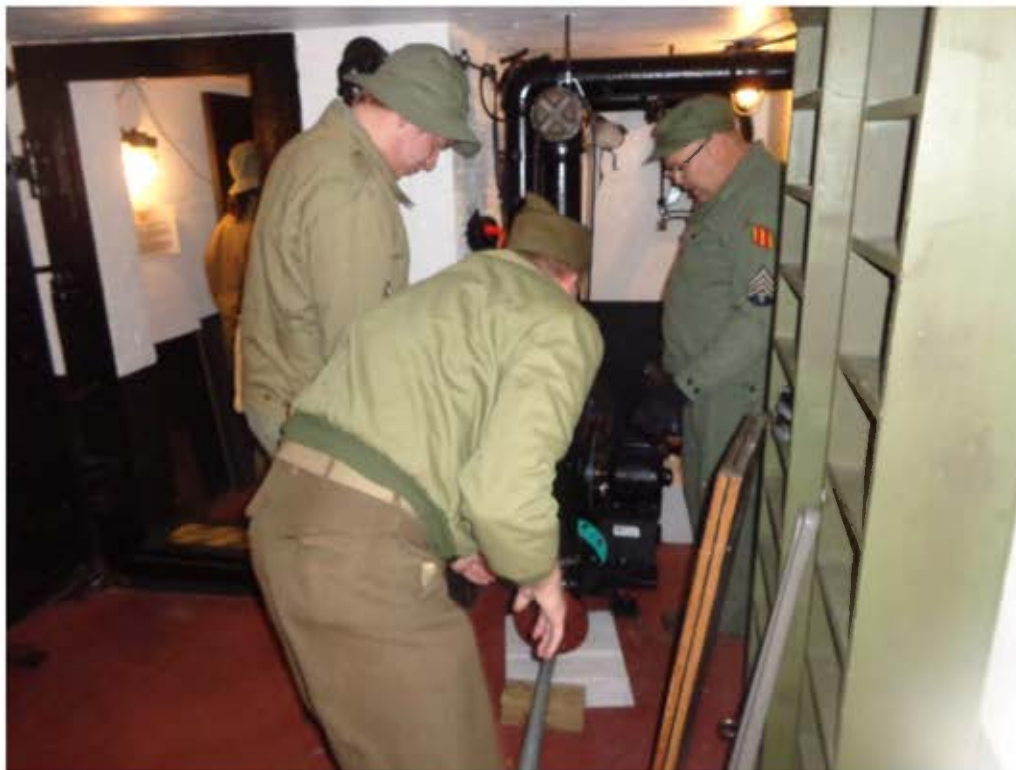
The initial fitting took a lot of effort. Below a shaft is used to lift the assembly and determine if a seal can be achieved. PVT Budjos, CPT(CH) Uhler and T-4 Ciemniecki are busy positioning the assembly below.

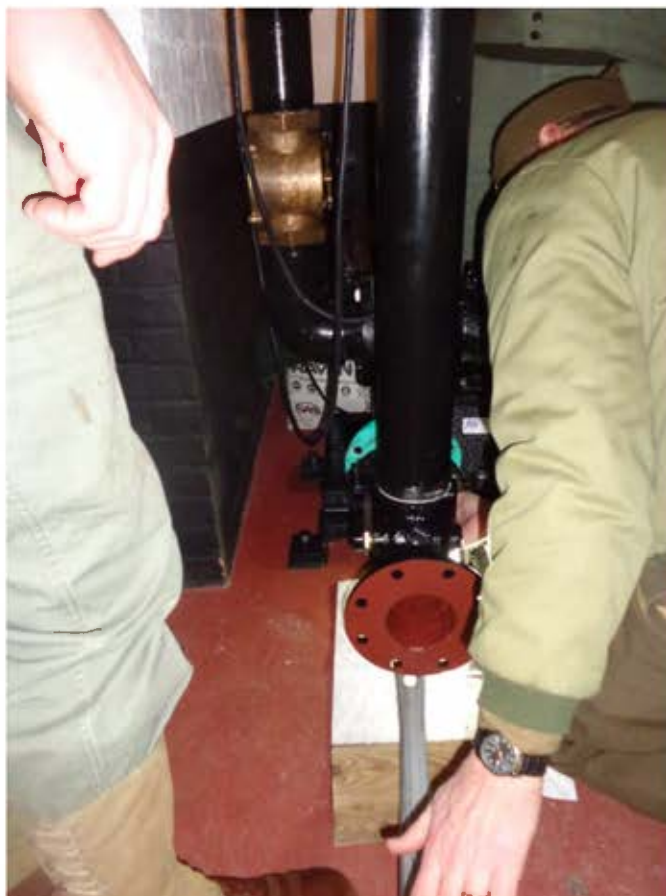
After additional work, it was determined the bypass pipe had to be shortened.

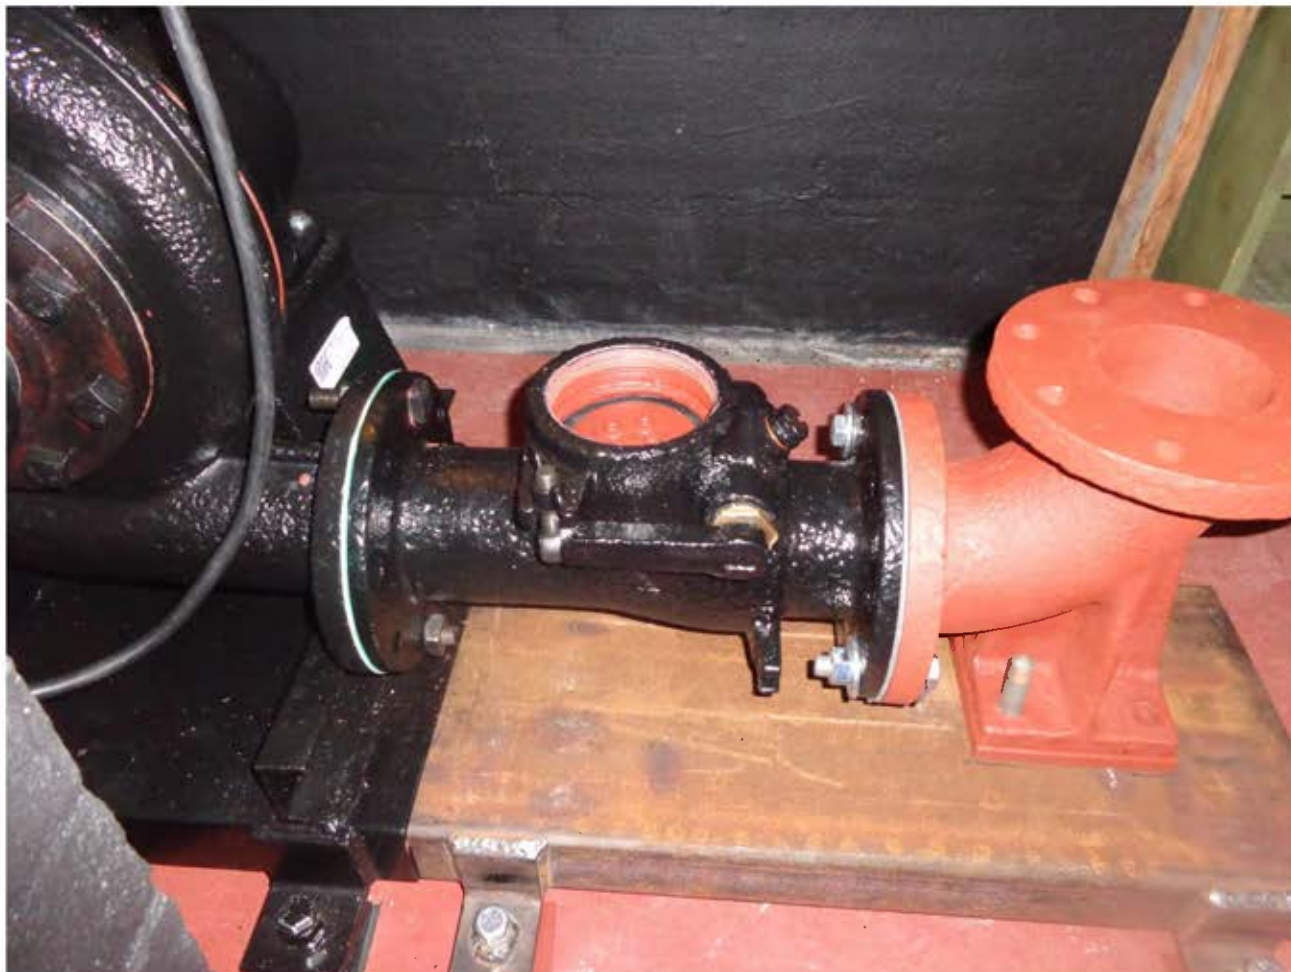
The photo below shows the lower valve assembled to the blower (left) and the 90 degree elbow. The filter will be bolted to the top of the 90 degree elbow.

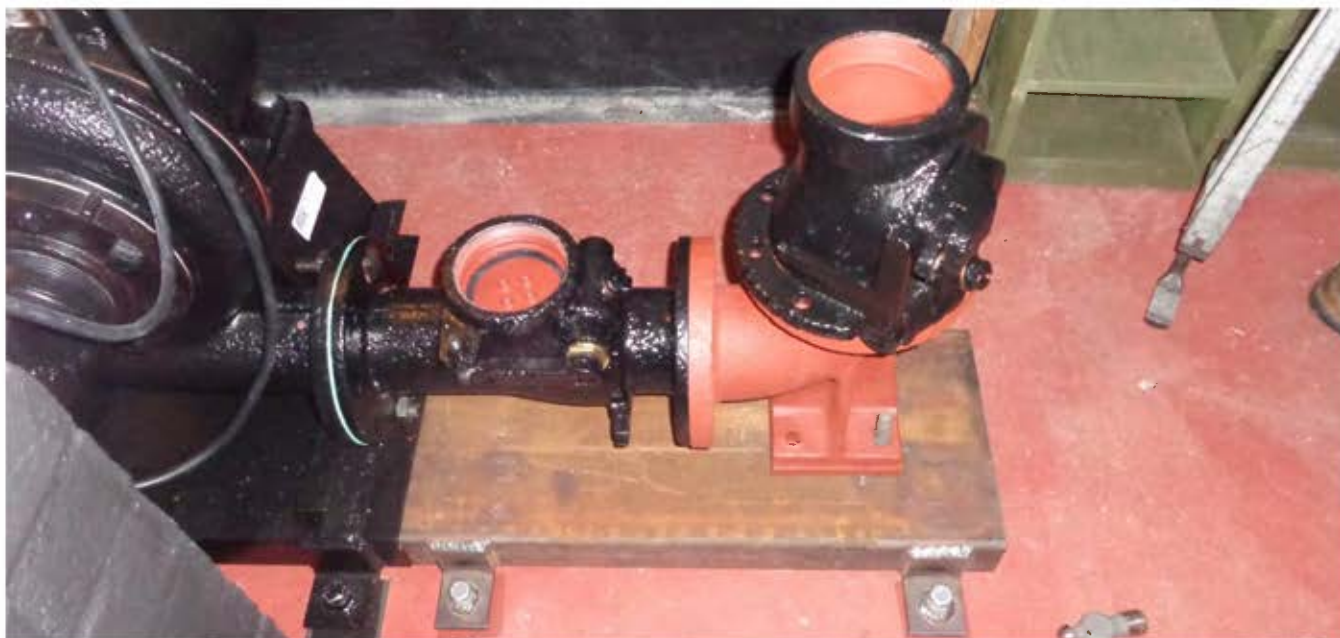
The photo below shows the lower valve with the upper valve sitting on top of the 90 degree elbow. The filter would be situated between the upper valve and the 90 degree elbow.

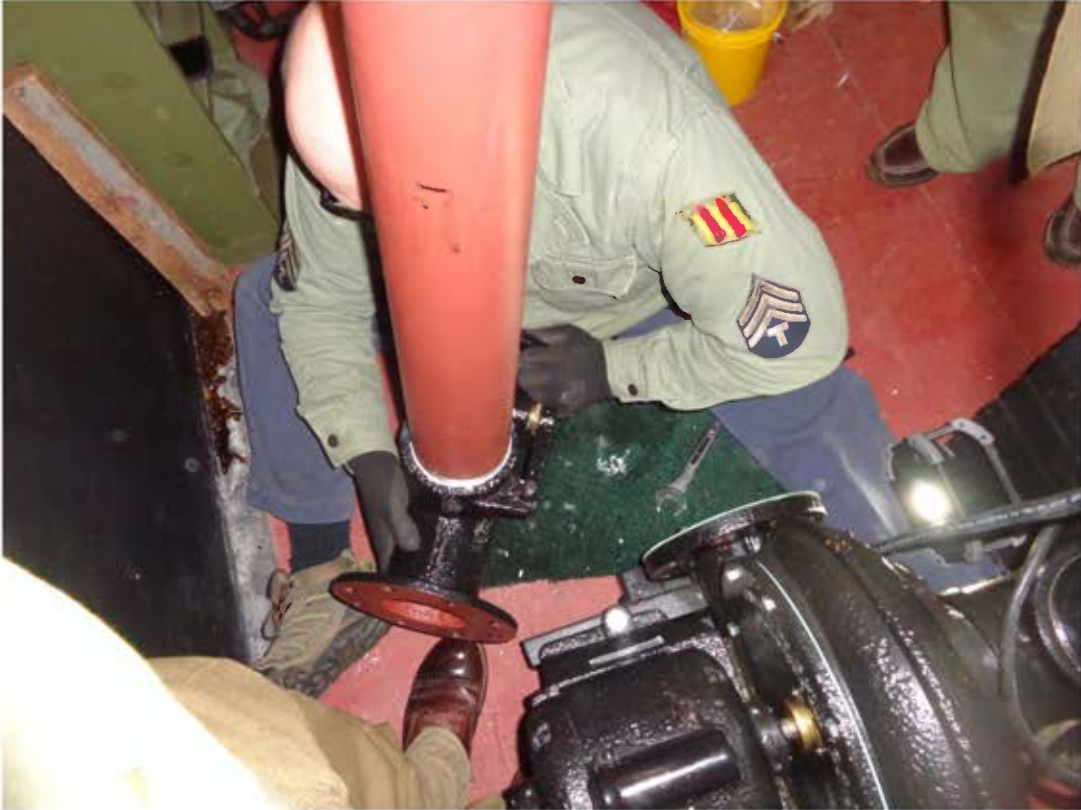
The new bypass pipe was then assembled to the lower valve and this required significant muscle power and several personnel to get it straight.

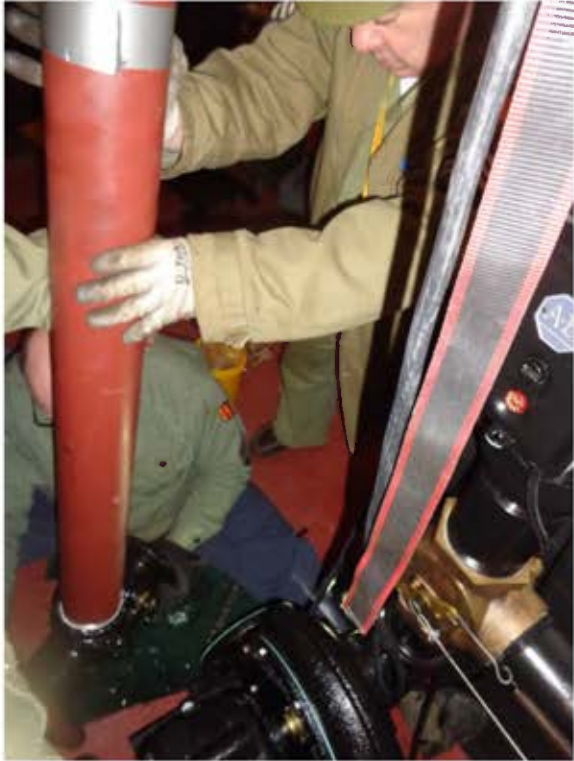
Below the team continues to seat the lower valve and the bypass pipe.

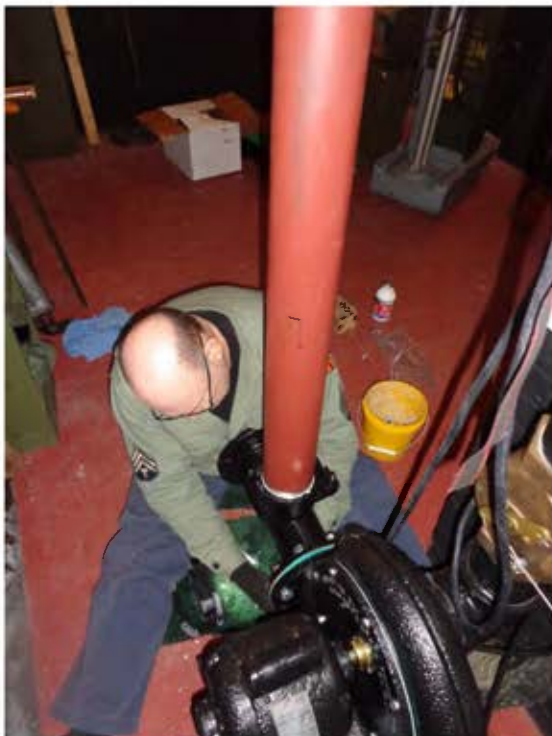
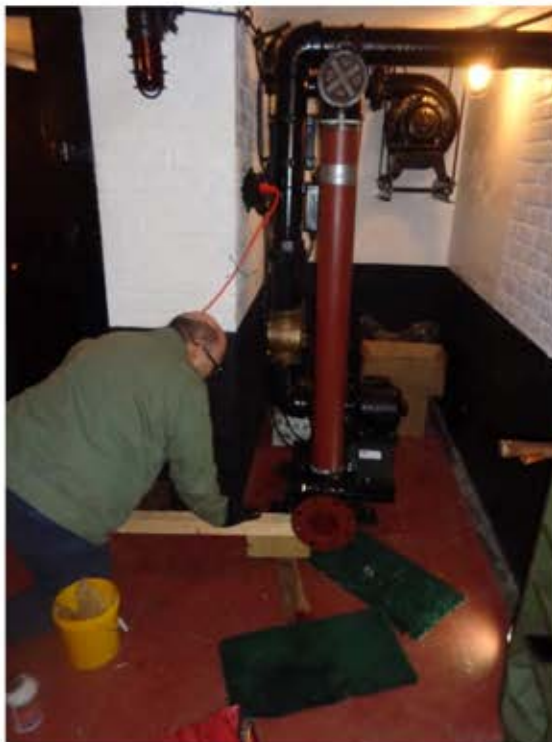
The two photos below show final seating of the lower valve and installing the bolts and seals.

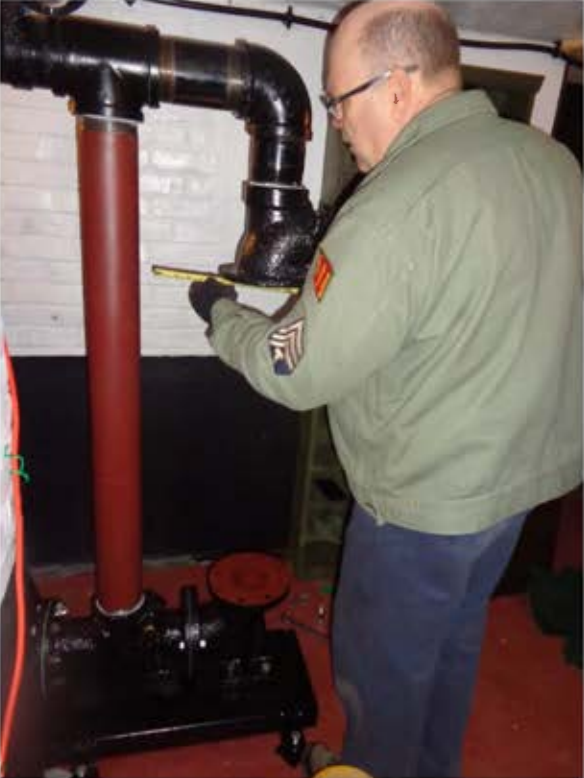
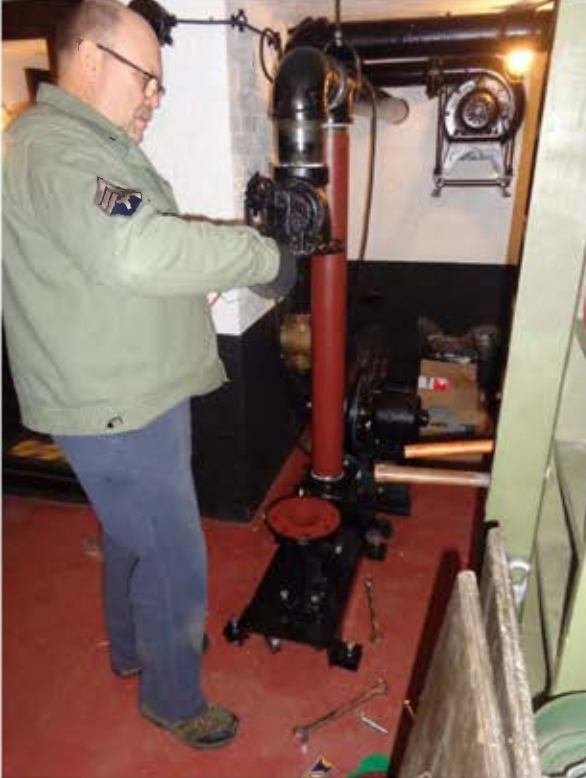
The two photos below show T-4 Ciemniecki as he fits the upper valve in place and taking measurements to confirm distances between the upper and lower valves.

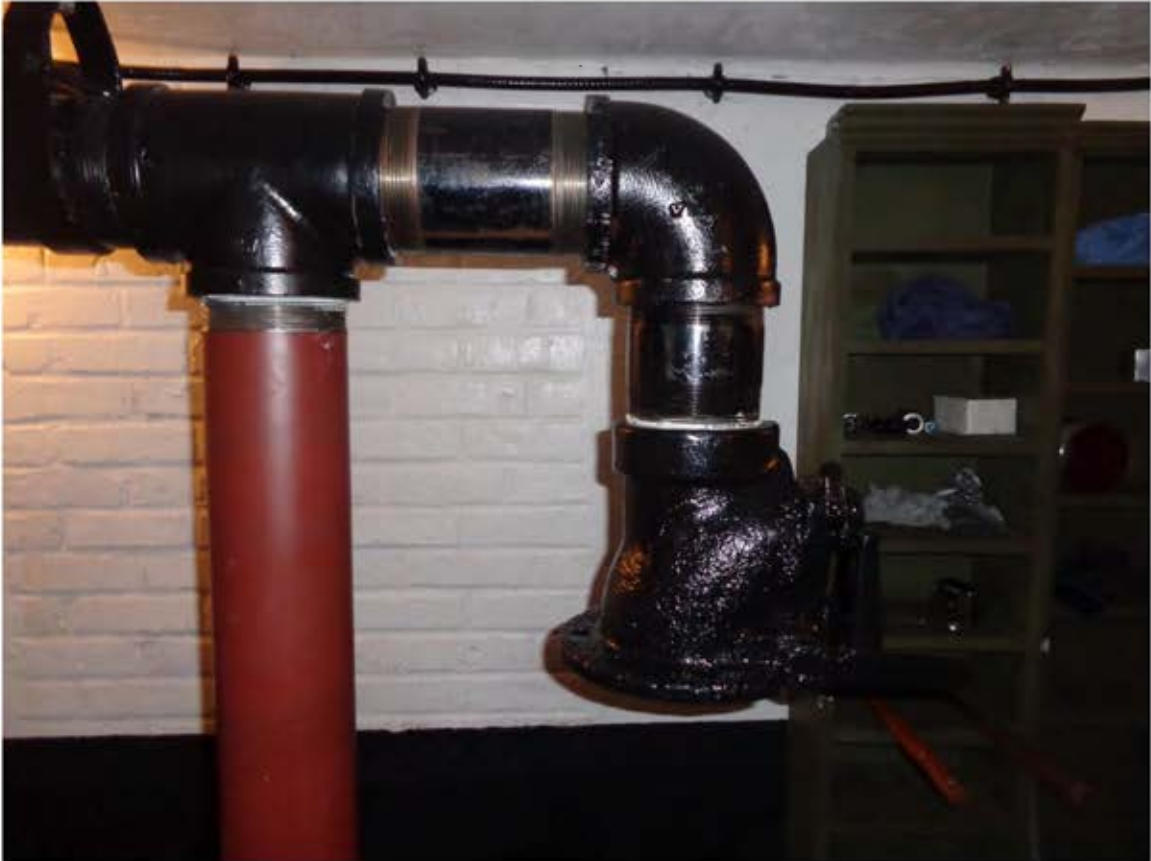
The photo below shows a clearer view of the upper valve in place.

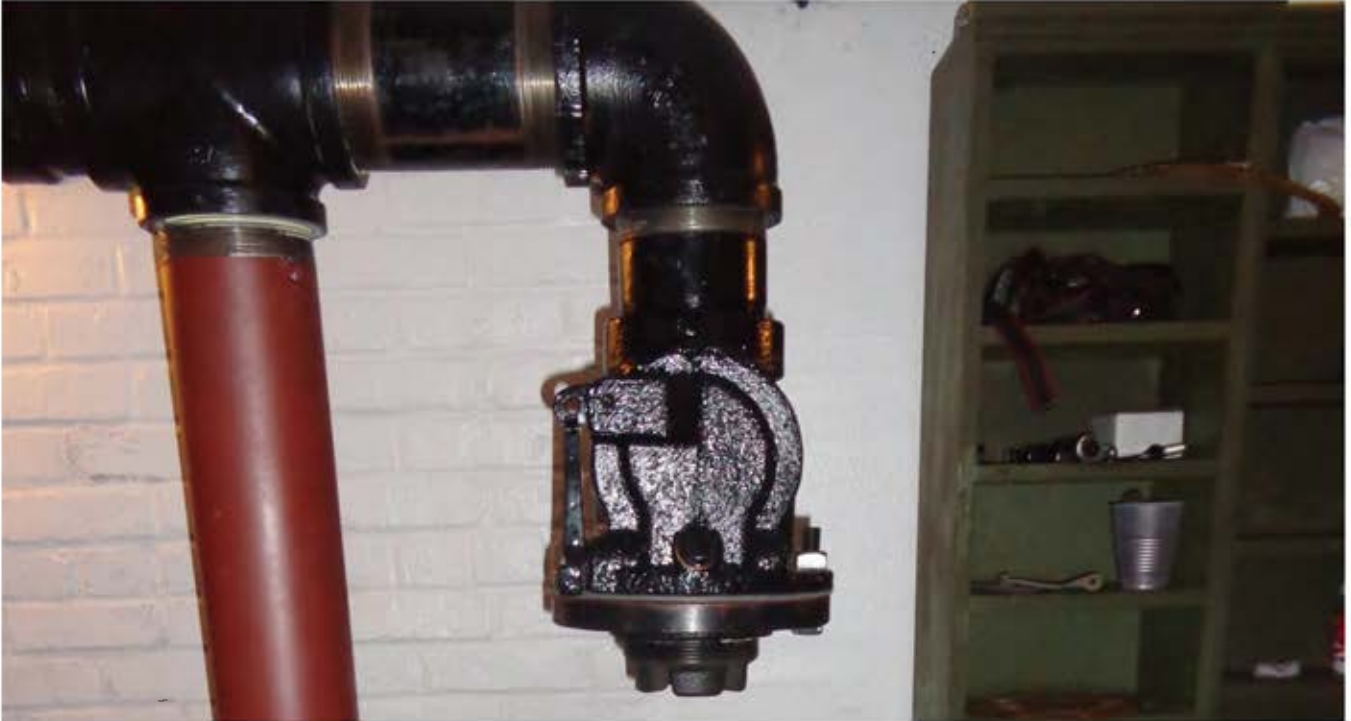
The photo below shows the upper valve in its proper orientation with a flange installed on the base of the valve and a plug fitted into the flange.

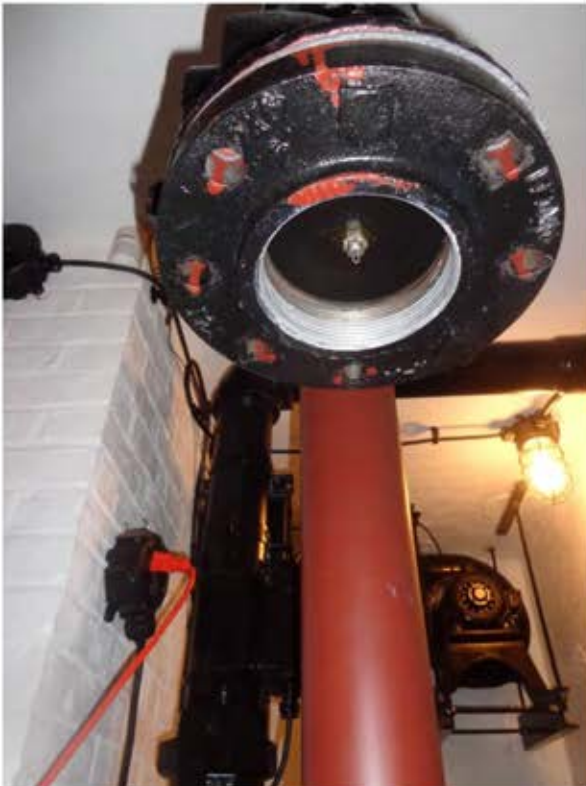
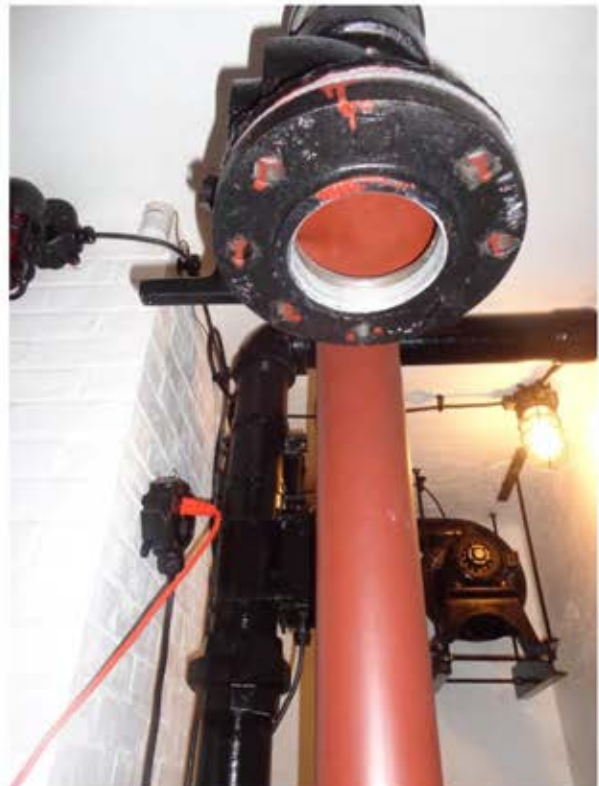
The photos below show the upper valve with the plug removed from the flange. The photo on the left shows the valve "closed" (black rubber sealer in place) and the photo on the right with the valve "open" to see the primed interior of the pipe. With the flange in place, the valve works to restrict airflow and close off the opening. This enables a physical experience of moving air to demonstrate the use of the valve when switching from the bypass pipe to the filter proper.
