**Restoring Chemical Warfare M1 Collective Protector System**  
**Battery Gunnison/New Battery Peck**  
***Ft. Hancock, New Jersey***

In the spring of 2014, the Army Ground Forces Association began locating and fabricating the required materials to restore the M1A1 Collective Protector Chemical Warfare system in Battery Gunnison/New Battery Peck. During this time AGFA was able to obtain a very significant quantity of original chemical warfare equipment, to include a 3,500 rpm AC motor and blower, switches, valves, pulleys and ancillary materials. Most of this equipment was in good to excellent condition and well within the capabilities of the membership to restore to a functional condition.

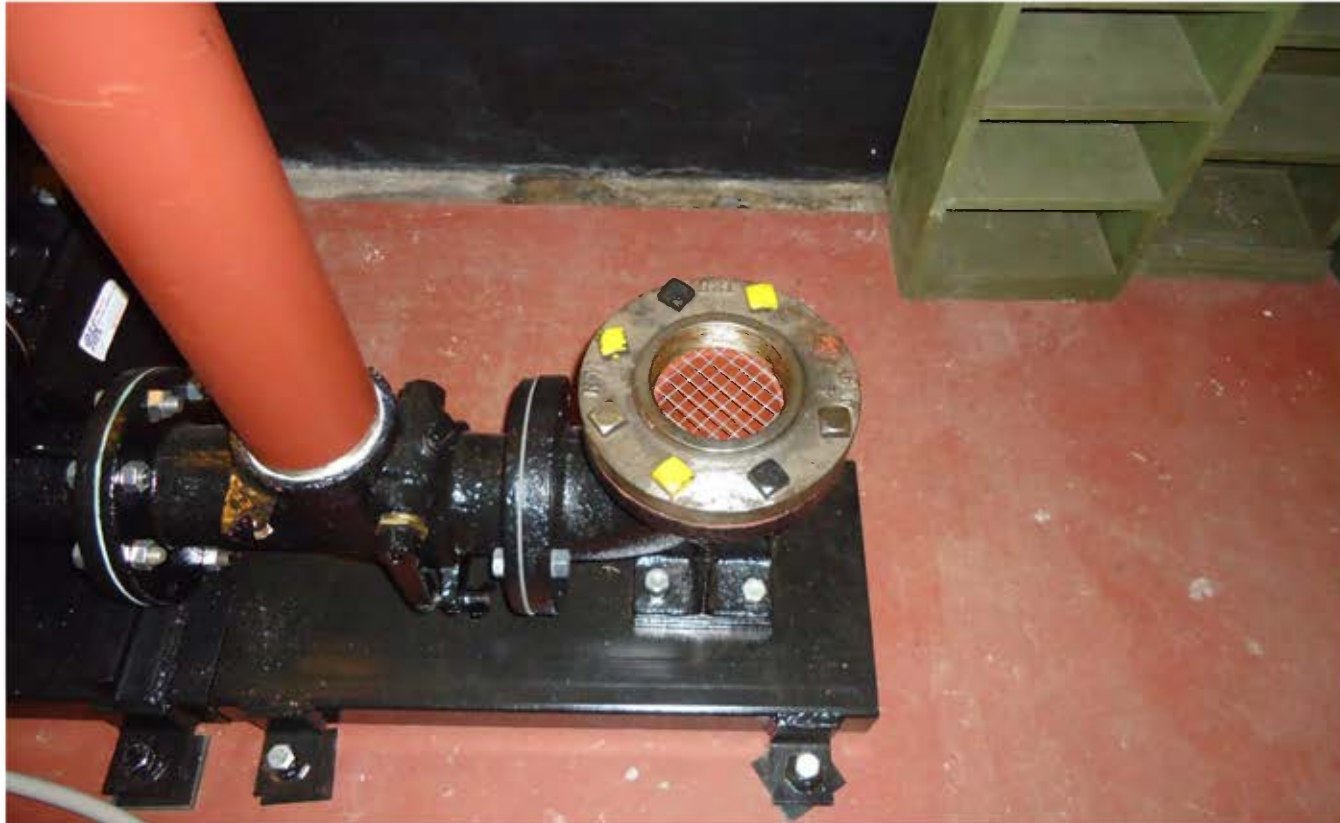
The photo below shows the Lower valve and the 90 degree pipe in its proper orientation with a flange installed on the top of the 90 degree pipe. A section of wire mesh was secured between the flange and the top of the 90 degree pipe to keep objects from falling into the pipe and damaging either the blower or the valve.

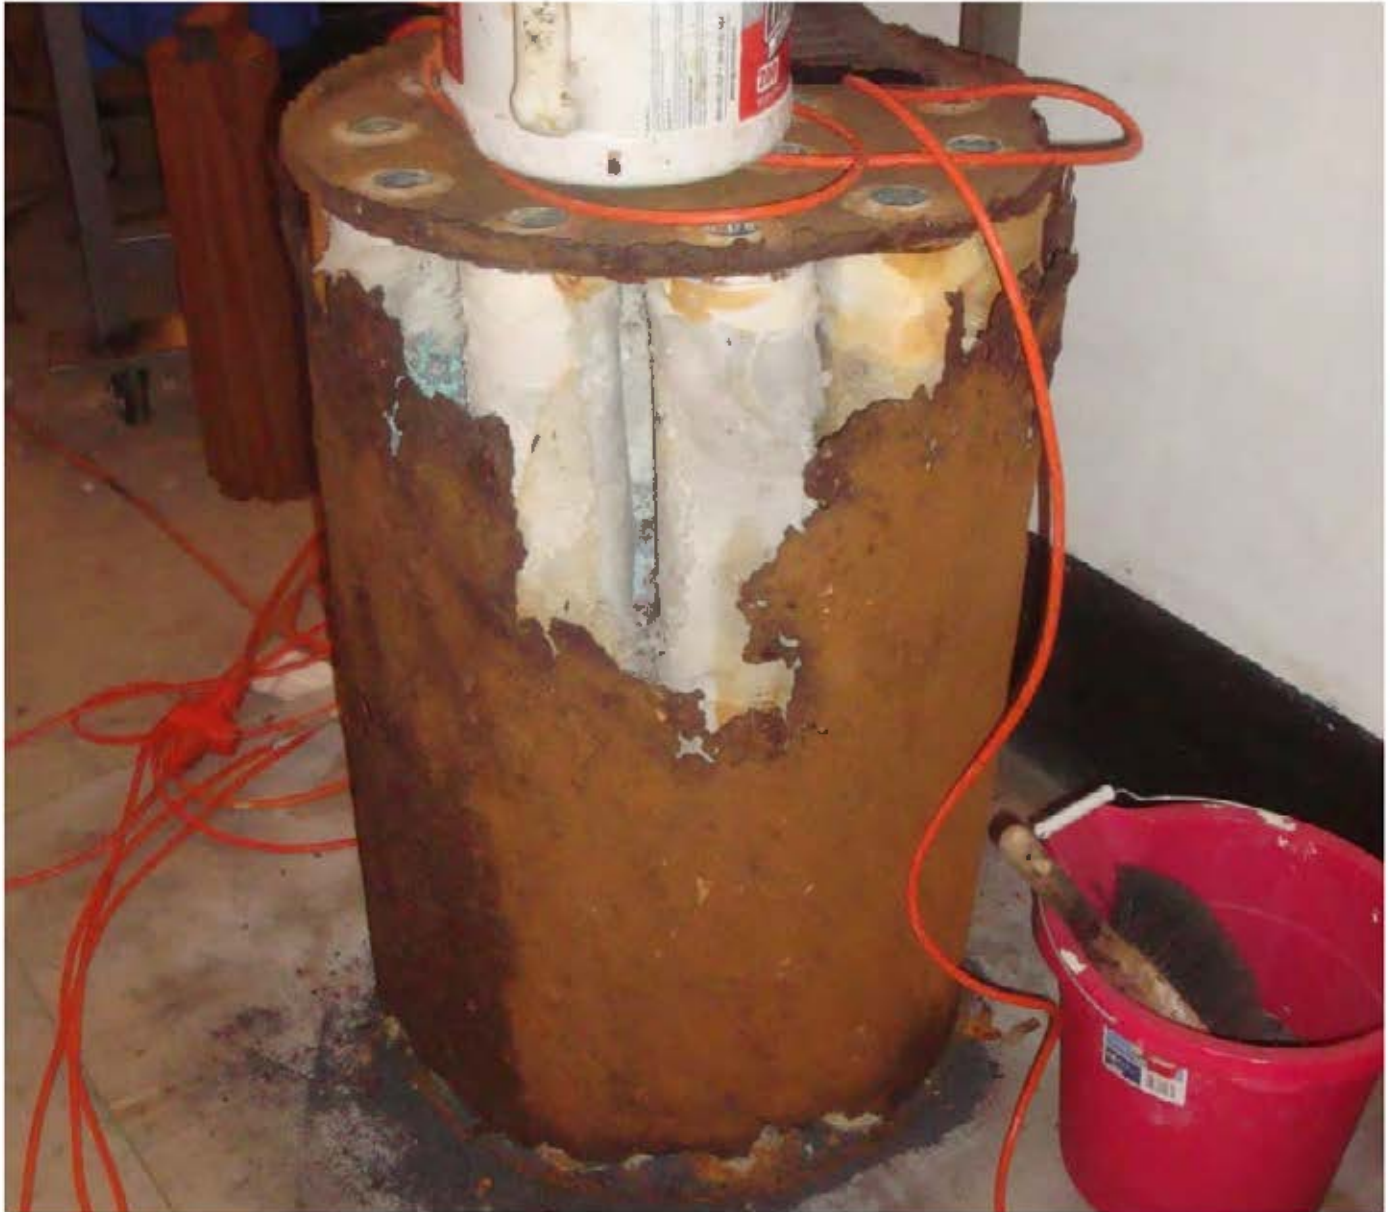
The photo below shows the deteriorated filter as recovered from Battery Mills. Notice the red bucket to the lower right and the black "dust" at the bottom of the filter. This is the actual charcoal filter material leaking out of the deteriorated canister.

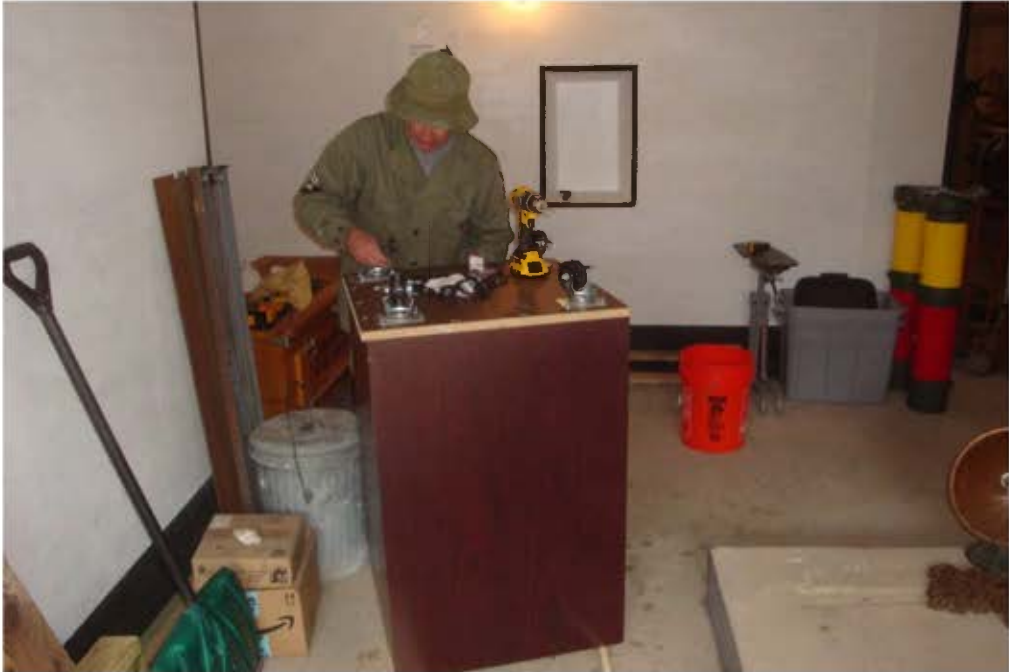
In the photo below T-5 Morrison is attaching the large casters to the bottom of the display case.

The display case design is two sides of hard wood, and two sides and top of clear Plexiglas. The inside wooden portion will be painted bright white to improve visibility. The case will be on casters, with two handles on reinforced boards to enable easy relocation within the Battery as needed. The case will be sealed so none of the loose charcoal can leak from the case.

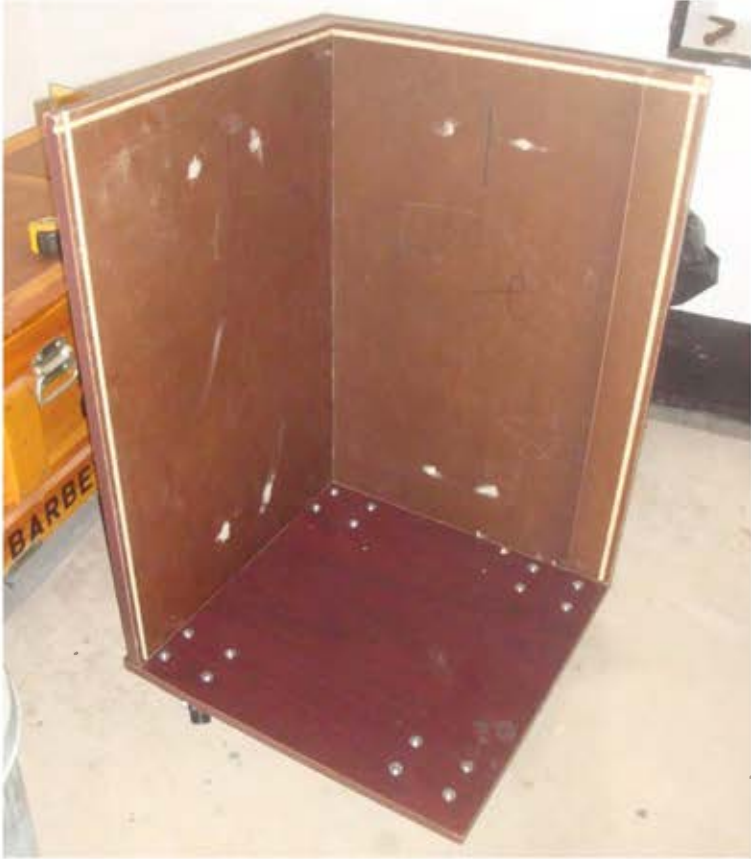
The partially completed case is shown below on its casters.

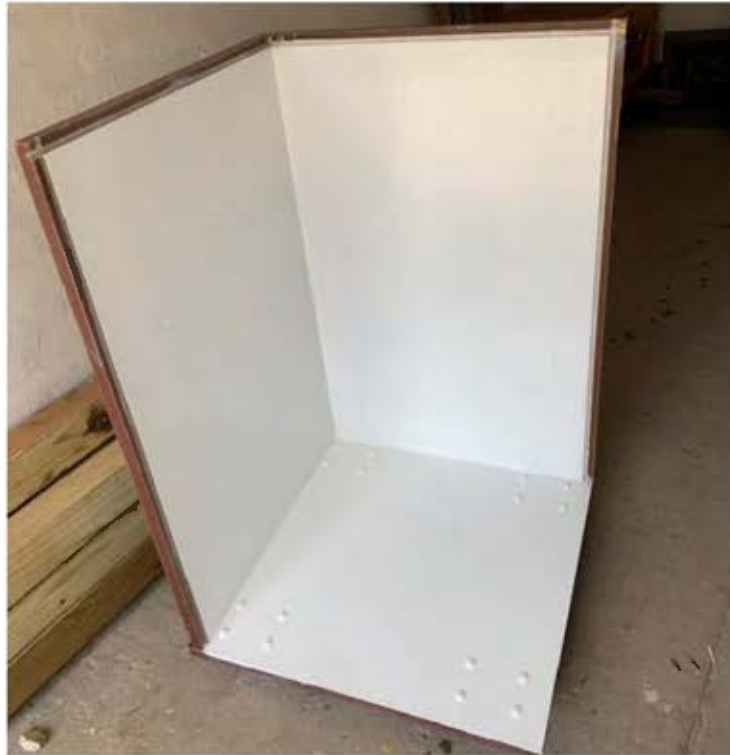
The interior of the case was painted gloss white on 18 April 2021 as shown below.

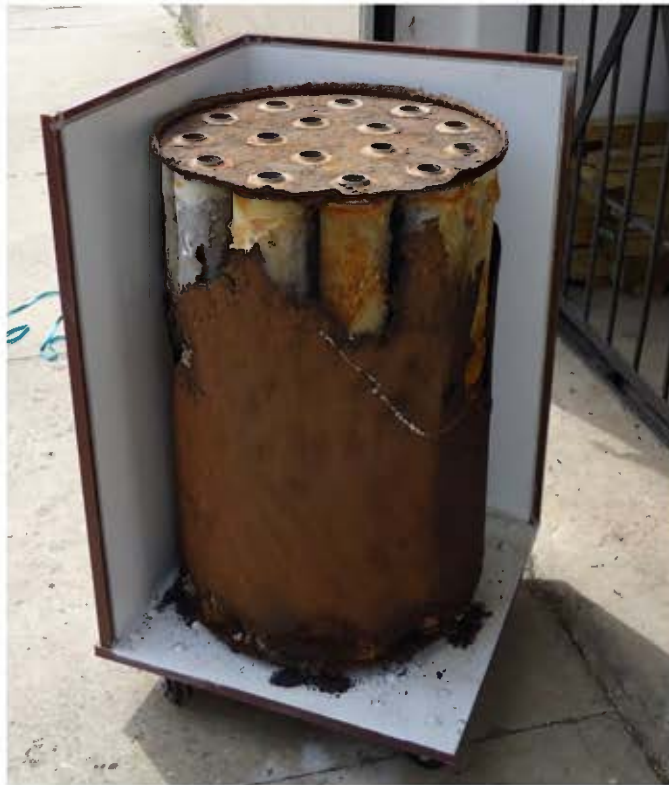
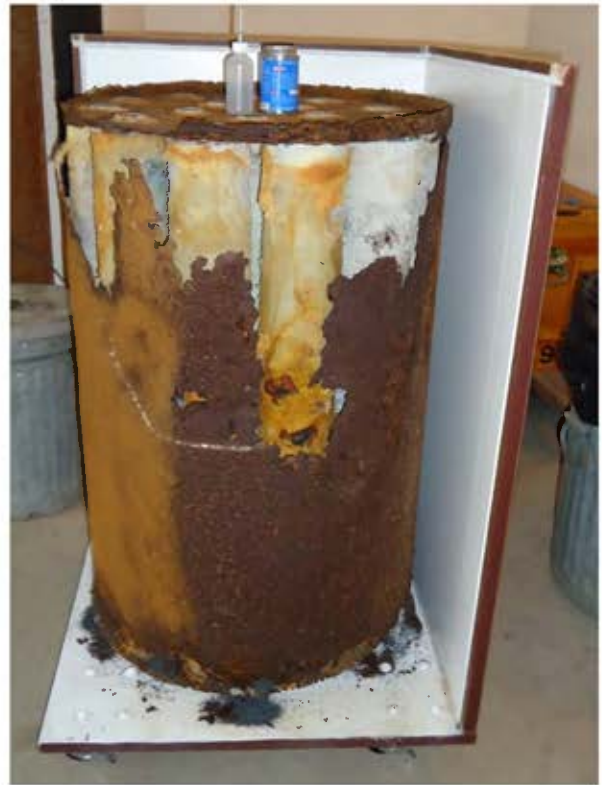
The photo below shows the filter proper inside the case after painting. Notice the charcoal powder at the bottom of the filter case.

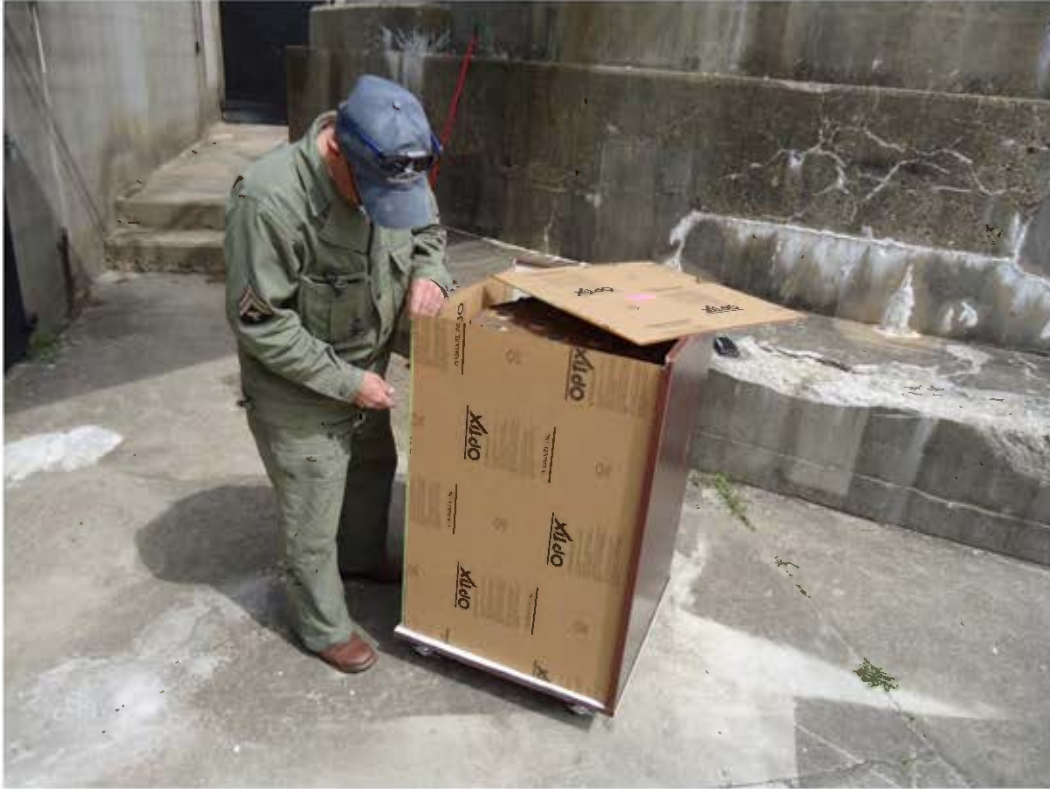
The next step for the case was fitting the 3/8-inch Plexiglas to the case. This work started on 7 May 2021.

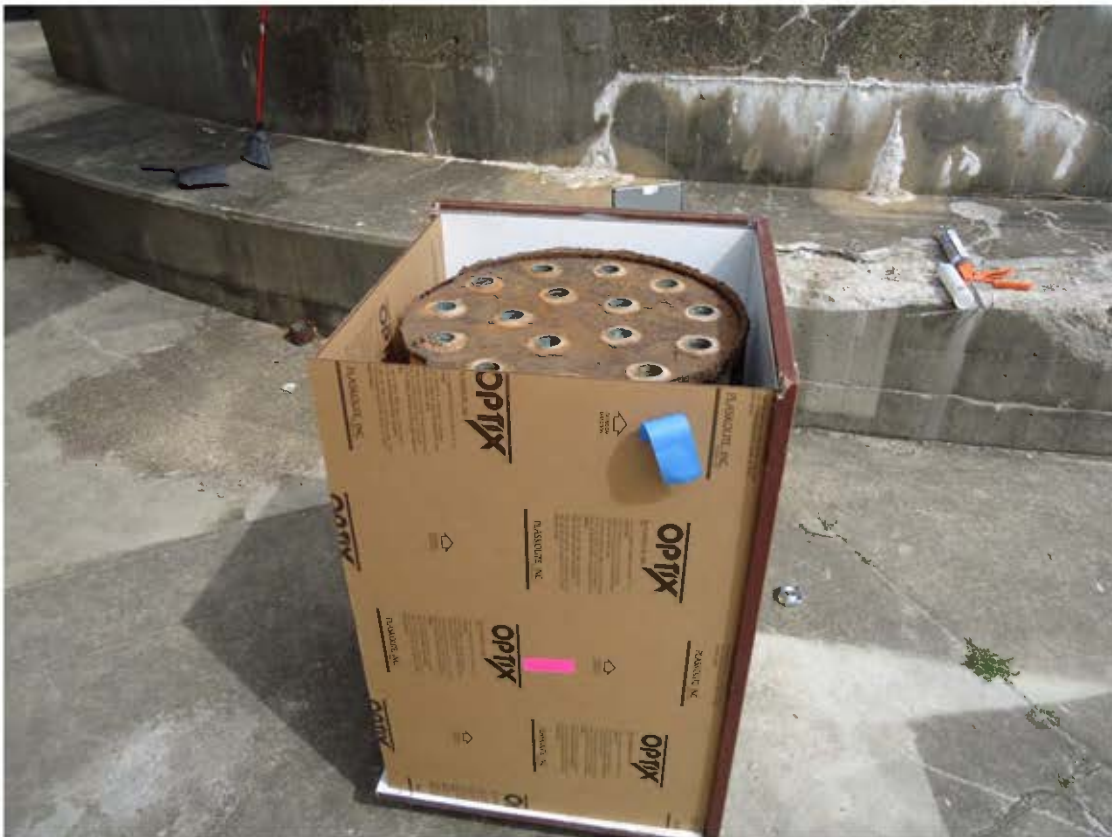
The photo below shows the filter with the two Plexiglas sides in place.

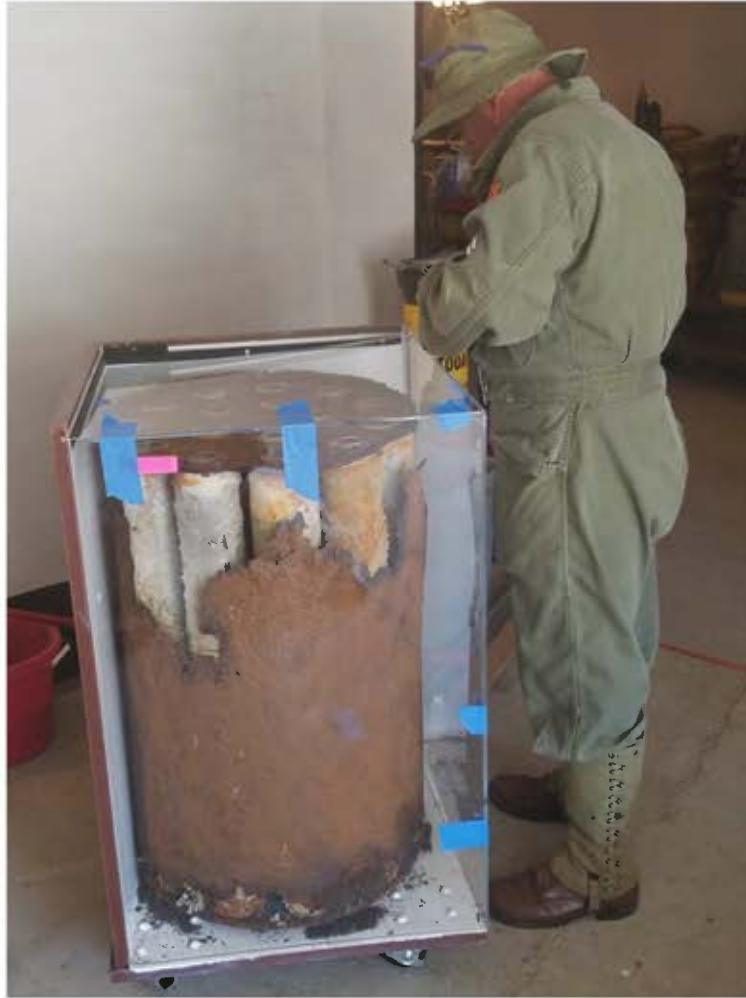
The photo below shows T-5 Morrison fitting the Plexiglas sides onto the case.

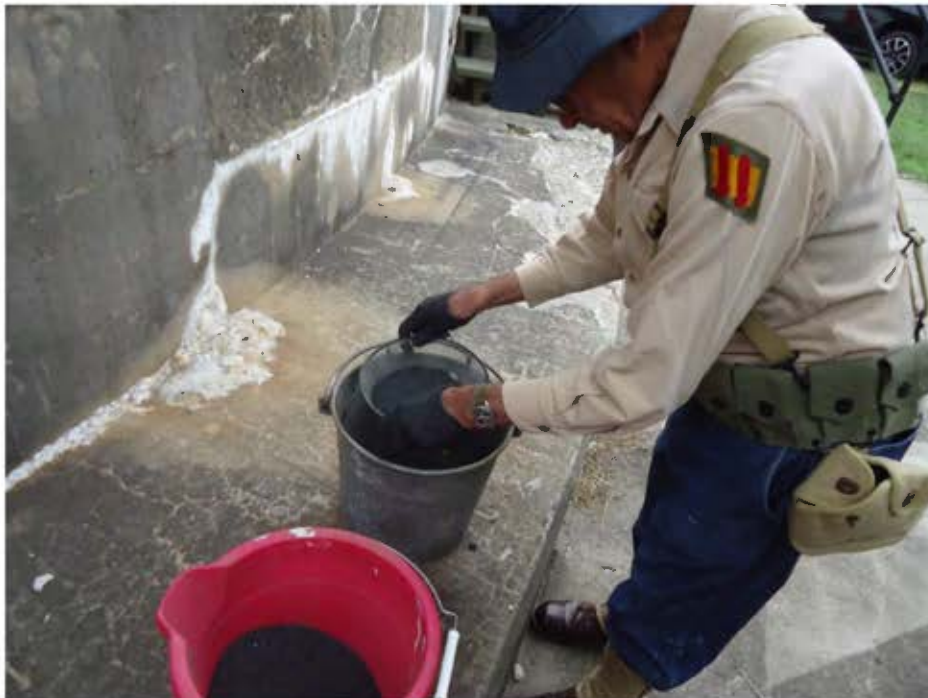
On 11 June 2021 CPL Cusano began the process of filtering all the foreign materials out of the charcoal and preparing it for display.

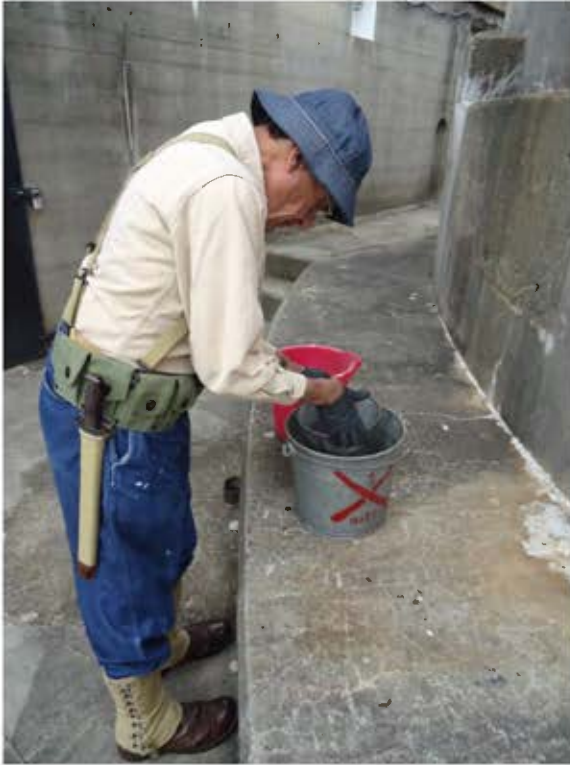
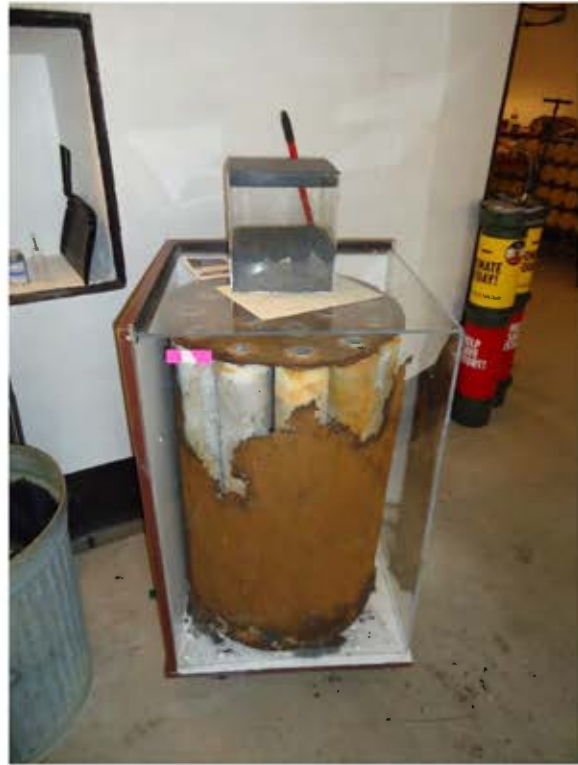
Below CPL Cusano finishes filtering the charcoal (left) and then placed it inside a display cube (right).

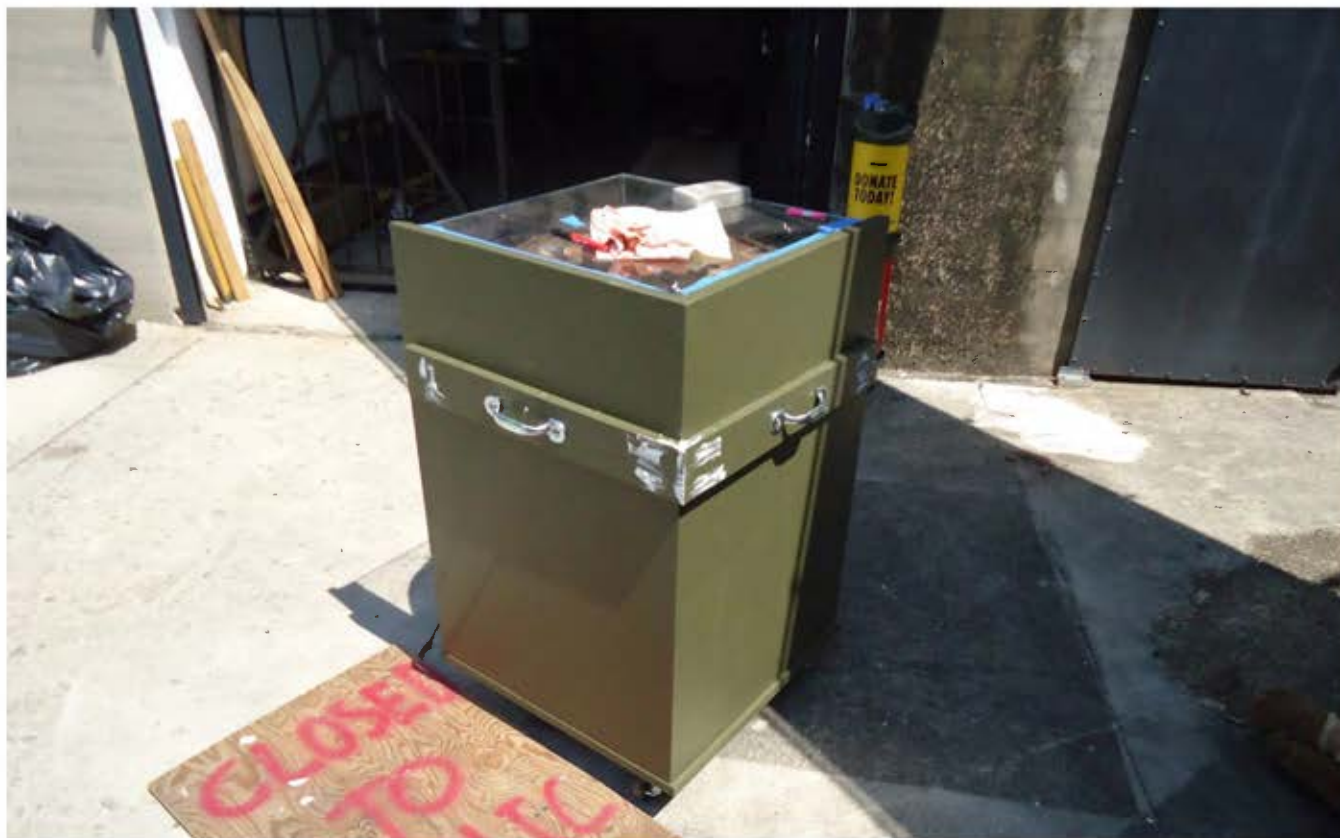
The next step was to secure the movement handles to the wooden sides of the display case. The photo below from 23 July 2021 shows the handles in place on the reinforcing boards on the sides of the case.

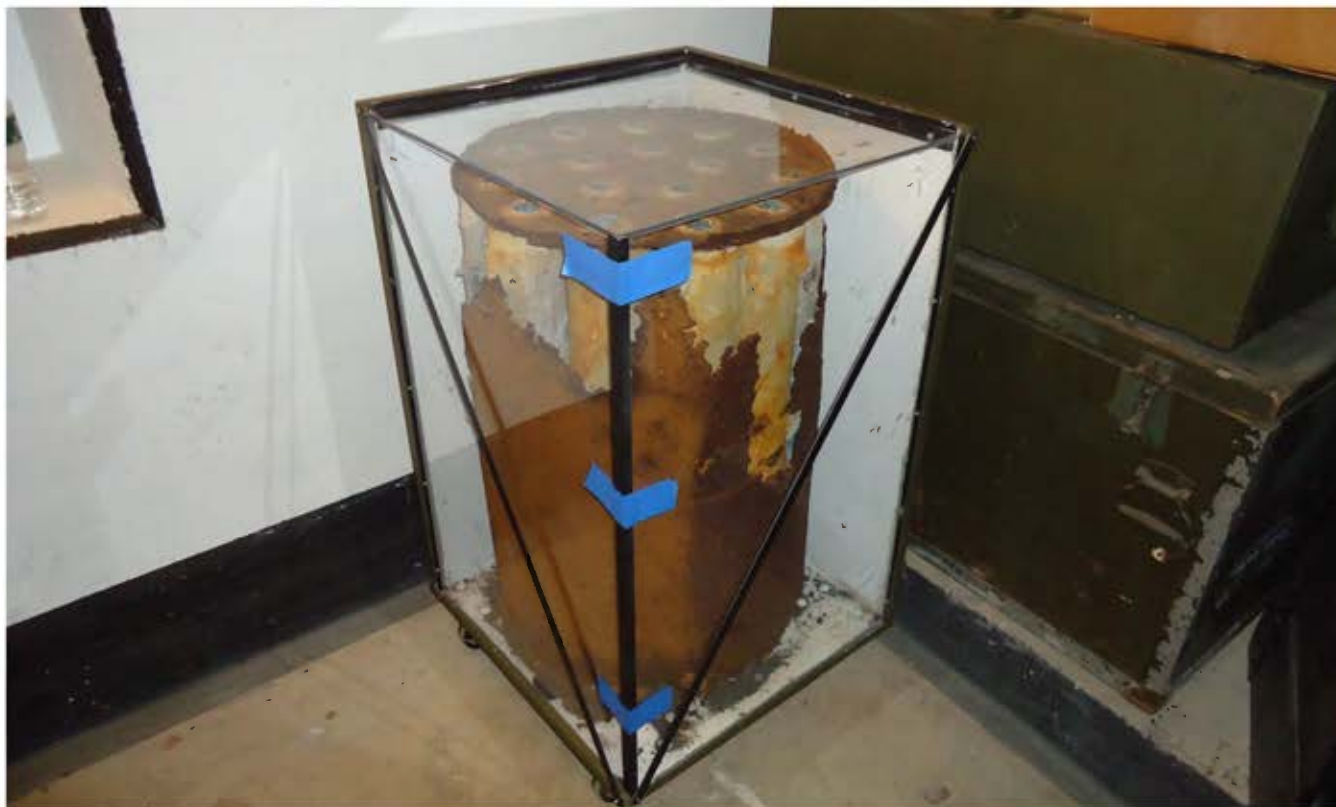
The photo below from October 2021 shows the final glue setting to seal the case.

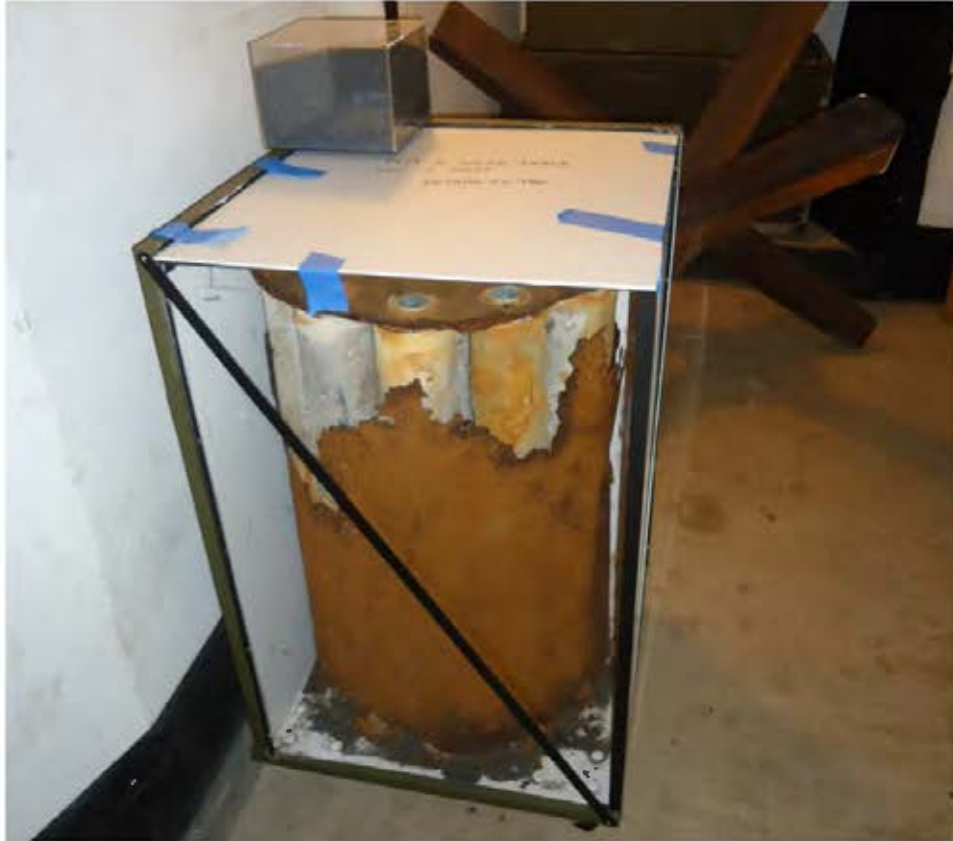
The photo below shows the case completed with a top cover to prevent scratching the plexiglass surface.

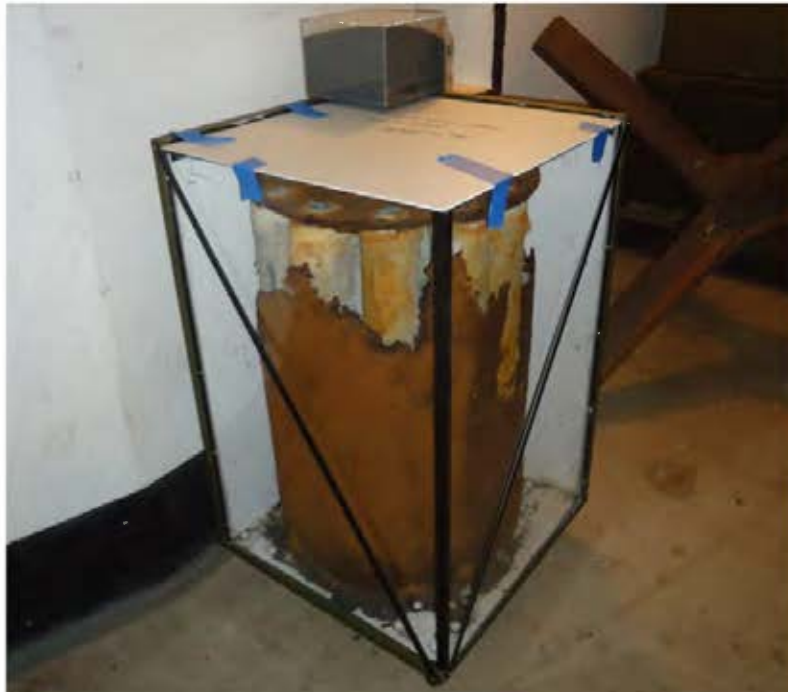
Another view of the case - it is now ready to use for interpretation.
