CULTURAL LANDSCAPE REPORT  
FOR  
PROVING GROUND  
AND  
WARTIME EXPANSION AREAS

Sandy Hook Unit  
Gateway National Recreation Area

Olmsted Center for  
Landscape Preservation

Prepared by  
Norma E. Williams  
July 1999

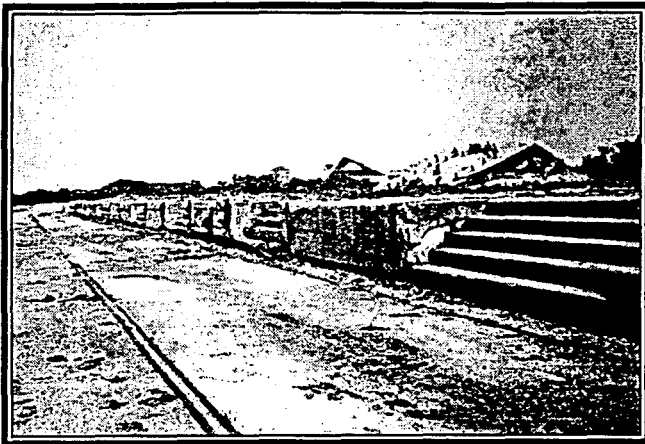
Figure 3: View to the east of the Proof Battery. Photo by author, 1998.

A week-end visitor to Sandy Hook's North Beach passes concrete ruins in the sand - tall freestanding walls inset with alcoves, another long wall topped by large sloped blocks with rusting bits of iron and weeds growing from small cracks (Figure 3). What are these ruins? What happened here? With the quiet of the dunes and the murmur of the surf in the background, it is difficult to imagine that a hundred years ago this place trembled with explosions from rifled artillery as large as 14 inches that sent projectiles whistling down the dune range (Figure 4).

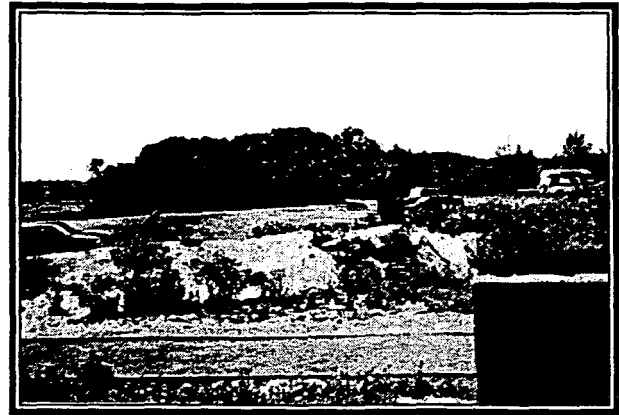
Figure 6: View looking north of parking lot 'J', former site of Gun Park. Photo by author, 1998.

The Proving Ground's gun park is now parking lot "J", where visitors headed for the beach leave their cars in rows almost as neat as the hundreds of guns and live projectiles that formerly were stacked in neat rows ready to be tested (Figures 5 & 6).

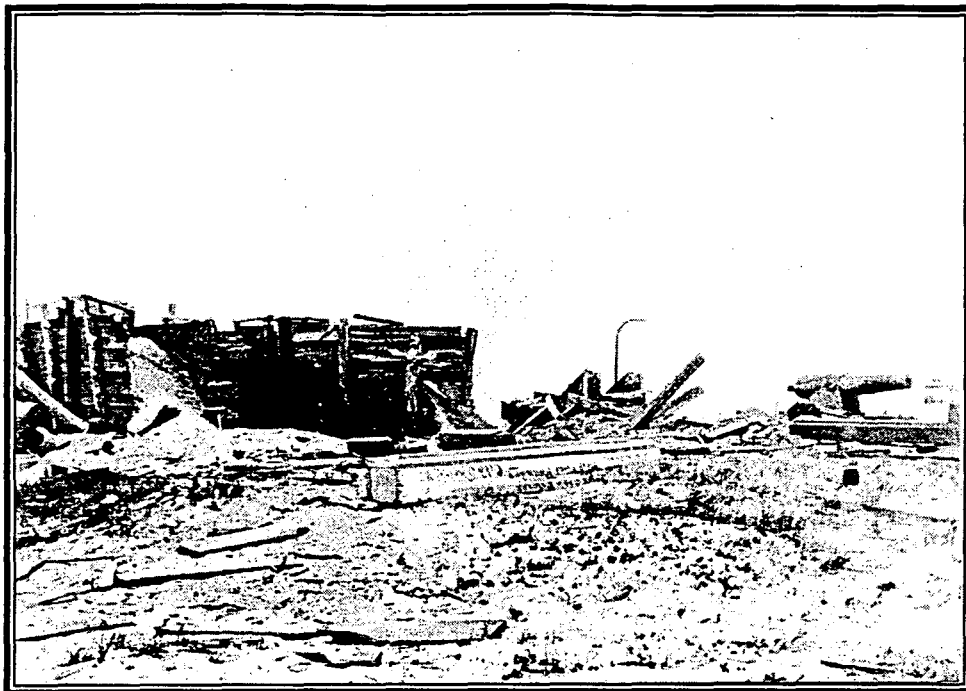
Figure 8: Sand-filled revetment, or traverse, that has contained the explosion of a large caliber gun that blew up during testing c. 1876-1886. Photo from files at Sandy Hook, Gateway NRA.

chronoscope had been built east of the walls of the old granite fort.<sup>7</sup> Four wooden gun platforms were located about 100 yards south of the office with the bombproof, or shelter, nearby. The range was laid out down the dunes to the south, with a proof butt, or target, constructed down range (Figure 8).

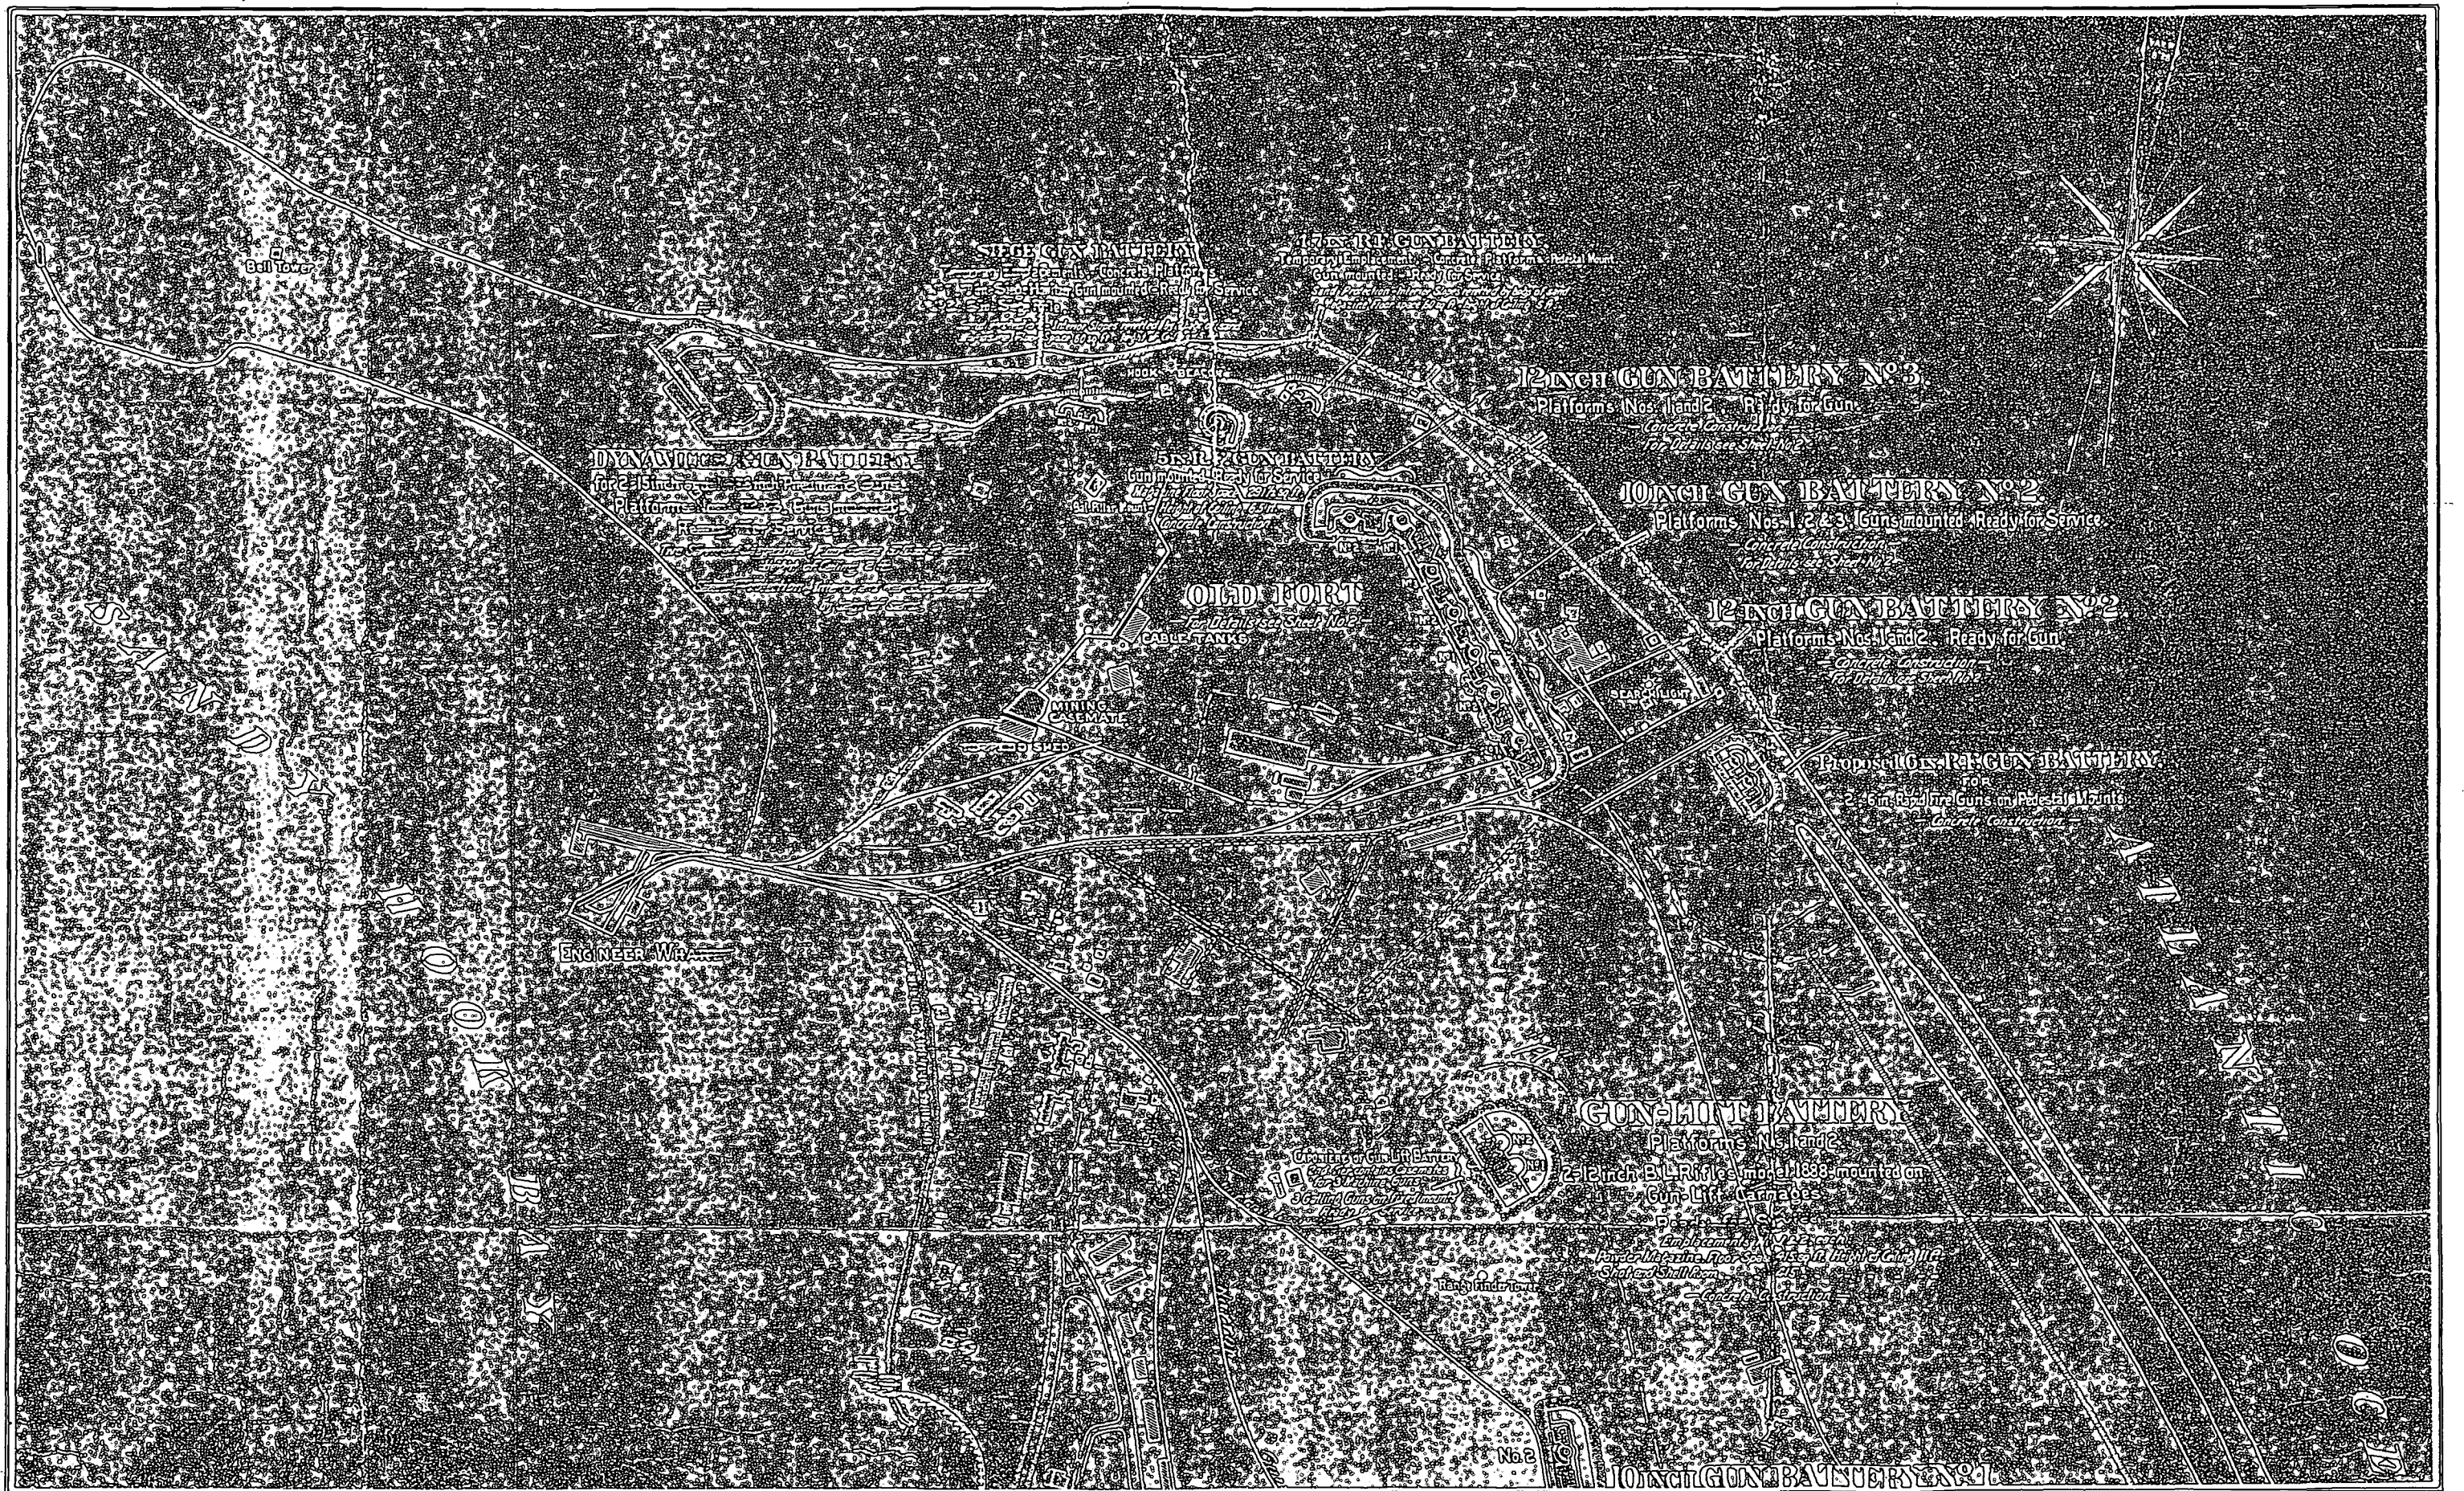
Figure 13: "Map showing Armament on December 3, 1898." From files at Sandy Hook Unit, Gateway NRA.

The Endicott Board, established to review the status of coastal defenses in the United States, recommended in 1886 that Sandy Hook be updated with new weaponry and fortifications.<sup>26</sup> As a result, Sandy Hook was to be expanded and manned by a permanent garrison of well-trained artillery soldiers. This garrison, which became known as Fort Hancock, would be a self-sufficient community where the soldiers would live and train. Captain Arthur Murray drew up a preliminary master plan for the new garrison after initially seeking advice from the New York architectural firm of Carrere and Hastings. The design featured consistency of style, materials, and colors among all buildings, and featured buff-colored exterior brickwork. The basic buildings were completed in 1899 and are shown on the map drawn in 1898 (Figure 13).<sup>27</sup>

In response to the Endicott Board's recommendations to update coastal defenses, the Army Corps of Engineers started the construction of new gun emplacements along the eastern wall of the old granite fort at Sandy Hook. The "Map Showing Armament in 1898" shows the extent of the new construction (Figure 13). Since the Proof Battery would then be directly in front of the new batteries, the Engineers requested that it be moved.<sup>28</sup> In addition, several accidental explosions and fires at the Proof Battery, as well as an increase in manpower in the Proving Ground from 35 to 62 men, indicated that the operations and facilities needed improvement and expansion.<sup>29</sup>

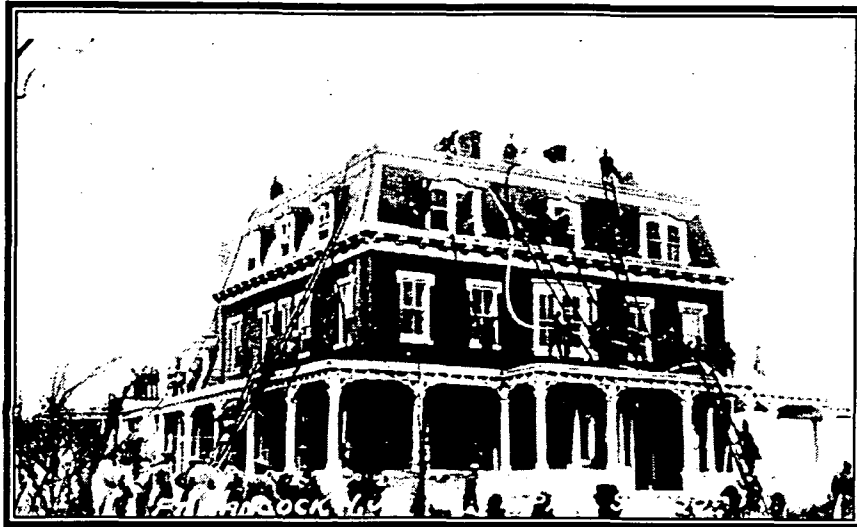
Figure 20: Officers' Quarters (Brick House) at the time of the fire in April 1938, view from the southeast. Photo from files (#2036) at Sandy Hook, Gateway NRA.

Very little documentation has been found concerning the grounds of the Officers' Club during this period. In 1937, foundation plantings and other landscaping were accomplished with CCC labor and funds. Unfortunately, however, there is no known surviving plan or list of materials used in this work.<sup>58</sup> In April 1938, a fire at the Officers' Club damaged the roof and third floor. Photographs documenting this fire are a rare source of information about the exterior and grounds of the Officers' Club (Figures 20 & 22).

1905 A dining room is added south of the original, effectively making two dining rooms with an arched doorway between. The new dining room had a bow window very nicely detailed on the exterior as can be seen in a photograph at the time of the fire in 1938 (Figures 20 and 21). The 1918 drawing and the 1924 aerial are clearly in agreement with this photograph. Buff colored bricks were not used in the construction of this addition as evident in the 1938 photographs at the time of the fire, nor is the building painted buff at this time as suggested by Sulam.

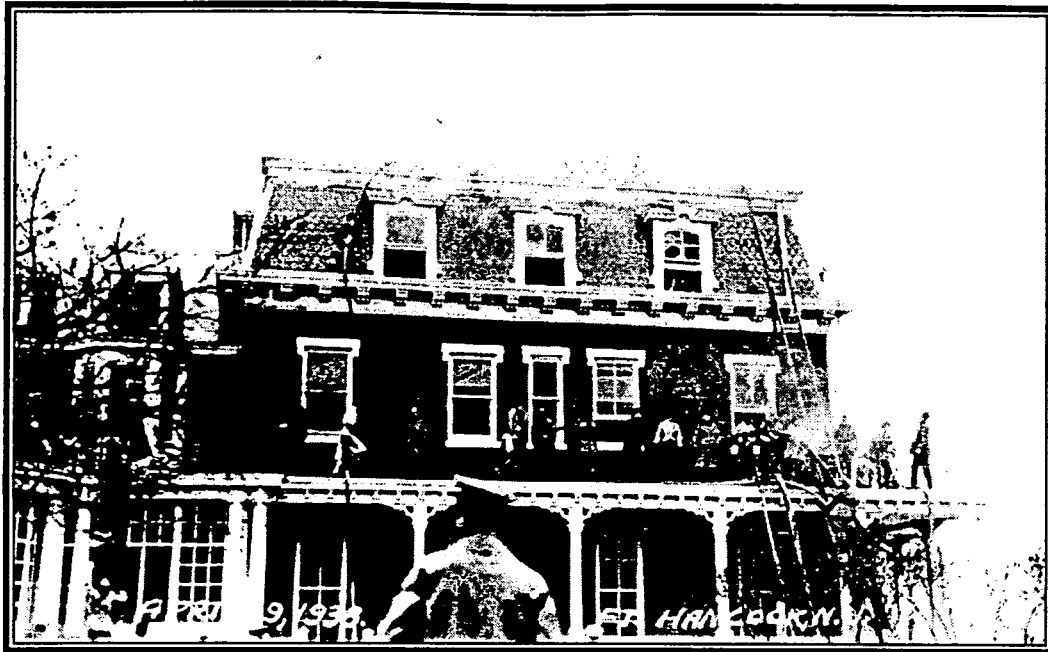
Figure 22: The Officers' Club (Brick House) at the time of the fire, April 1938, view looking north. The bay window and columns of the new dining room can be seen on the left. Photo from files (#2037) at Sandy Hook, Gateway NRA.

In 1905 the officers' elegant dining room was expanded, and an additional dining room was added to the south along with additions to increase the space in this building. A bay window, perhaps the original, was located in the same relative position as had been in the original dining room, as shown in the aerial photograph enlargement (Figure 18). This additional dining space indicates the expanded role the Officers' Quarters played for the Proving Grounds personnel. No photographs from the Proving Ground period are available, but photos of the south facade taken at the time of a fire in 1938 shows a rounded bay, with classically detailed windows and columns (Figures 20 & 22). The top of the bay follows that of the porch and the wooden columns and window trim is painted the same color as the trim on the porch. The bay window would have provided a view of the lighthouse and a pleasant extension into the landscape from the dining room when it was not possible to be outdoors. The wooden porches on the

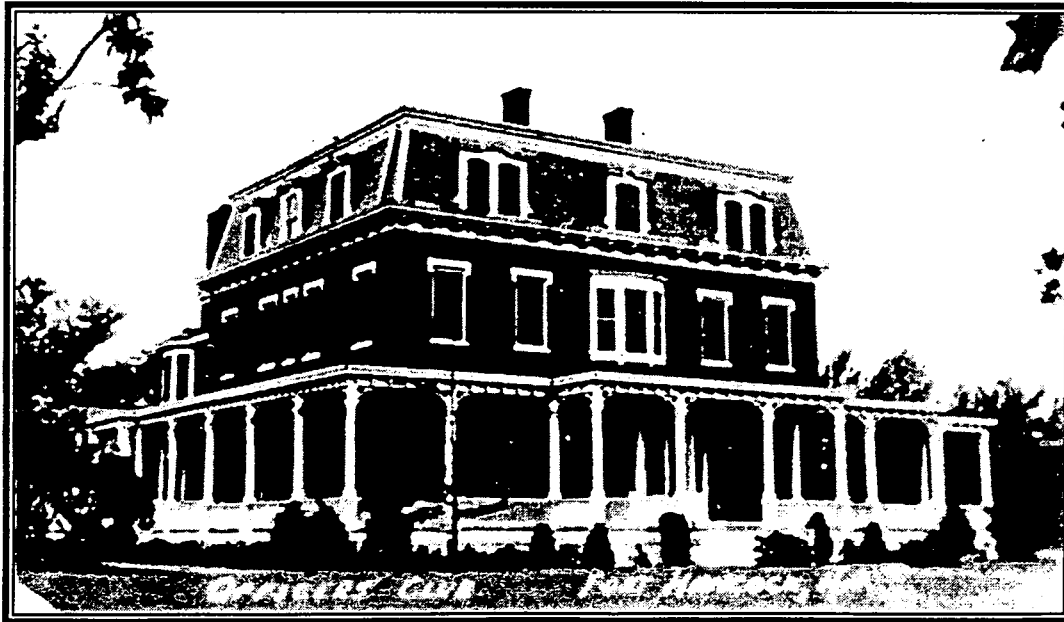
Figure 23: Officers' Club (Brick House) view looking northwest c. 1937-40. Photo from files (#7050) at Sandy Hook, Gateway NRA.

Another photograph from this period shows low evergreen foundation plantings along the front and south side of the Officers' Club, as well as a small deciduous tree located in the southeast corner in front of the walkway (Figure 23).

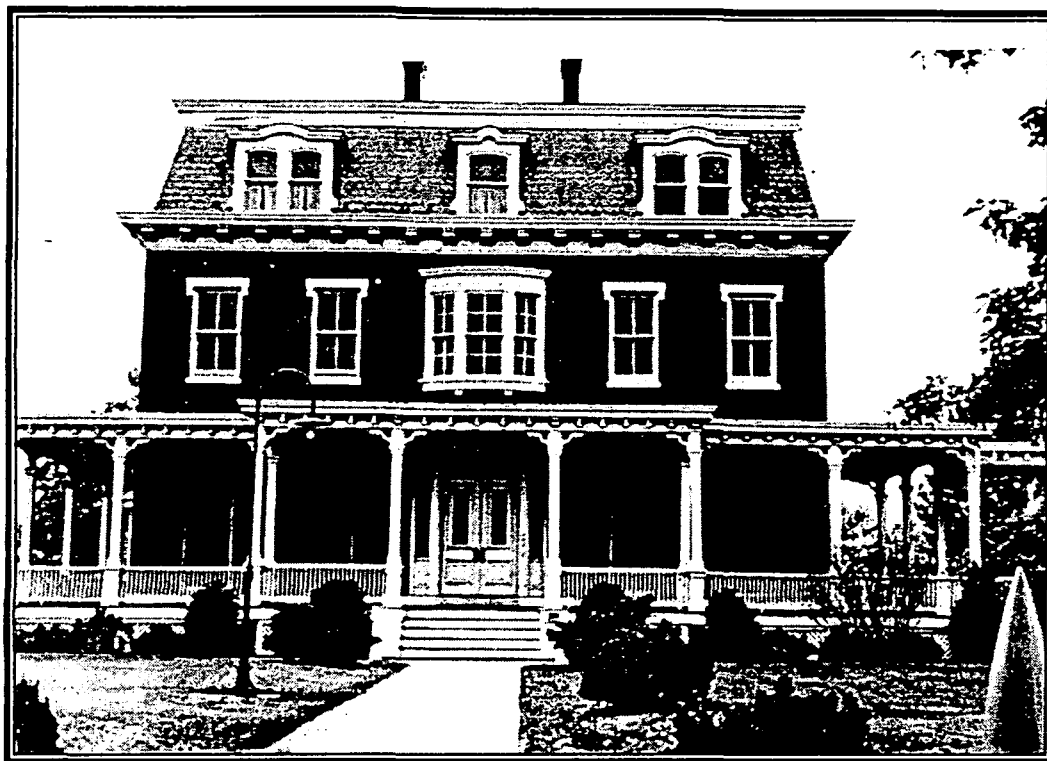
Figure 24: Officers' Club view looking west at front door, c. 1937-40. Lighting fixture and ornamental artillery shell shown along the walk to front door. Photo from files (#7317) at Sandy Hook, Gateway NRA.

A photograph taken slightly later shows low evergreen foundation plantings which might include yews, along the front of the house (Figure 24). A deciduous shrub, possibly a lilac, is to the north of the building, and clumps of evergreens, possibly junipers, appear along the concrete walk to the front door. In the lower right-hand corner of the photograph the tip of an artillery shell can be seen, indicating that military objects were used ornamentally at the Officers' Club, as at Fort Hancock.

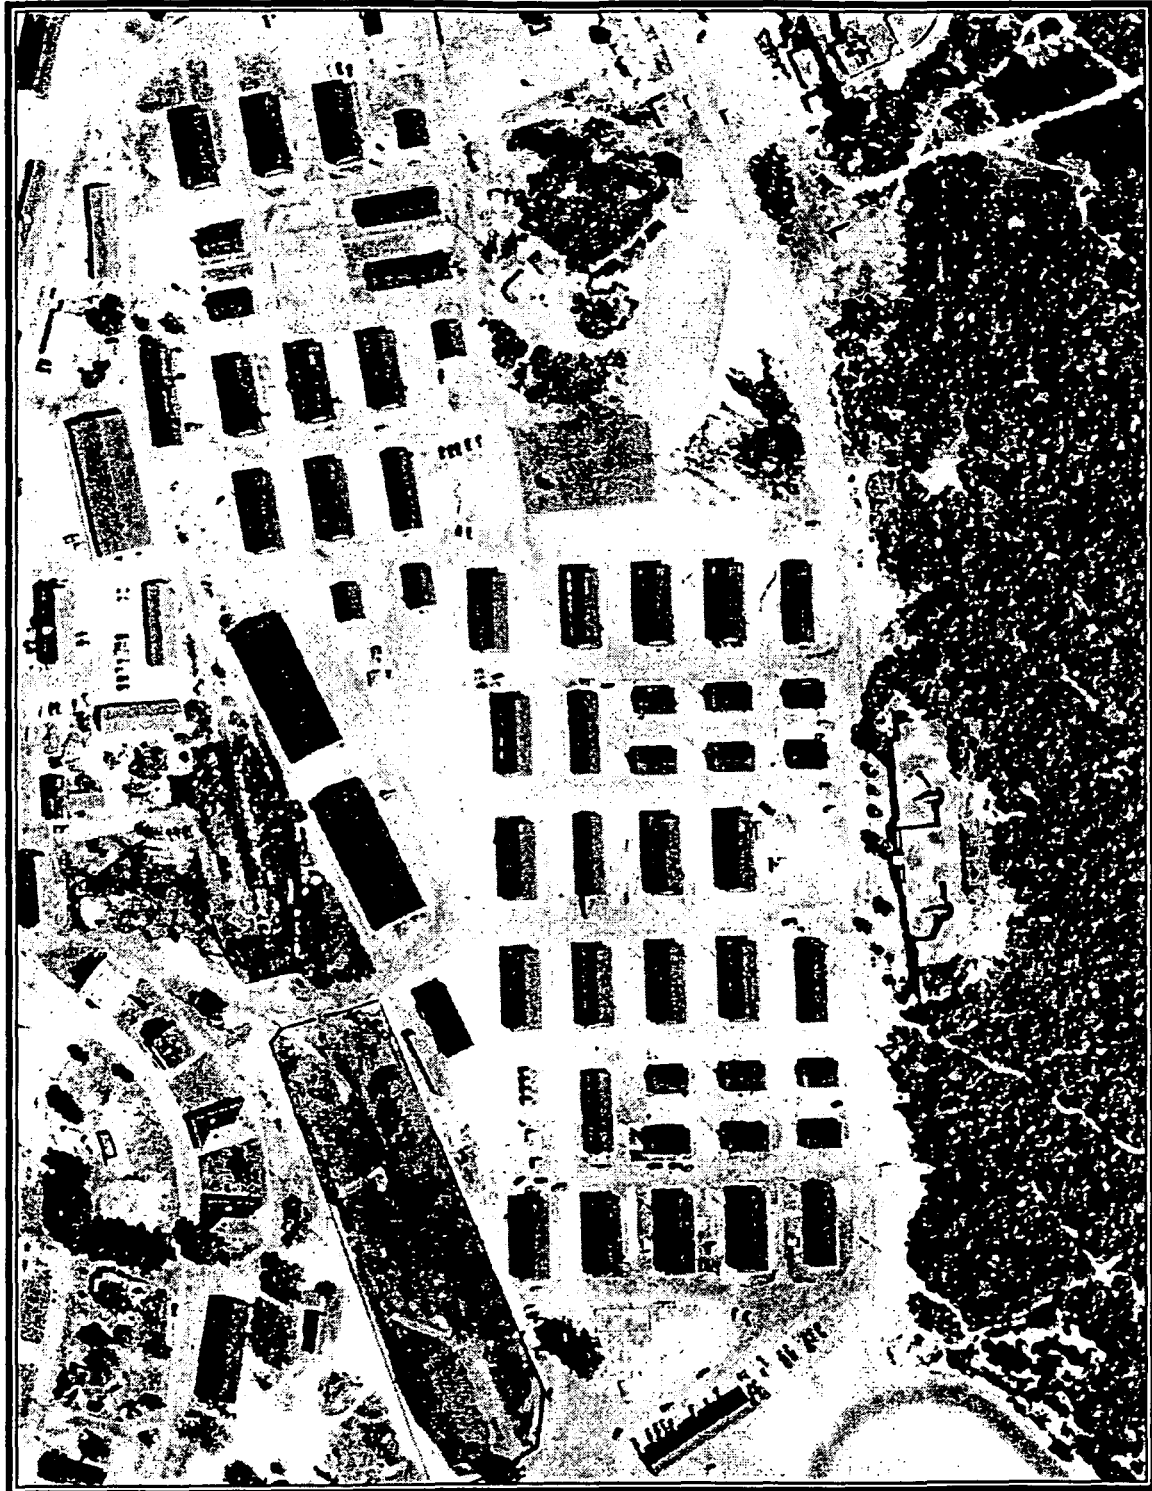
Figure 28: WWII expansion areas. Hudson Drive and Battery Granger can be seen on the right. The older support buildings of Fort Hancock are along the left. The landscape surrounding the WWII structures appears devoid of plant materials, either for functional or ornamental purposes. (north is located at the top of page) Enlargement from 1943 aerial photograph, Figure 27.

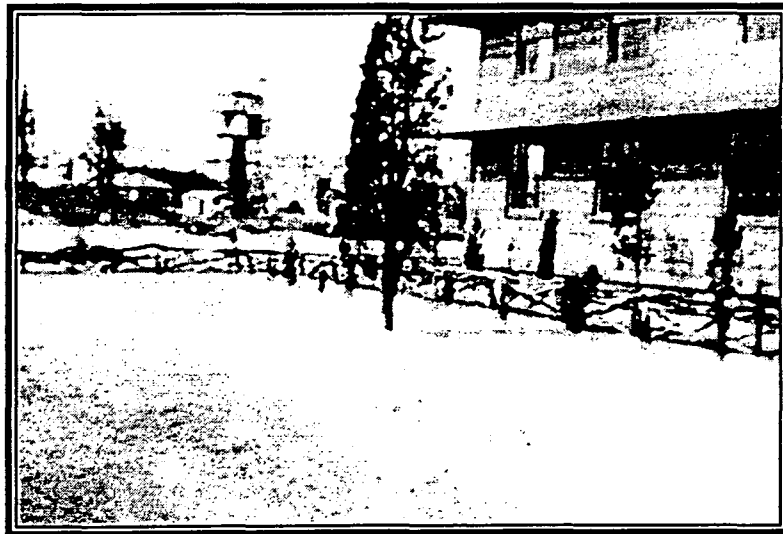
Figure 32: Fencing and plantings (Eastern redcedar) in front of barracks in area southwest of Battery Potter, c.1941. Photograph from files at Sandy Hook, Gateway NRA.

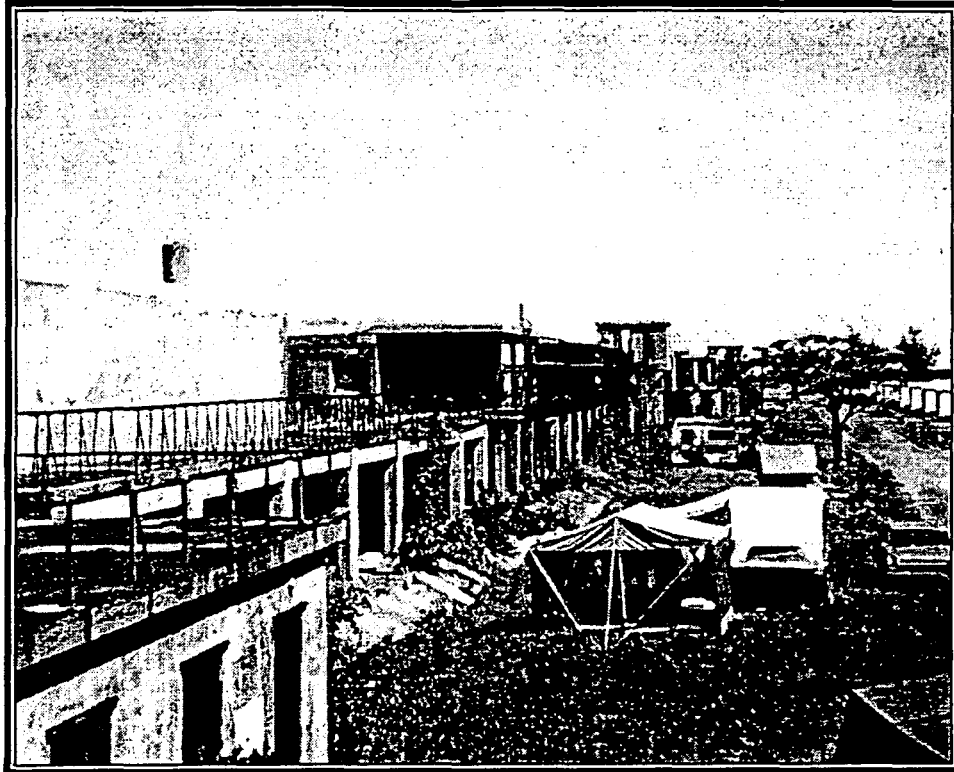
Figure 35: 1<sup>st</sup> U.S. Army Recreation Area, west of Nine-Gun Battery, looking south. Photo by Thomas J. Hoffman, August 1974.

Another area developed for a new use in this period was west of Nine-Gun Battery. This location has undergone many different uses, including cantonments in World War I, and additional housing and service areas in World War II. Starting in 1966, it had a non-defensive use as the 1<sup>st</sup> U.S. Army Recreational Area for vacationing retired or active members of the military (Figure 35). Four remaining WWII barracks, two mess halls, twenty permanently installed trailers, and a recreation building were available to vacationing Army personnel for a nominal fee. In addition, space and services were available to those who had their own trailers. A "Camper Support" building (#157) was added in 1971, offering laundry and restroom facilities. The docks, still part of the Army reservation, were used for fishing, and vacationing Army personnel could dock their own boats or use small boats supplied by the Army for fishing or excursions into the bay or ocean.<sup>63</sup> This recreational use of the site presaged the next phase of use of the landscape at Sandy Hook.

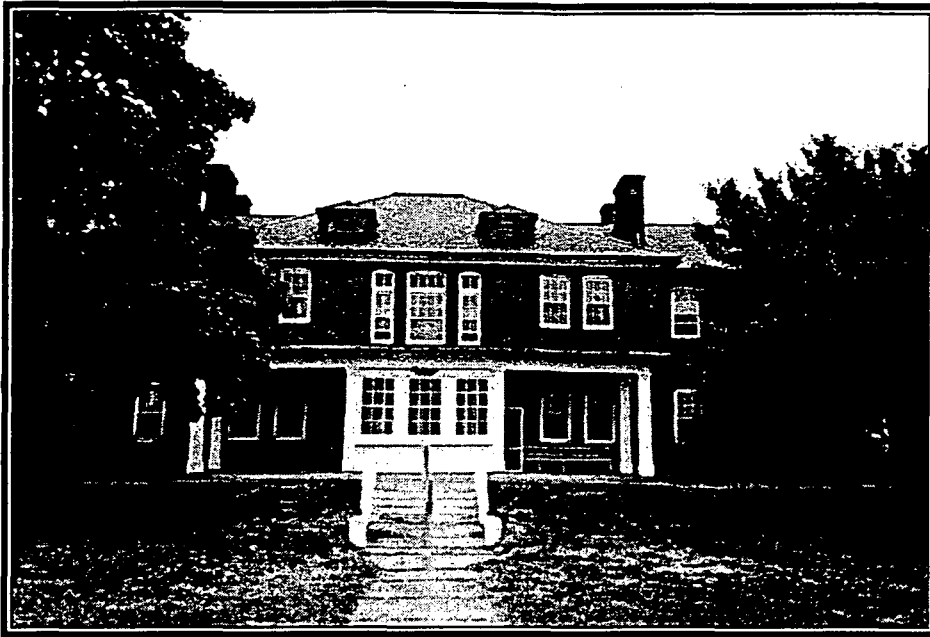
Figure 37: View to the east of the front door of the Education Center (Building 102) formerly the enlisted men's barracks for the Proving Grounds. Photo by author, 1998.

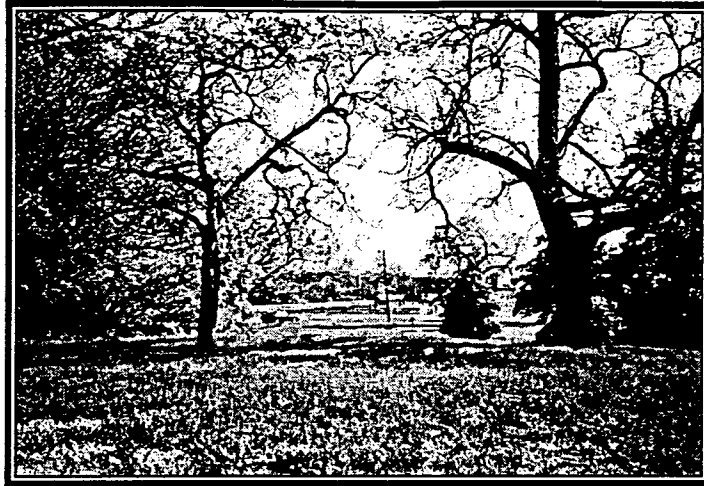
Figure 45: Contemporary view looking south of Officers' Club lawn. Photo by author, 1998.

The grounds around the Officers' Club include lawn with several large catalpa and hackberry trees (Figure 45). London plane trees and maples line the roads around the Officers' Club. Large American holly trees and ornamental shrubs such as lilacs, yews, and junipers are scattered informally throughout the lawn. Many of these trees, especially the holly trees, are overgrown and crowd the walks that lace the grounds (Figure 46).

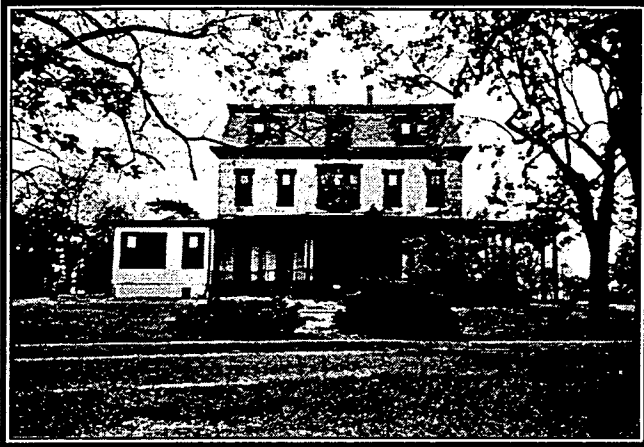
**Figure 47:** View looking west at the front of the Officers' Club. Compare with similar view from 1930's (Figure 24). Photo by author, 1998.

The Officers' Club faces east toward the ocean and the former Proof Battery, and a concrete walk with overgrown spreading junipers planted at the street curb extends to the porch (Figure 47). The front porch steps are missing and large weeds are growing in the three-foot wide planting beds next to the house. There is a utility vault flush with the lawn approximately halfway up the walk on the south side, and across from it is a very large spreading juniper. The walk continues parallel to the front of the house connecting the driveway to the south lawn and farther to South Bragg Drive. A large, 20 foot high yew is growing in the north corner of the intersecting paths in the front of the Officers' Club, with a small chokecherry to the north of the yew (Figure 48).

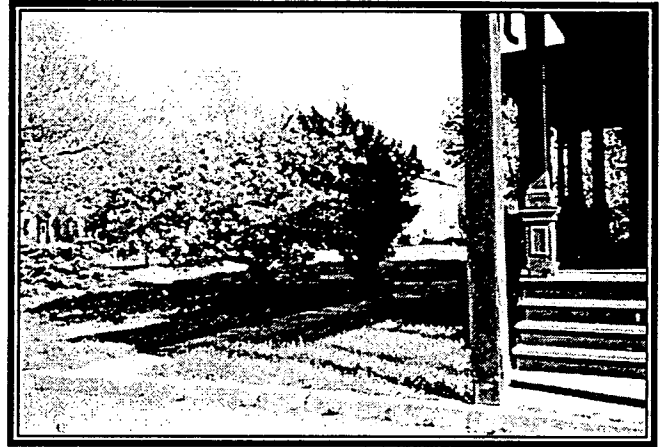
**Figure 48:** Close-up of overgrown shrubs and small chokecherry tree at northeast corner of Officers' Club. Photo by author, 1998.

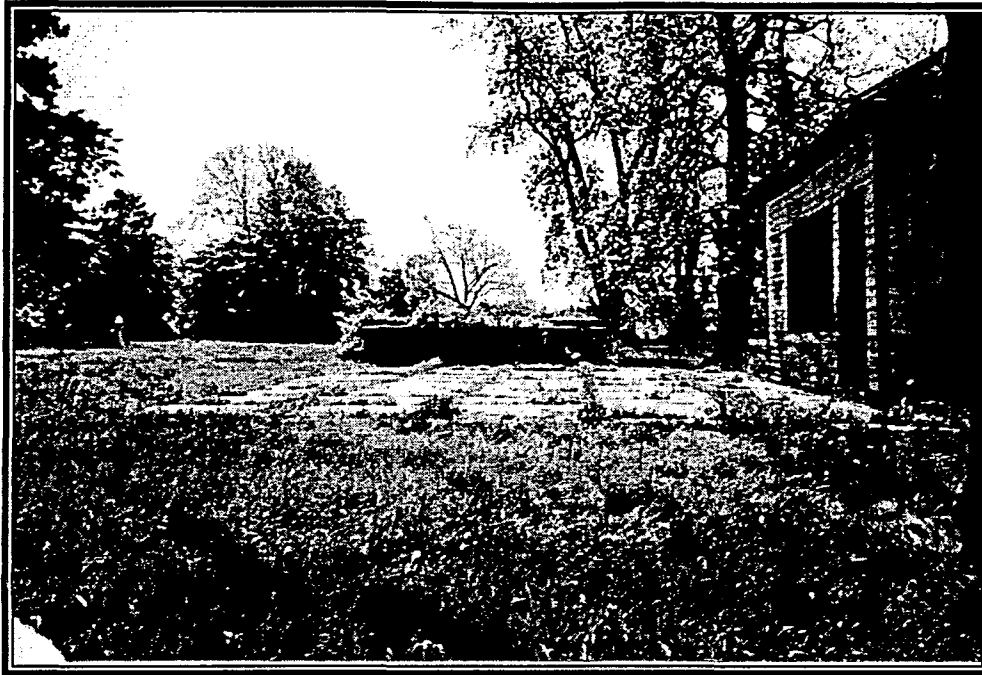
Figure 50: Caddy House with terrace and barbecue, looking south. Photo by author, 1998.

Another concrete walk extends from the paved area at the rear of the Officers' Club to the Caddy House (Building 113). To the north of this walk near the house is a garbage shed painted white with lattice on the upper half of the wooden and concrete block structure (Figure 49). In front of the Caddy House is a concrete terrace with a barbecue with three grills built into a curving concrete block wall that stretches almost the whole length of the southern edge of the terrace (Figure 50). Poison ivy and other weeds are growing through the cracks in the concrete, and metal parts of the structure have rusted. However, the location is very pleasant, offering views to the south and west. The concrete steps from the Caddy House to the road to the north need repair. Large electrical boxes north and east of the terrace intrude on the residential nature of this landscape (Figure 51).

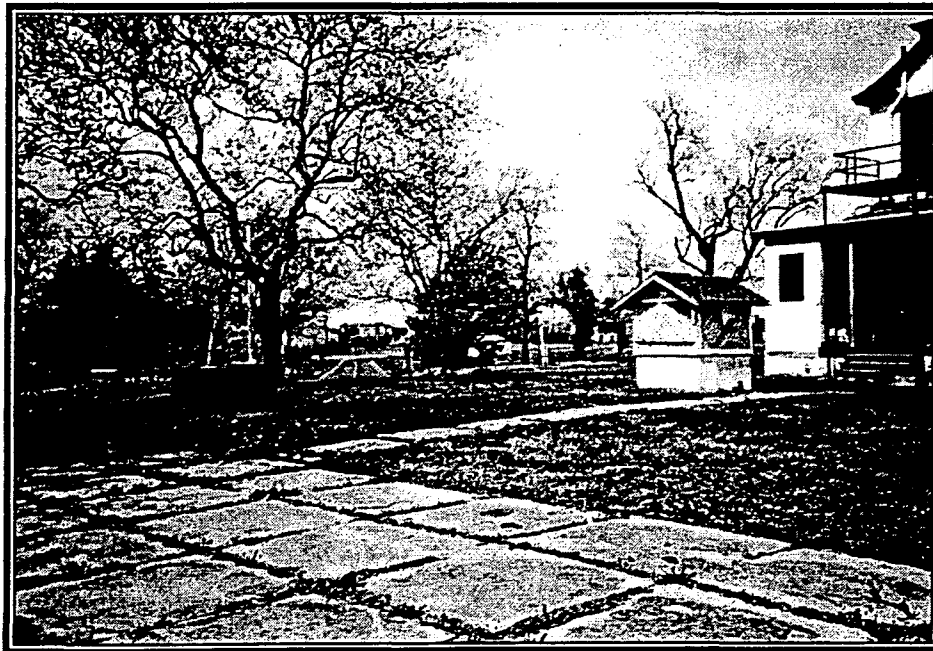
Figure 51: Looking north from terrace at Caddy House, with electrical vault dating from 1981-82 on left, garbage shed on right behind Officers' Club. Photo by author, 1998.

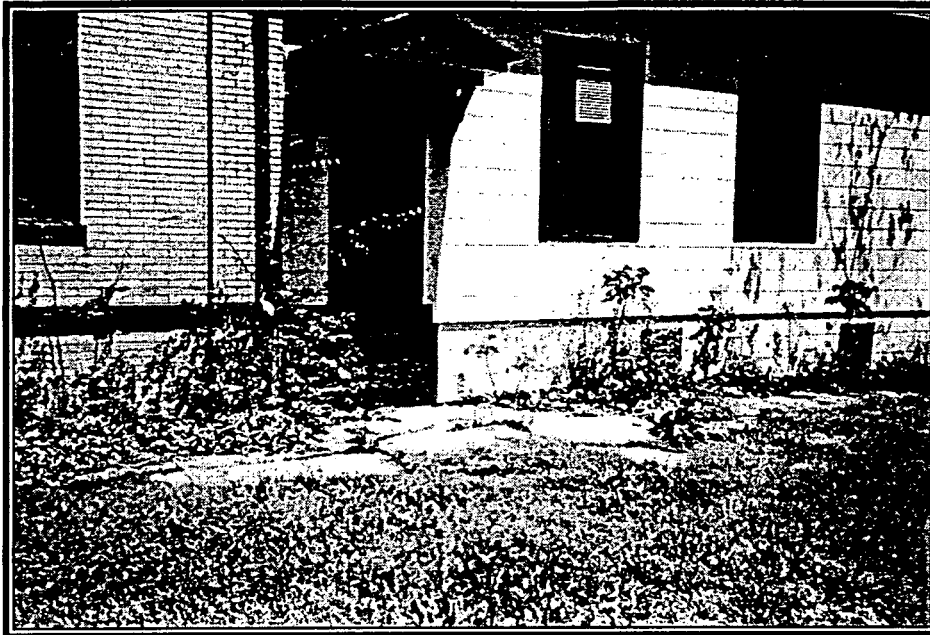
Figure 52: South facade of Officers' Club with concrete paving at doorway. Photo by author, 1998.

On the south side of the Officers' Club is a four-foot wide concrete walk extending the length of the façade. It is in disrepair and weeds grow between it and the building. Near the door frame in the middle of this façade the paving widens slightly, although its exact shape is obscured by weeds (Figure 52).

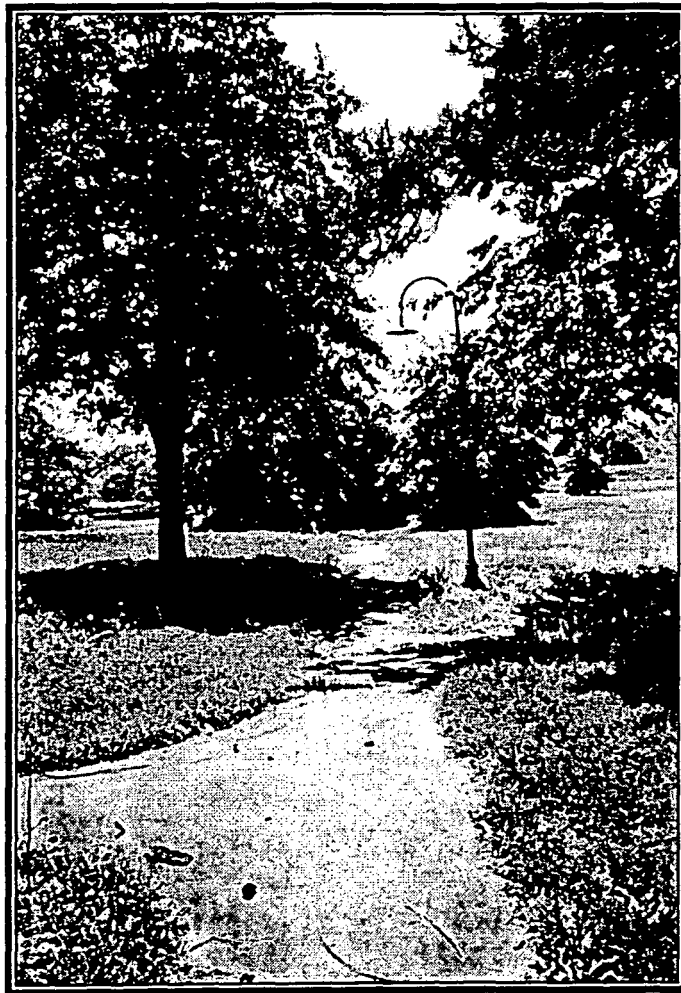
Figure 53: Historic light fixture along walkway, near southwest corner of Officers' Club. Photo by author, 1998.

One of these lightposts is now located at the southwest corner of the Officers' Club. Joe Boyle remembered painting it dark green when he worked at Sandy Hook from 1953-1985. He also remembered repairing the wiring which ran down the interior of the post, and that it had a simple porcelain fixture with an exposed bulb. Conversation with the author and Tom Hoffman, February 3, 1999. (see Figure 50)

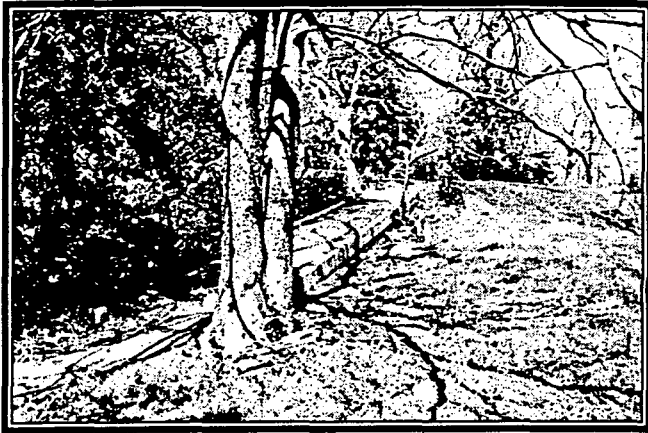
Figure 54: View to north of ramped walkway going from South Bragg Drive, past location of former greenhouse, to Officers' Club. Photo by author, 1998.

From this side of the building there is a view to the south of the lighthouse. This view is not obscured either by the catalpa and hackberry trees scattered across the lawn of the Officers' Club or by the overgrowth in the flat open space across the road. On the southwest corner of the building, between a fork in the concrete walks, is a light fixture dating from 1897 (Figure 53). However, this is probably not the original site of this fixture. About 100 feet from the building, the ground drops to a flat area where the former greenhouses were located. A concrete ramp descends from the east to this lower area (Figure 54). At the top of the ramp is a fragment of the base of a light fixture similar to that near the southwest corner of the house.

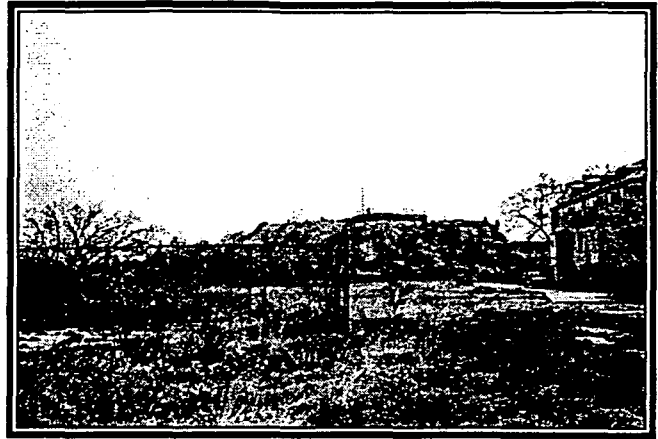
Figure 55: View south from Officers' Club tennis court to Battery Potter and rear of duplex (Building 145). Photo by author, 1998.

Across Canfield Road in the open area containing the tennis court, are visible sections of concrete walks. These once served the World War II structures that filled this area. From the tennis court area there is a dramatic view to the south of the mounded side of Battery Potter (Figure 55).

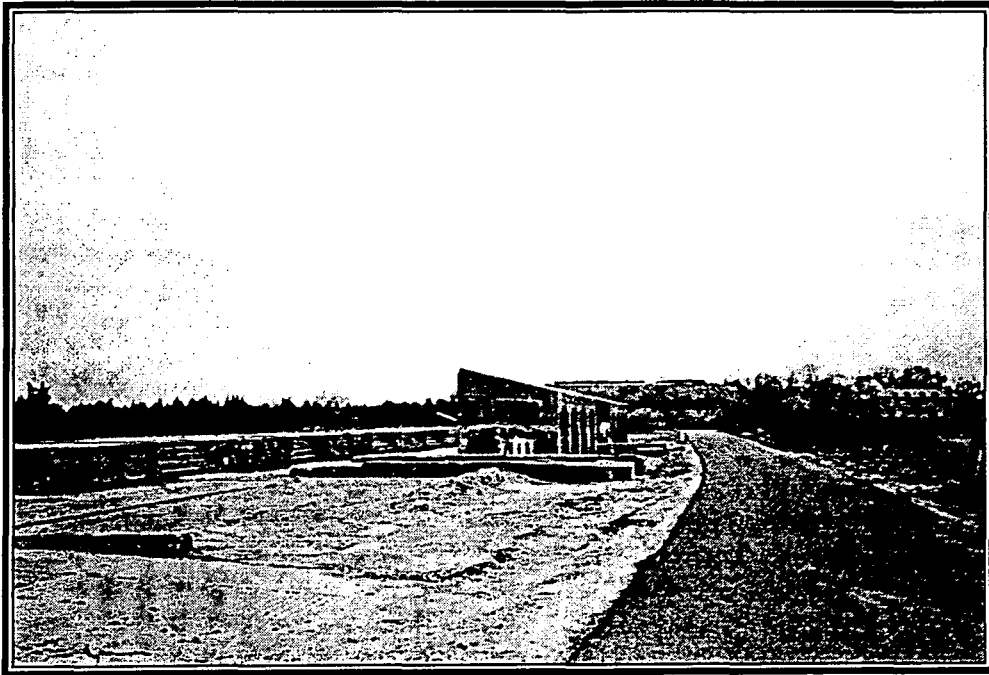
Figure 56: Proof Battery traverses looking west, with Building 145 in background. Photo by author, 1998.

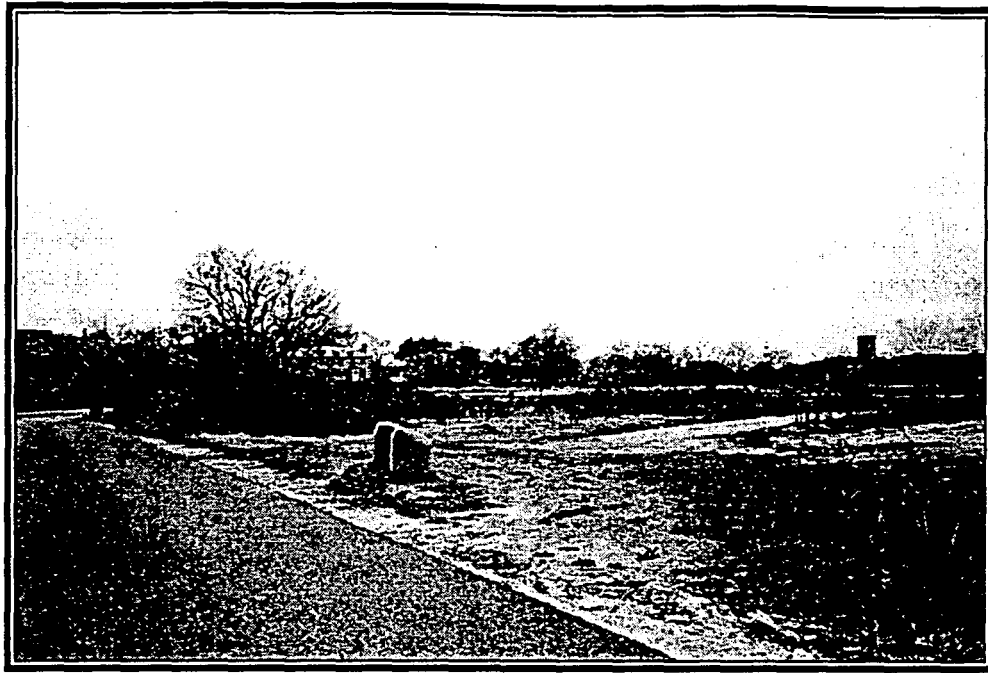
Figure 57: Proof Battery looking west with interpretive sign in the foreground and Officers' Club and rear of duplex (Building 145) in background. Photo by author, 1998.

Taking a left onto South Bragg Drive, the visitor continues east to Atlantic Drive and the North Beach parking area 'J' which is north of the former Proof Battery. The concrete ruins of the traverses, gun mounts, and other structures (173, 174, 174A) are very prominent features in the landscape and their unusual shapes make it difficult to determine their original use (Figure 56). This area is sandy, with some herbaceous plants and small shrubs. Looking back toward the west you can see Battery Potter, the rear of duplex 145 and the Officers' Club. There is a small concrete interpretive sign between the parking lot and the Proof Battery (Figure 57). Looking south, down the dunes from the top of the concrete ruins, the newly constructed parking lot for North Beach is hidden from view. The concession stand and beach are farther along the service road.

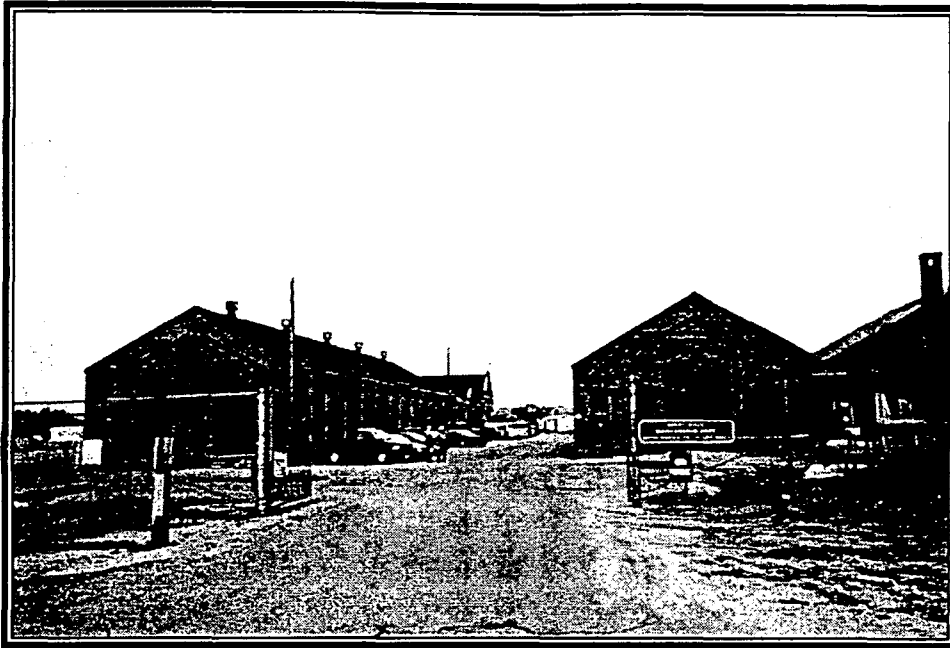
Figure 58: Park Service maintenance area looking east. Photo by author, 1998.

The NPS North Maintenance Area consists of several large brick buildings (# 124, 125, 130, 131, 132, 133), and is located on the north side of Canfield Road, across from building 108 (Figure 58). The brick detailing of these buildings is very well done and their wooden trim is painted green. Although these structures appear to be mostly well cared for, the roof of Building 125 is collapsing as can be seen from the road (Figure 59). These buildings are used by the park service for maintenance offices and shops, and cars and trucks are parked in the large paved area between the buildings.

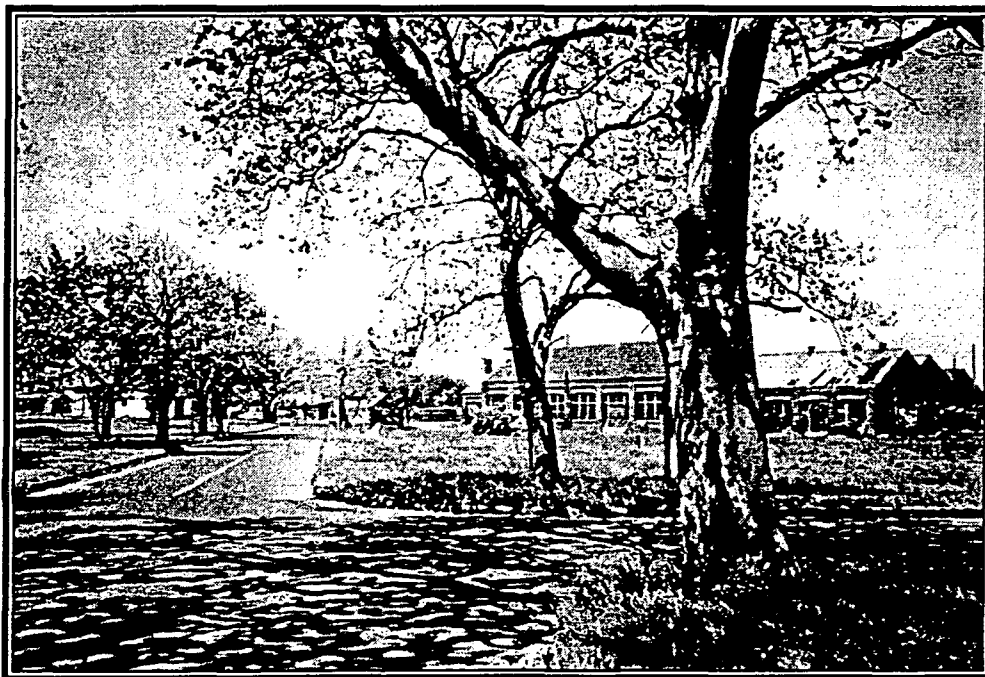
Figure 59: Looking west along Canfield Road; note collapsed roof on Building 125 at the far right. Photo by author, 1998.
