Historic Fortification Preservation Handbook

Pacific Northwest Preservation Partnership

Published by Washington State Parks and Recreation Commission, 2003

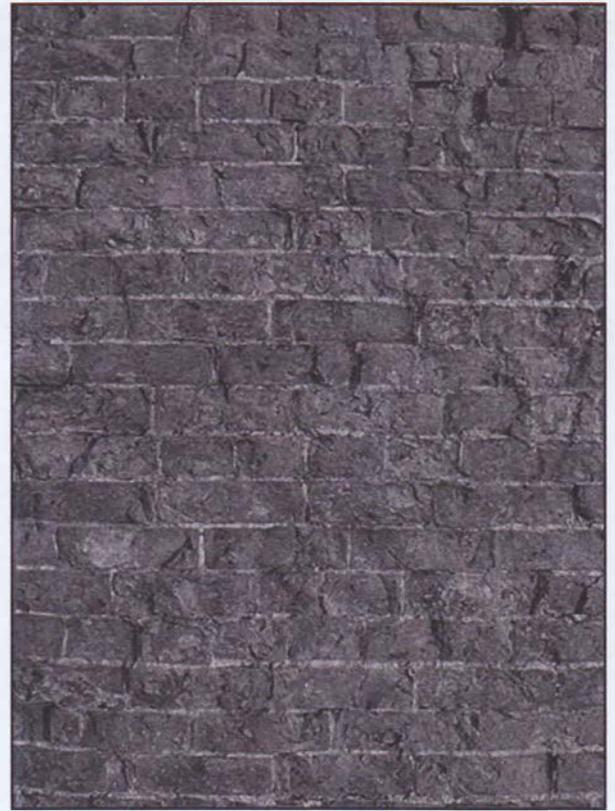
Exterior wall surface in poor condition—note use of non-lime based mortar for finish pointing of joints also eroded face of bricks.

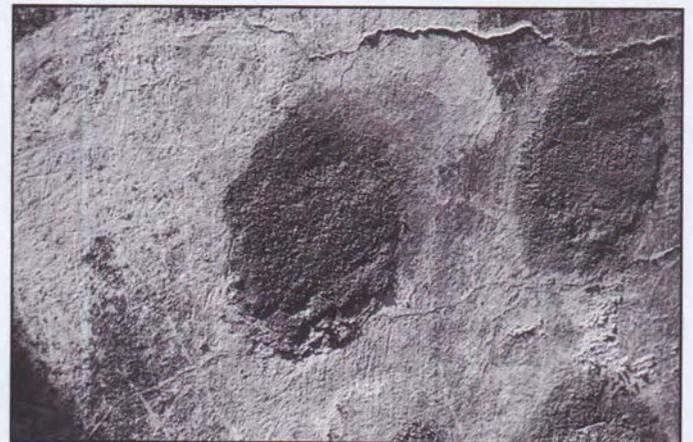
Removing core leaves a large hole that must be repaired. This repair needs to be resurfaced so that it will better match the surrounding historic fabric. Battery Worth.

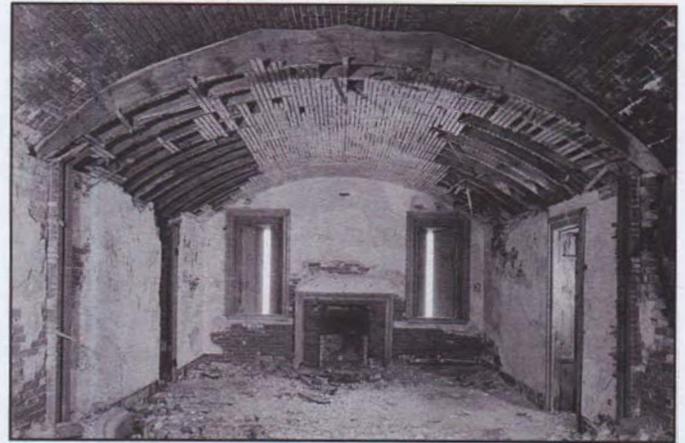
The edge of a sheet metal diversion membrane is visible above the lath and plaster ceiling of this casemate interior at Fort Gorges, Maine.

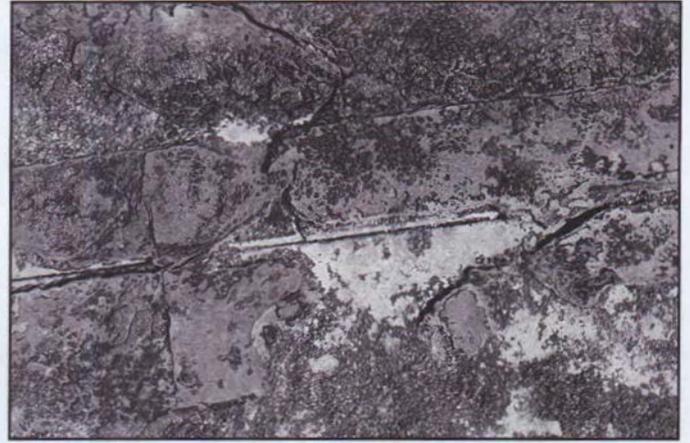
The remains of tar and roofing felt on this battery at Fort Winfield Scott, California, are ample testimony to the continuing quest for dry interior spaces during the period of historic use.

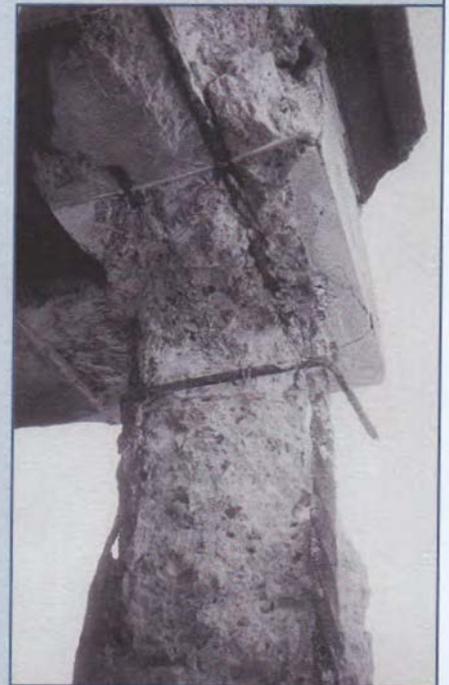
Figure 5. Severe spalling of vertical pillar supporting overhead protection at ammunition hoist, 2000.

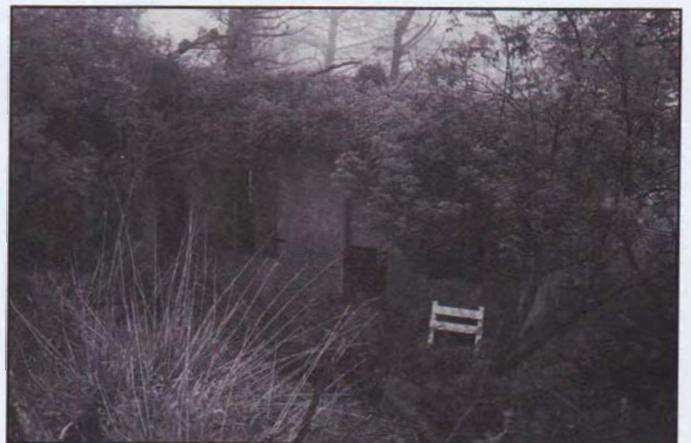
Uncontrolled plant growth can lead to the rapid deterioration of wood-frame structures that are also part of many fortifications. Fire Control Dormitory, Fort Canby, Washington.

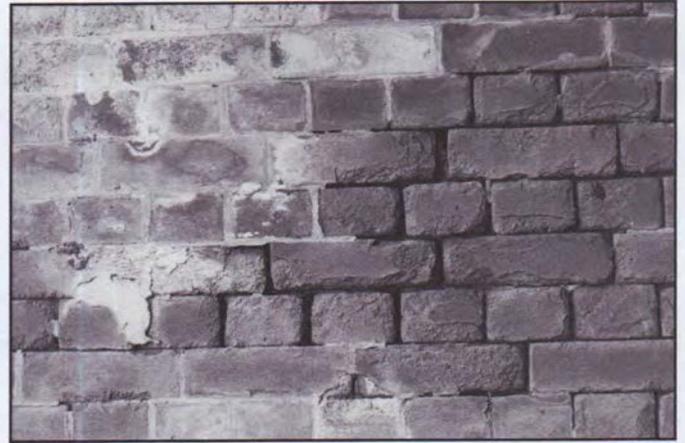
Open joints indicate that this brick wall is overdue for repointing. Battery Cavallo, Fort Baker, California.

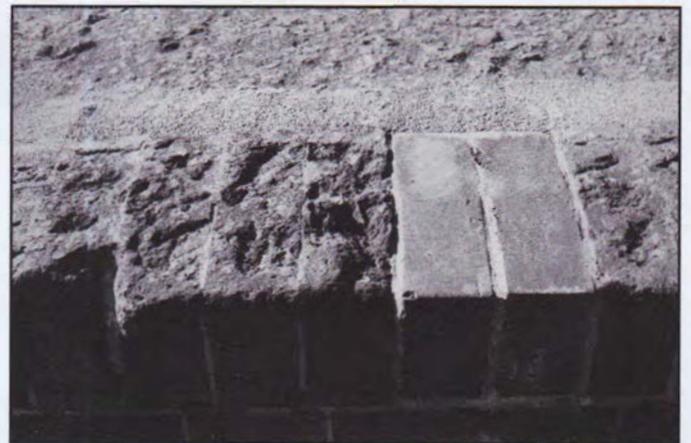
These two new bricks replaced damaged units. Avoid distressing new material to give it the appearance of age. Fort Point, California.

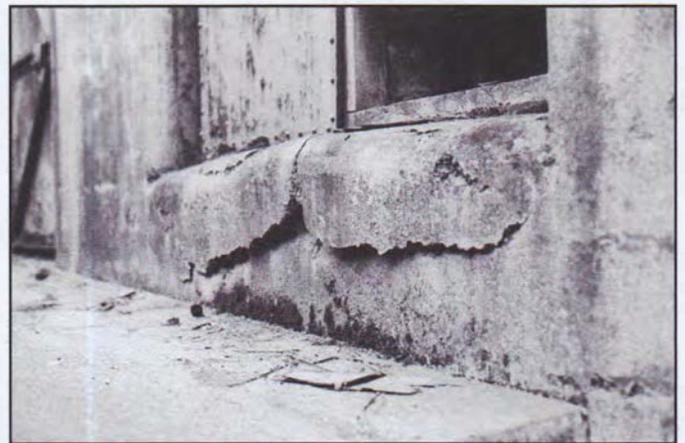
When corroded, metal expands to approximately ten times its original volume. The force is sufficient to break and detach surrounding concrete or masonry. Battery Tolles, Fort Worden, Washington.

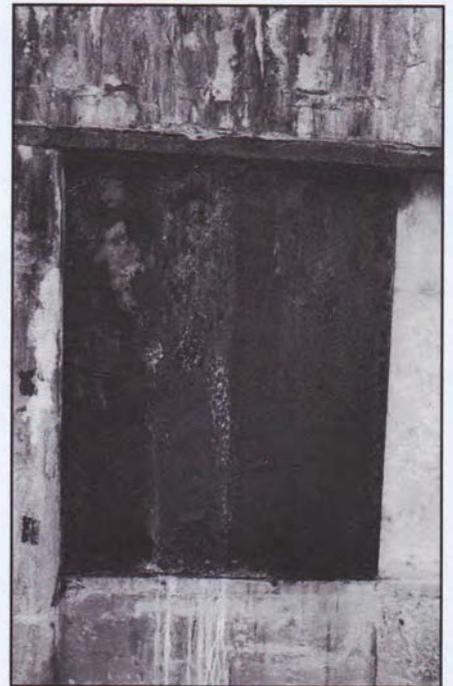
Always test products, especially rust converters. Here, several products are undergoing longterm trials (including one that has left a white residue on the surface) Battery Crattan, Fort Flagler, Washington.

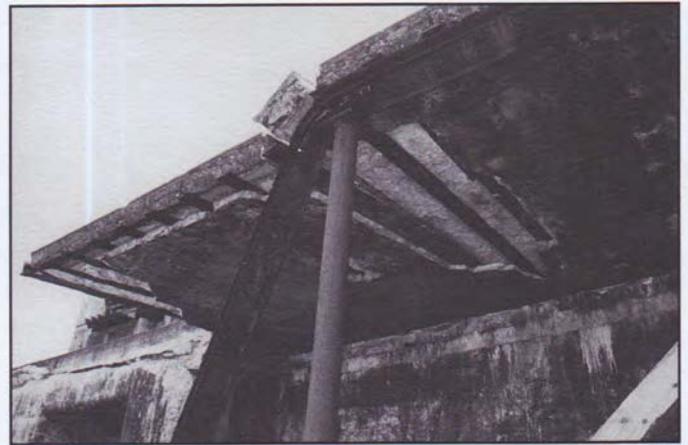
Several causes contributed to the failure of this platform at Battery Cullum at Fort Pickens. Included among them are loss of a supporting column, corrosion-induced loss of section in the beam, and questionable original design detail.

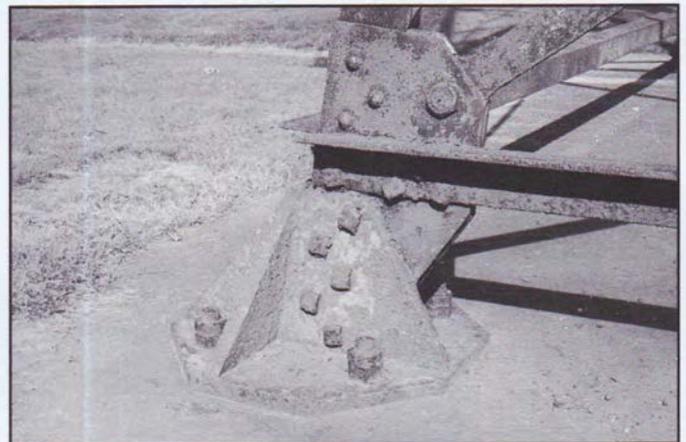
This cast-iron shoe is the connection for an assortment of stiffener angles at the base of a fire control tower at Fort Mott. It displays a variety of connectors. Loss of section of any components will compromise the structural integrity of the tower.

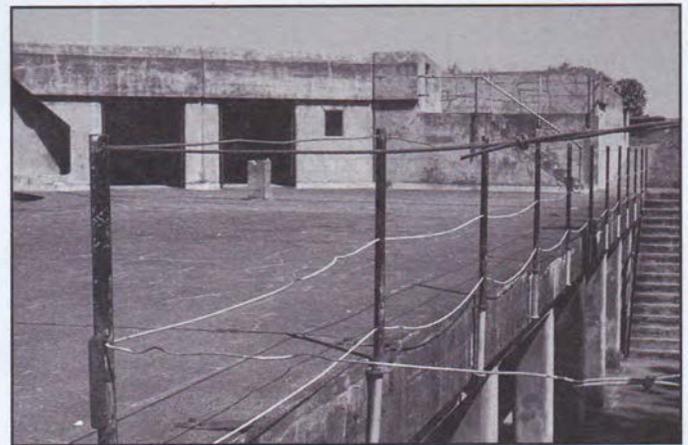
This expedient railing repair is difficult to maintain, offers little protection, and is not in keeping with the historic design. Battery Kinzie, Fort Worden.

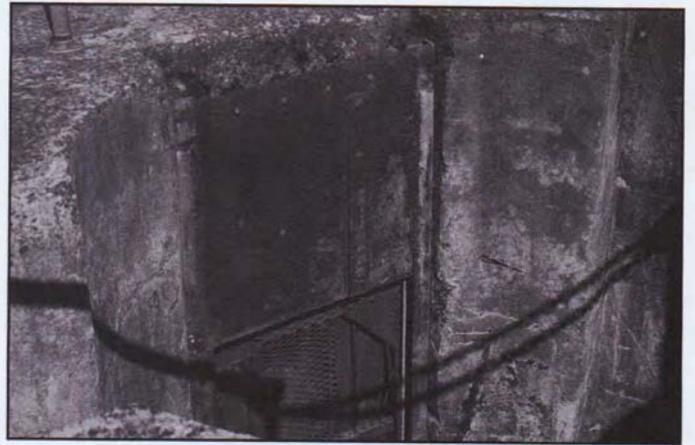
The historic resource should never be scavenged for materials. Doors taken from other locations have been cut and welded together to close this opening at Battery Mishler, Fort Stevens.

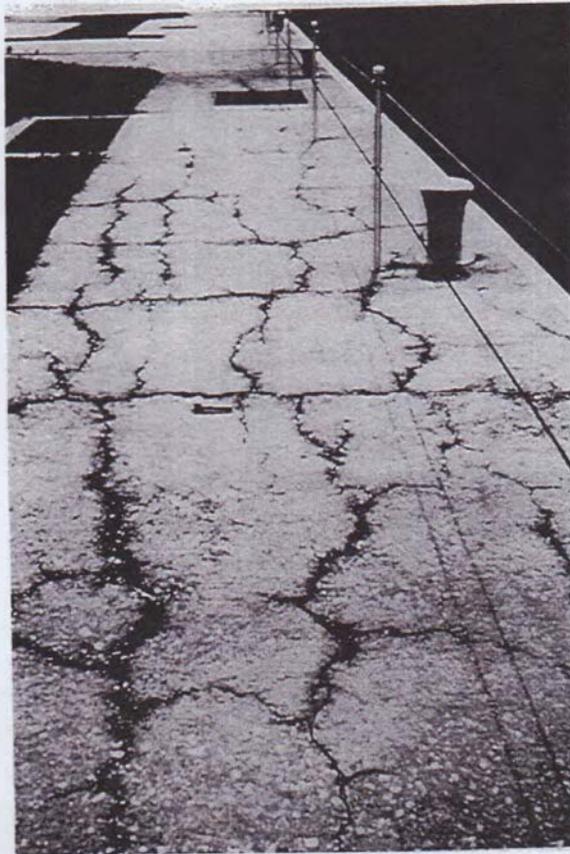
Fig. A.1.6d-Pattern cracking (alkali-silica reaction)
